# Visual Site Inspection Report

<b>Project Name</b>	H-600 Pipeline Spread G	<b>AFE</b>	124300137	<b>Spread</b>	H-600 Pipeline Spread G
<b>Contractor</b>	Precision			<b>Report #</b>	1187
<b>Inspector</b>	Garrett Barclay			<b>Date/Time</b>	4/24/2018 2:56 PM
<b>Permit #</b>	TBD	<b>Inspection Type</b>	Weekly	<b>Station Begin</b>	+0
<b>State</b>	VA	<b>Inspection Area</b>	Full	<b>Station End</b>	+0
<b>County</b>	Giles	<b>Ground</b>	Wet	<b>Temperature (°F)</b>	47.00
<b>Municipality</b>	N/A	<b>Weather</b>	Light Rain	<b>Rain Gauge (in)</b>	0.35
<b>GPS Location</b>	37.2427058592786, -80.4292438925062			<b>Rain Accumulation Time (days)</b>	1.00

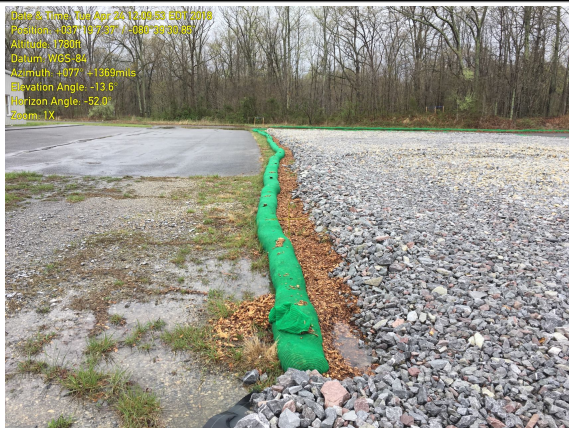
GPS Location	37.2427371237774, -80.4295100179319		GPS Location	37.2427062783737, -80.4294545297329	
Description	LDY 26		Description	LDY 26
