Visual Site Inspection Report

Report # 2380

Spread I Yard

Project Name	H-600 Pipeline Spread I	AFE	124300139	Spread	H-600 Pipeline Spread I
Contractor	Precision	Report #	2380		
Inspector	Tracey Hilbun	Date/Time	5/29/2018 1:29 PM		
Permit #	TBD	Inspection Type	VA SWPP	Station Begin	00000+00
State	VA	Inspection Area	Full	Station End	00000+00
County	Franklin	Ground	Damp	Temperature (°F)	74.00
Municipality	N/A	Weather	Cloudy	Rain Gauge (in)	0.00
GPS Location	36.9793861080305, -79.5958549809452			Rain Accumulation Time (days)	1.00

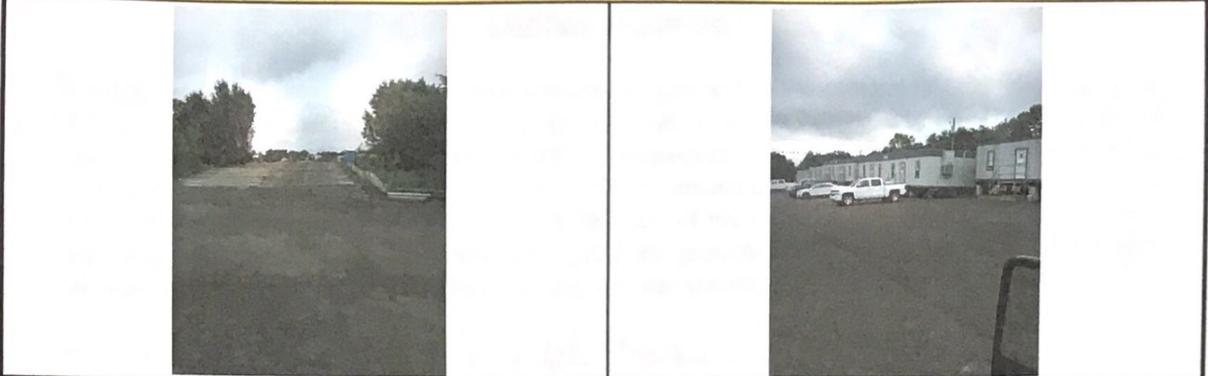
Description	Mat crossing	Description	Offices still in setup mode.
--------------------	--------------	--------------------	------------------------------

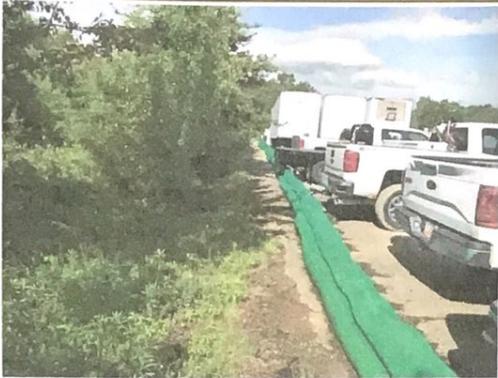
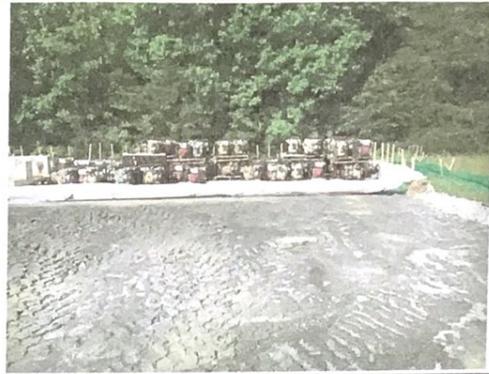
GPS Location	37.0437379414456, -79.8768753271395	GPS Location	37.0437379414456, -79.8768753271395
Description	Stacked log	Description	Pumps contained in storage
Insert image here		Insert image here	
GPS Location		GPS Location	
Description		Description	
Insert image here		Insert image here	
GPS Location		GPS Location	
Description		Description

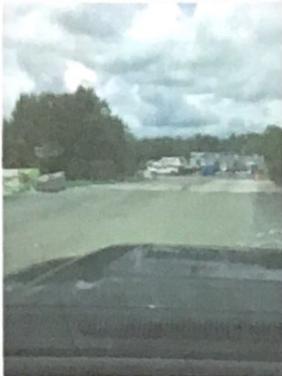
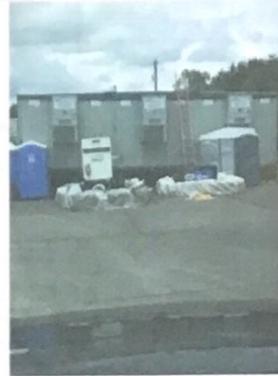
GPS Location	36.9709096569912, -79.8691419047116	GPS Location	36.9708585273819, -79.8690570798515
Description	View of mat crossing and ECD's	Description	Generators in containment

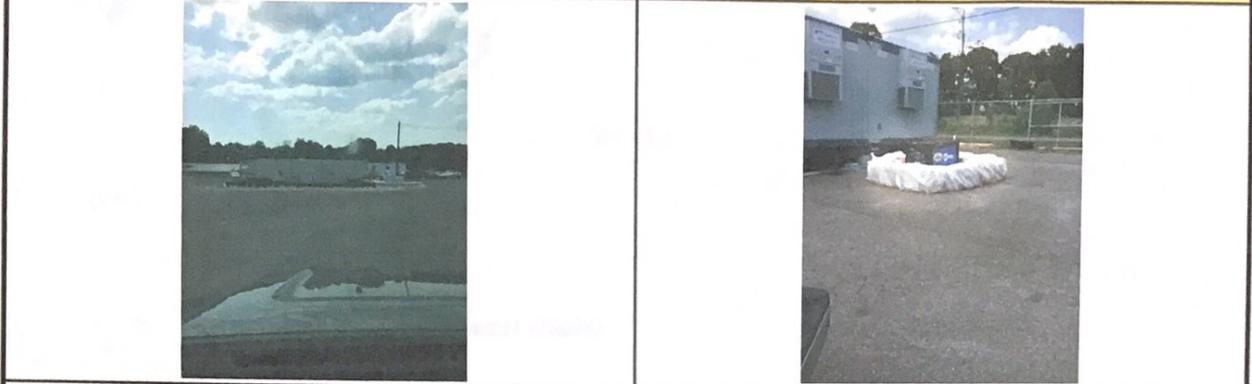
Description View of fuel tank contained.	Description Generator in containment
---	---

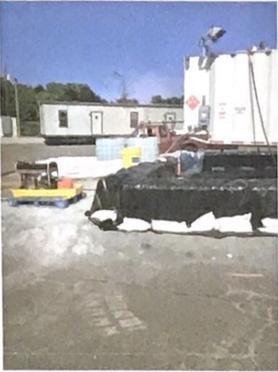
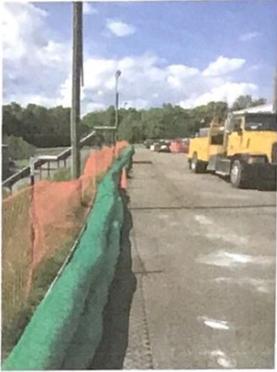
GPS Location	36.97132527366, -79.8702108488231		GPS Location	36.9712953921752, -79.8706058041005	
Description	Fuel containment as well as generator and DEF all contained.		Description	Triple stacked sock and safety fence.

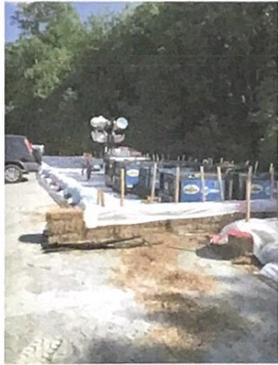
Insert image here		
GPS Location	36.970029054244, -79.8696276360004		GPS Location		
Description	Containment of light plants and welding machines.		Description		
Insert image here			Insert image here		
GPS Location			GPS Location		
Description			Description
