Report #3681

Spread I Laydown Yard

Visual Site Inspection Report

Project Name H-600 Pipeline Spread I		A/E 124300139	Spread H-600 Pipeline Spread I
Contractor Precision		Report # 3681	
Inspector Glenn Mike Renfro		Date/Time 6/26/2018 4:37 PM	
Permit # TBD	Inspection Type VA SWPP	Station Begin	0000+00
State VA	Inspection Area Full	Station End	0000+00
County Franklin	Ground Wet	Temperature (°F)	70.00
Municipality N/A	Weather Light Rain	Rain Gauge (in)	0.35
GPS Location 36.9717885649539, -79.8701951920788		Rain Accumulation Time (days)	1.00

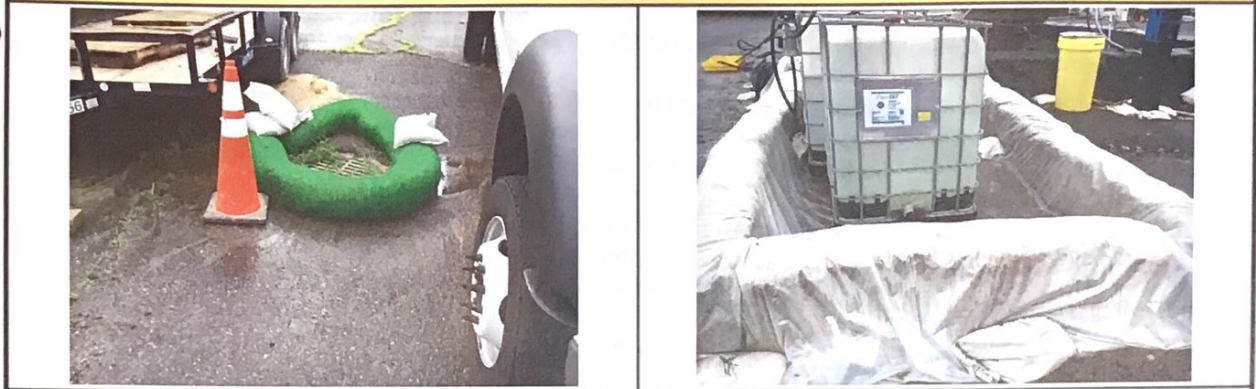
Performed SWPPP inspection of main laydown yard in Rocky Mount, Va. All parameter ECD's were inspected and no issues were found. The RCE was clean and free of any debris. There were some secondary containments that need to be dewatered there was no any oily sheen visible. The site received 35" of rainfall. The site is currently in compliance.

GPS Location	36.9718098450438, -79.870257153403	GPS Location	36.9718070054168, -79.8702876665376
Description	Filter sock around parking lot drain.	Description	Secondary containment around Blue Def containers.

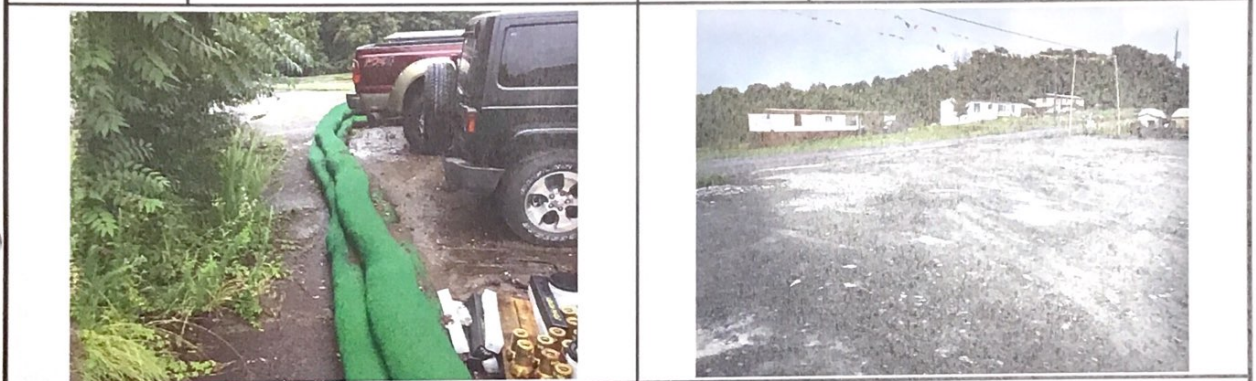
GPS Location	36.9718189104382, -79.8701671446641	GPS Location	36.9718186335983, -79.8701671677027
Description	Parameter EDC functioning properly.	Description	RCE in good condition

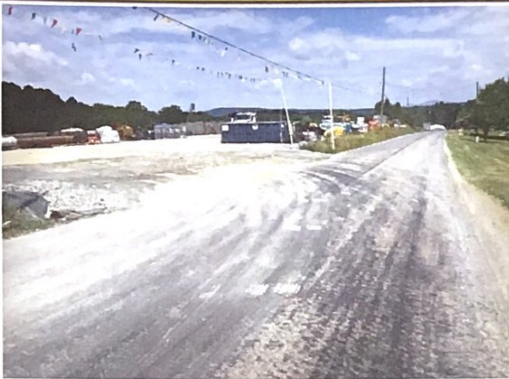
Description RCE in good condition.

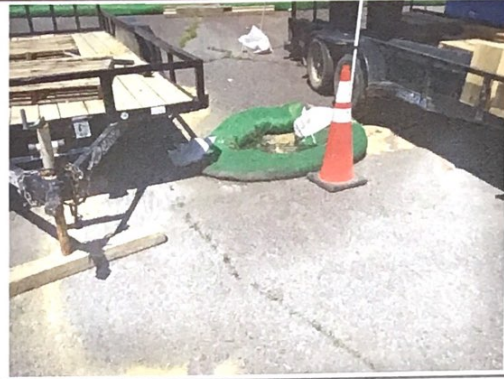
Performed SWPPP inspection of main laydown yard in Rocky Mount, Va. Inspected all parameter EDC's one issue was observed, the filter sock on the south parameter of the paved area needs repair. It was also noticed that the filter sock around the drain at the upper north end of the paved area needs some general upkeep. The RCE is clean and free of any debris. A communication was made to address any potential issues with filter sock and general housekeeping. Contractor addressed these issues immediately. The location is currently in compliance.

Description Upkeep needed of filter sock

E&S BMPs	Compliance Level	Corrective Action	Corrective Time Frame
Compost Filter Sock	Communication	Needs repair (south side parameter)	24 Hours
Silt Fence (Filter Fabric Fence)	Acceptable		
Rock Construction Entrance	Acceptable		
Housekeeping	Communication	General clean up (bottles, paper, etc)	24 Hours
Compost Filter Sock	Communication	Upkeep around drain on north end	24 Hours

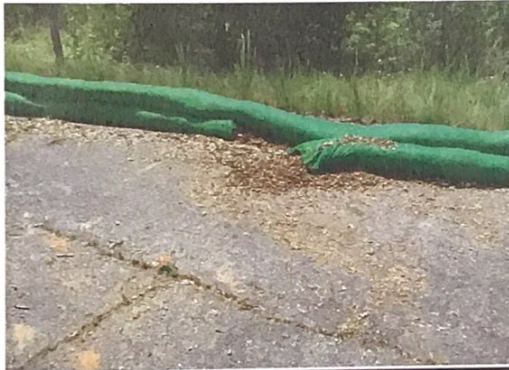
Description Repair needed on south parameter of paved area.

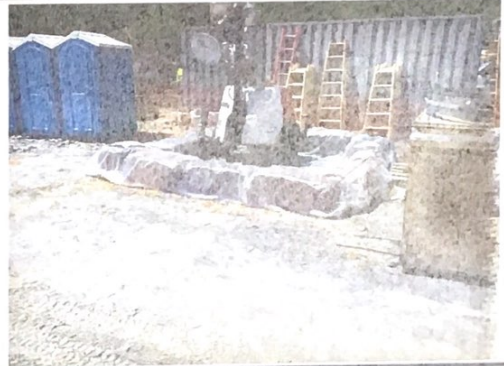
Description Containment of light plant.

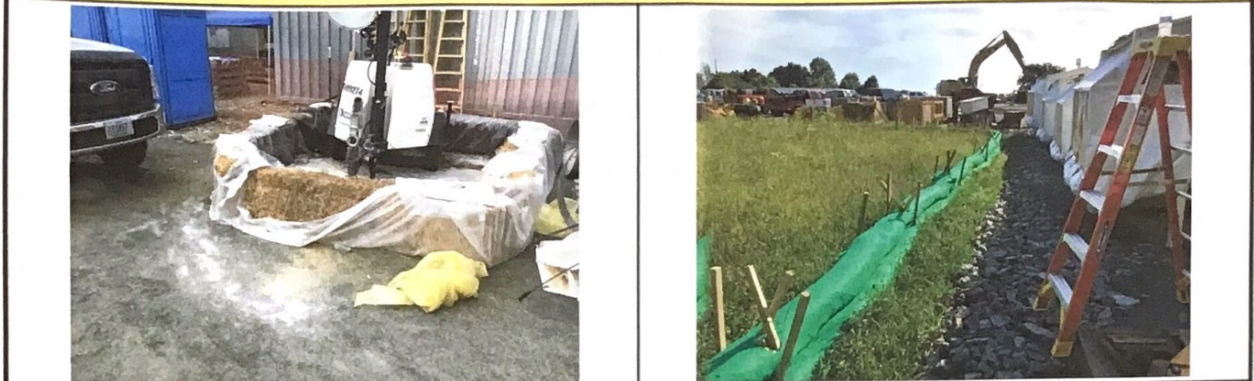
Performed SWPPP inspection of main laydown yard. All parameter ECD's were inspected and one issue was found on south side of paved laydown yard. The RCE was clean and free of any debris. A communication was given for potential housekeeping and containment issues. All issues were addressed by the contractor. Location is currently in compliance.

GPS Location 37.0593681465499, -79.8825622649122	GPS Location 37.0593681469091, -79.8825622638305
Description Light plant containment repair needed.	Description Parameter Filter sock at north end of gravel laydown yard.

4. E&S BMPs (List BMPs and note if installed and maintained as per the plan. If corrective action is needed, a picture is required.)					
E&S BMPs	Compliance Level	Corrective Action	Corrective Time Frame		
Compost Filter Sock	Communication	Repair needed on south side of paved area	Addressed		
Housekeeping	Communication	General clean up	Addressed		
Rock Construction Entrance	Acceptable				
Silt Fence (Filter Fabric Fence)	Acceptable				
Wash Rack	Acceptable				
Other	Communication	Containments need maintenance.	Addressed		
Compost Filter Sock	Communication	Filter sock missing around drain on lower south end of paved area.	Addressed

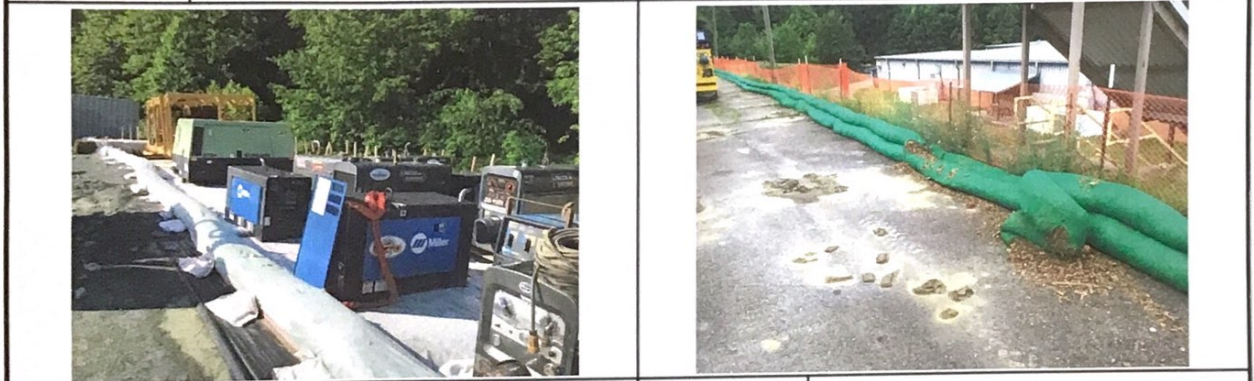
GPS Location 37.059368048703, -79.8825625595558	GPS Location 37.0593675895757, -79.8825622618319
Description Welder containment in good condition.	Description Filter sock in need of repair on south side of paved yard.

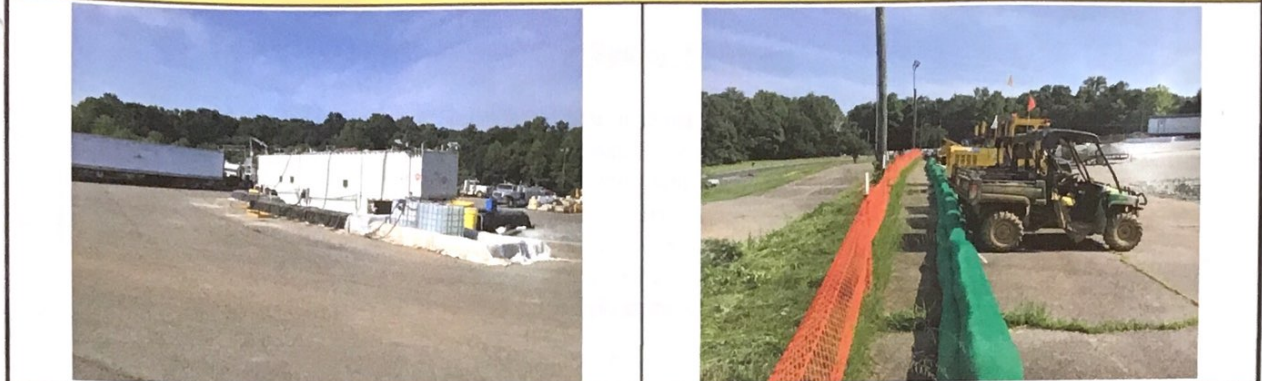
Performed SWPPP inspection of Main Laydown Yard in Rocky Mount, Va. Inspected all ECD's, containments, and housekeeping activities there were no issues observed. The RCE was clean and road was free of any debris. The E&S and Stormwater plans are posted at main entrance. The Laydown Yard is currently in compliance.

GPS Location 37.0593633270037, -79.8825607038872	GPS Location 37.0593633270037, -79.8825607038872
Description Fuel cell containment.	Description Perimeter ECD's in good condition.

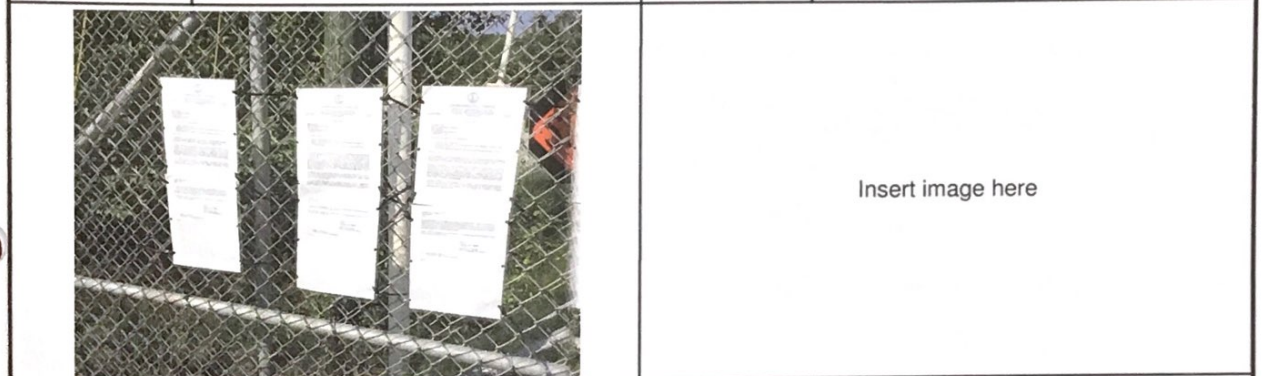
GPS Location 37.0593809634337, -79.8825544827872	GPS Location
Description E&S and Stormwater Plan Approval documents are posted.	Description

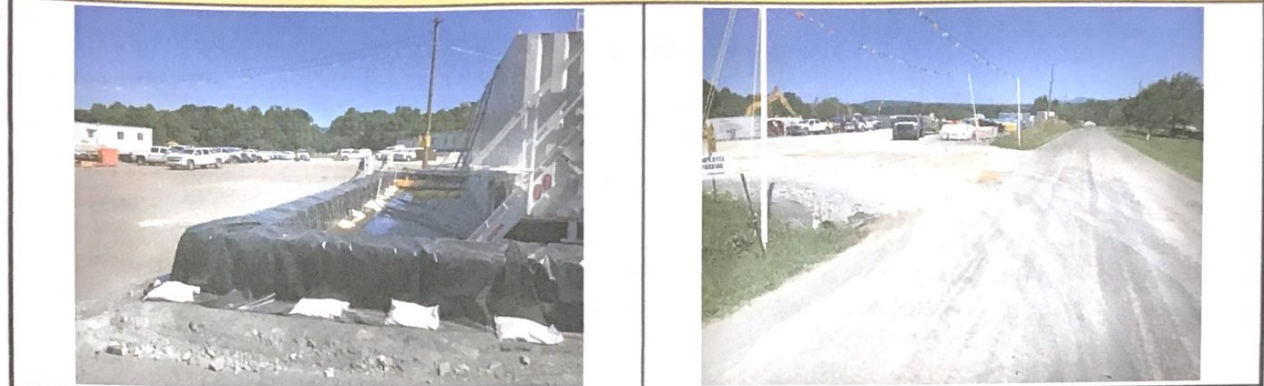
Preformed SWPPP inspection of main laydown yard in Rocky Mount, Va. All ECD's and secondary containments were checked and no issues were found. Housekeeping is being keep up. Site is currently in compliance.

GPS Location	37.0593896421983, -79.8825625344985	GPS Location	37.0593896421983, -79.8825625344985
Description	Containment for fuel cell.	Description	RCE free on any road debris.

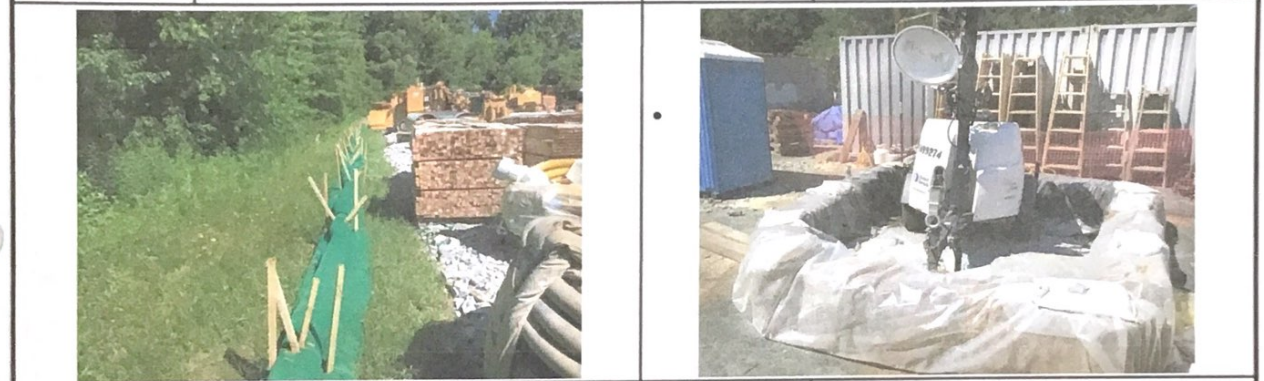
GPS Location	37.0593700418594, -79.8829329852759	GPS Location	37.0593629172417, -79.8828084301947
Description	Parameter ECD on south end of parking area.	Description	Light plant containment.
