Visual Site Inspection Report

Project Name	H-600 Pipeline Spread G	AFE	124300137	Spread	H-600 Pipeline Spread G
Contractor	Precision			Report #	1811
Inspector	Brian Shields			Date/Time	5/16/2018 1:25 PM
Permit #	TBD	Inspection Type	VA SWPP	Station Begin	11788+43
State	VA	Inspection Area	Partial	Station End	11687+42
County	Montgomery	Ground	Muddy	Temperature (°F)	66.00
Municipality	N/A	Weather	Light Rain	Rain Gauge (in)	0.84
GPS Location	37.295964346302, -80.3676552605632			Rain Accumulation Time (days)	1.00

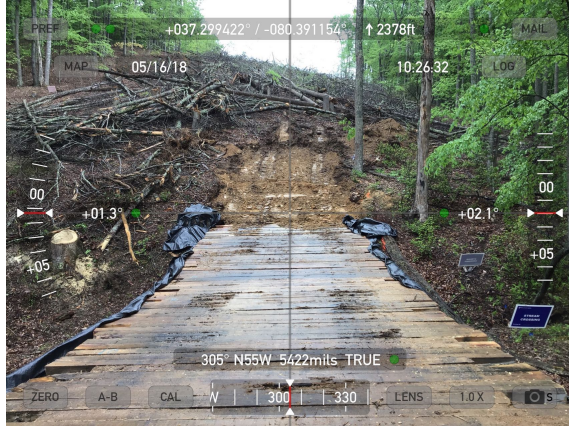
GPS Location	37.2960110335027, -80.3676130157713	GPS Location	37.2961406596352, -80.3675636463616		
Description	Travel lane to S-MN 21 with slope breakers installed. GPS coordinates in photo above.	Description	Away side of crossing at S-MN 22. Slope breakers installed. GPS coordinates in photo above

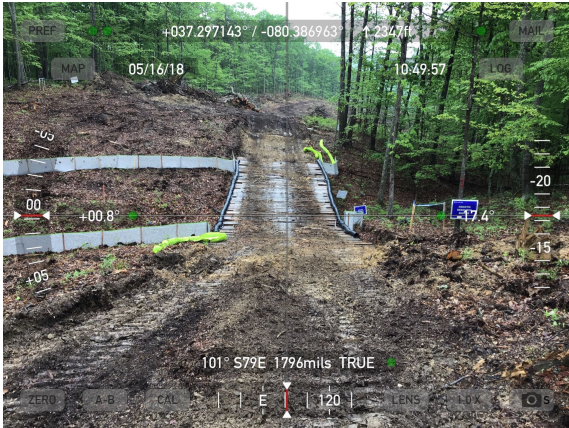
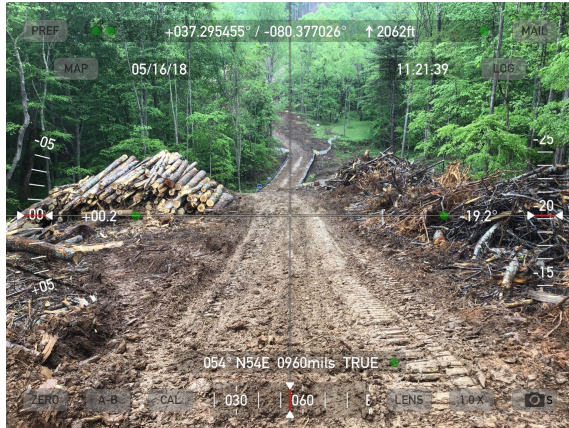
GPS Location	37.2961372649644, -80.3675587848577	GPS Location	37.2961372649644, -80.3675587848577		
Description	Travel lane to S-MN 22 with slope breakers installed. GPS coordinates in photo above.	Description	Slope breakers installed along travel lane. GPS coordinates in photo above.

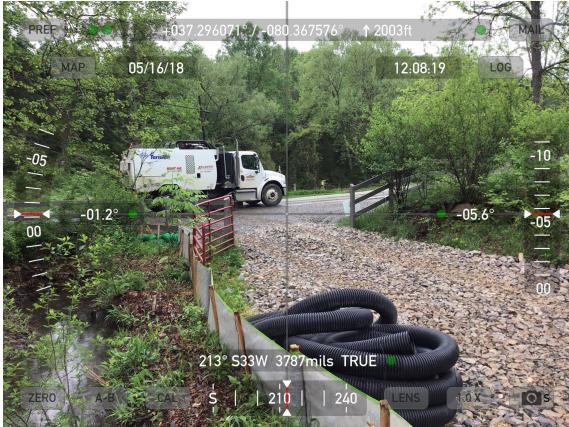
GPS Location	37.2961372649644, -80.3675587848577	GPS Location	37.2961372649644, -80.3675587848577		
Description	Sweeper along Mt Tabor road. GPS coordinates in photo above.	Description	Travel lane to S-IJ52. GPS coordinates in photo above.
