# Visual Site Inspection Report

<b>Project Name</b>	H-600 Pipeline Spread G	<b>AFE</b>	124300137	<b>Spread</b>	H-600 Pipeline Spread G
<b>Contractor</b>	Precision			<b>Report #</b>	2057
<b>Inspector</b>	Brian Shields			<b>Date/Time</b>	5/22/2018 7:30 AM
<b>Permit #</b>	TBD	<b>Inspection Type</b>	VA SWPP	<b>Station Begin</b>	11788+43
<b>State</b>	VA	<b>Inspection Area</b>	Partial	<b>Station End</b>	11670+00
<b>County</b>	Montgomery	<b>Ground</b>	Wet	<b>Temperature (°F)</b>	80.00
<b>Municipality</b>	N/A	<b>Weather</b>	Sunny	<b>Rain Gauge (in)</b>	0.13
<b>GPS Location</b>	37.4169865390634, -80.7414005511261			<b>Rain Accumulation Time (days)</b>	1.00

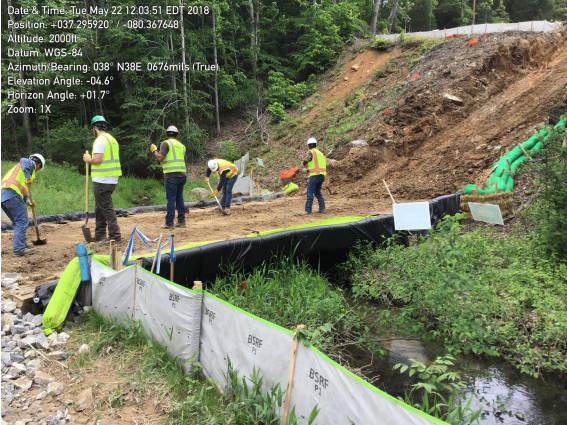
<b>GPS Location</b>	37.4169498263275, -80.7413613238192	<b>GPS Location</b>	37.4169498263275, -80.7413613238192	<b>Description</b>	Stream crossing at S-IJ52. GPS coordinates in photo above.
<b>Description</b>	Stream crossing at S-IJ52. GPS coordinates in photo above.	<b>Description</b>	Perimeter control at resource crossing. No maintenance needed. GPS coordinates in photo above.

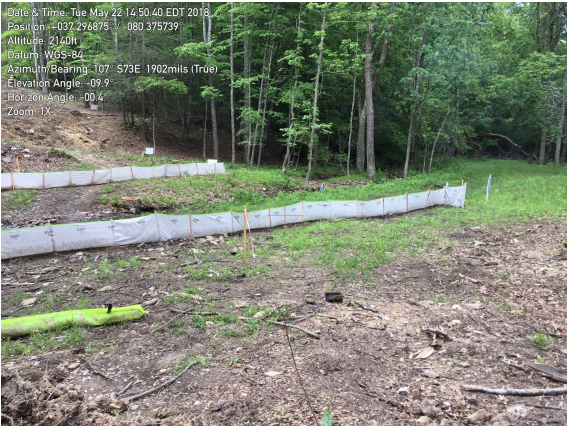
<b>GPS Location</b>	37.4169512093416, -80.7413717173792	<b>GPS Location</b>	37.4169368343776, -80.7414353360243	<b>Description</b>	Perimeter controls at resource crossing. No maintenance needed. GPS coordinates in photo above.
<b>Description</b>	Perimeter controls at resource crossing. No maintenance needed. GPS coordinates in photo above.	<b>Description</b>	Separated geotextile at s-mn22. GPS coordinates in photo above.
