## Visual Site Inspection Report

<b>Project Name</b>	H-600 Pipeline Spread G	<b>AFE</b>	124300137	<b>Spread</b>	H-600 Pipeline Spread G
<b>Contractor</b>	Precision			<b>Report #</b>	2277
<b>Inspector</b>	Brian Shields			<b>Date/Time</b>	5/26/2018 8:46 AM
<b>Permit #</b>	TBD	<b>Inspection Type</b>	Weekly	<b>Station Begin</b>	1178+83
<b>State</b>	VA	<b>Inspection Area</b>	Partial	<b>Station End</b>	11669+08
<b>County</b>	Montgomery	<b>Ground</b>	Wet	<b>Temperature (°F)</b>	74.00
<b>Municipality</b>	N/A	<b>Weather</b>	Light Rain	<b>Rain Gauge (in)</b>	0.15
<b>GPS Location</b>	37.4170410633436, -80.7414639183141			<b>Rain Accumulation Time (days)</b>	1.00

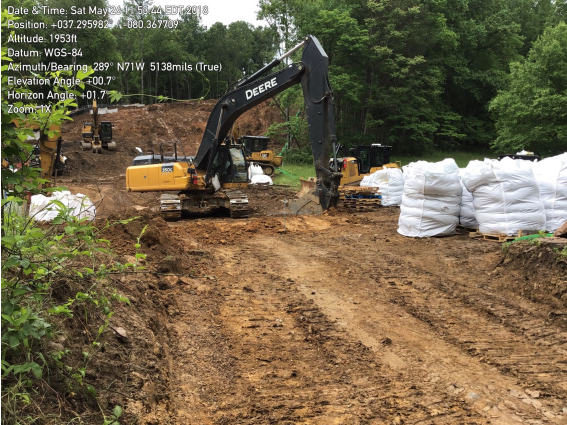
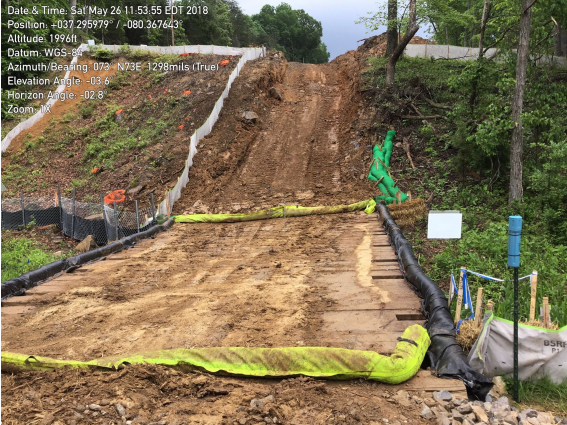
<b>GPS Location</b>	37.4170122715062, -80.7414484117932	<b>GPS Location</b>	37.4170122715062, -80.7414484117932		
<b>Description</b>	Environmental crew installing waterbars off of mlv26 access. GPS coordinates in photo above.	<b>Description</b>	Temporary crossing at S-IJ52. Waterbars installed on upslope side, bridge scraped, and waddles installed. GPS coordinates in photo

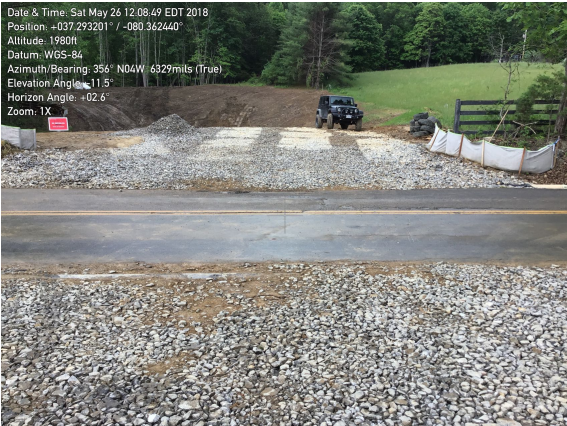
<b>GPS Location</b>	37.4170470564043, -80.7415210828937	<b>GPS Location</b>	37.4170470564043, -80.7415210828937		
<b>Description</b>	Mt Tabor rd off of mlv 26 access. Slight sediment tracking observed. GPS coordinates in photo above.	<b>Description</b>	Mt Tabor rd off of Mt Tabor access. GPS coordinates in photo above.		
<p>Insert image here</p>		<p>Insert image here</p>			
<b>GPS Location</b>	37.4170470564043, -80.7415210828937	<b>GPS Location</b>	37.4170470564043, -80.7415210828937
