Visual Site Inspection Report

Project Name	H-600 Pipeline Spread G	AFE	124300137	Spread	H-600 Pipeline Spread G
Contractor	Precision			Report #	2350
Inspector	Brian Shields			Date/Time	5/29/2018 9:14 AM
Permit #	TBD	Inspection Type	VA SWPP	Station Begin	11788+43
State	VA	Inspection Area	Partial	Station End	11669+08
County	Montgomery	Ground	Wet	Temperature (°F)	74.00
Municipality	N/A	Weather	Cloudy	Rain Gauge (in)	0.59
GPS Location	37.4169222498661, -80.7413524390019			Rain Accumulation Time (days)	2.00

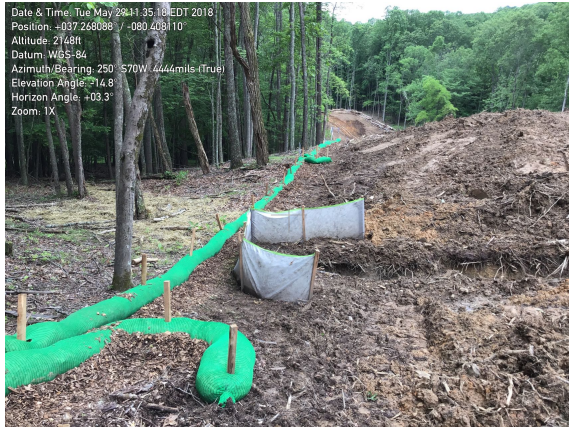
GPS Location	37.4168878002441, -80.741447908879	GPS Location	37.4168878002441, -80.741447908879		
Description	Installed silt fence at Stream S-MN21. GPS coordinates in photo above.	Description	RCE at mlv 26 in need of refreshment. GPS coordinates in photo above.		
  <p>Date & Time: Tue May 29 12:01:57 EDT 2018 Position: +037 295265 / -080 377264 Altitude: 2124ft Datum: WGS-84 Azimuth/Bearing: 072 N72E 1280mils (True) Elevation Angle: 24.5 Horizon Angle: -06.3 Zoom: 1X</p>		Insert image here			
GPS Location	37.4168878002441, -80.741447908879	GPS Location	37.4168878002441, -80.741447908879		
Description	Waterbars and outlet protection. GPS coordinates in photo above.	Description
