Visual Site Inspection Report

Project Name	H-600 Pipeline Spread G	AFE	124300137	Spread	H-600 Pipeline Spread G
Contractor	Precision			Report #	3671
Inspector	Brian Shields			Date/Time	6/26/2018 11:53 AM
Permit #	TBD	Inspection Type	VA SWPP	Station Begin	11766+80
State	VA	Inspection Area	Partial	Station End	11669+08
County	Montgomery	Ground	Muddy	Temperature (°F)	65.00
Municipality	N/A	Weather	Light Rain	Rain Gauge (in)	0.60
GPS Location	37.2962860018362, -80.3610499855879			Rain Accumulation Time (days)	1.00

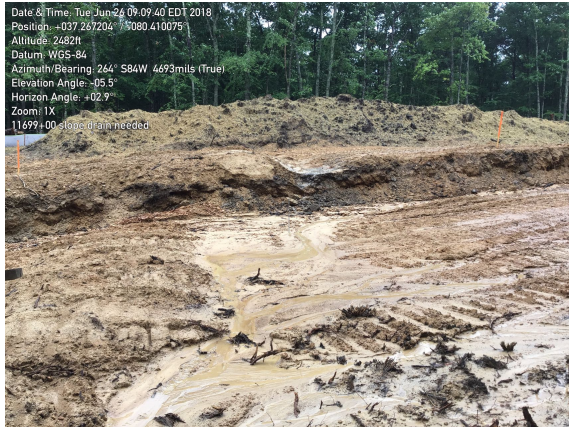
A/E	124300137	Date/Time	6/26/2018 11:53 AM	Report #	3671
Pictures					
<p>Date & Time: Tue Jun 26 09:09:40 EDT 2018 Position: +037.267204 / -080.410075 Altitude: 2482ft Datum: WGS-84 Azimuth/Bearing: 264° S84W 4493mils (True) Elevation Angle: +05.5° Horizon Angle: +02.9° Zoom: 1X 11699+00 slope drain needed</p>

GPS Location	37.2960878536452, -80.3609785717729		GPS Location	37.2960878536452, -80.3609785717729	
Description	Water discharge over two tone. Slope drain needed. GPS coordinates in photo above.		Description	Improperly installed waterbar. GPS coordinates in photo above.	
<p>Date & Time: Tue Jun 26 10:02:00 EDT 2018 Position: +037.293147 / -080.362817 Altitude: 2004ft Datum: WGS-84 Azimuth/Bearing: 175° S05E 3111mils (True) Elevation Angle: +18.9° Horizon Angle: +02.2° Zoom: 1X 11766+76 waterbar does not outlet</p>

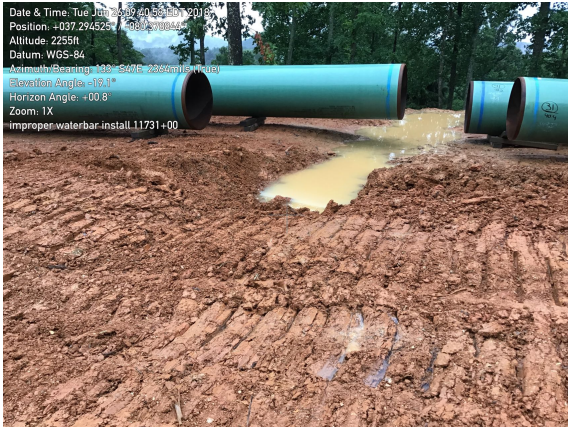
<p>Date & Time: Tue Jun 26 09:09:40 EDT 2018 Position: +037.294525 / -080.410075 Altitude: 2255ft Datum: WGS-84 Azimuth/Bearing: 188° S88W 339mils (True) Elevation Angle: +08.3° Horizon Angle: +00.8° Zoom: 1X improper waterbar install 11731+00</p>

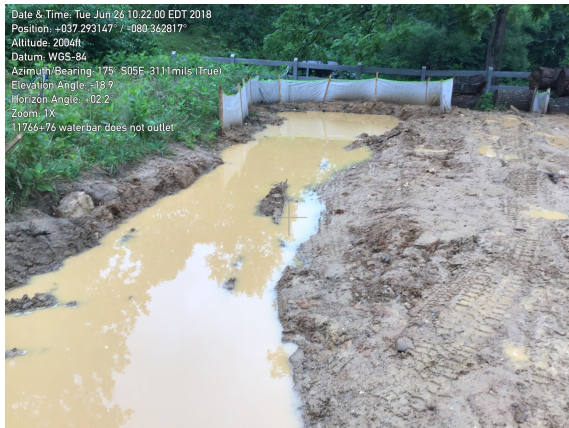
GPS Location	37.2960878536452, -80.3609785717729		GPS Location	37.2960878536452, -80.3609785717729	
Description	Waterbar does not drain. GPS coordinates in photo above.		Description	Compost sock in need of clean out. GPS coordinates in photo above.	
<p>Date & Time: Tue Jun 26 10:01:23 EDT 2018 Position: +037.29637 / -080.409552 Altitude: 2040ft Datum: WGS-84 Azimuth/Bearing: 294° N66W 5227mils (True) Elevation Angle: +19.2° Horizon Angle: +02.3° Zoom: 1X 11726+00 waterbar not functional beneath pipe</p>

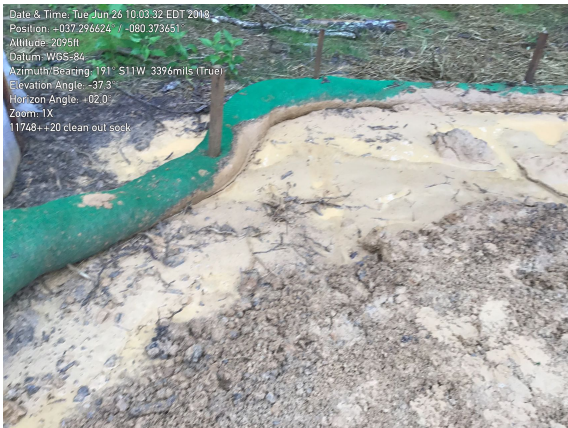
<p>Date & Time: Tue Jun 26 10:03:32 EDT 2018 Position: +037.296624 / -080.373651 Altitude: 2025ft Datum: WGS-84 Azimuth/Bearing: 191° S11W 3396mils (True) Elevation Angle: +37.3° Horizon Angle: +02.0° Zoom: 1X 11748+20 clean out sock</p>

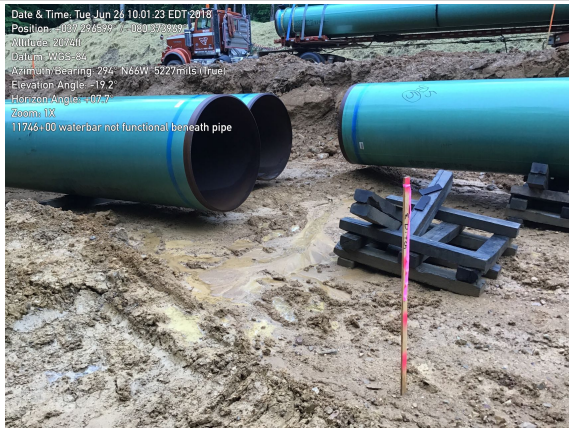
GPS Location	37.2963707009678, -80.3609255981449		GPS Location	37.2963707009678, -80.3609255981449	
Description	Non functional waterbar beneath pipe. GPS coordinates in photo above.		Description	Super silt fence full and in need of retrenching. GPS coordinates in photo above.

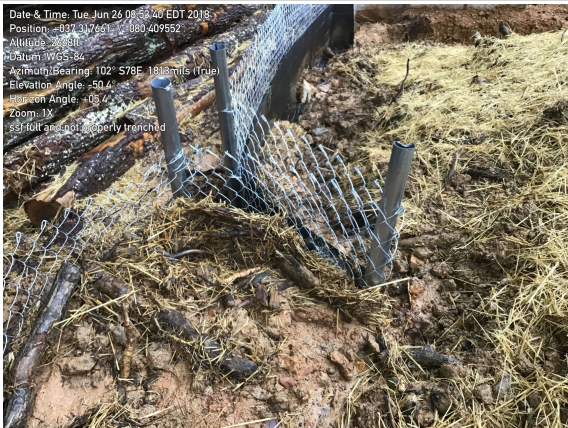
<p>Date & Time: Tue Jun 26 09:53:40 EDT 2018 Position: +037.317491 / -080.409552 Altitude: 2035ft Datum: WGS-84 Azimuth/Bearing: 102° S78E 1616mils (True) Elevation Angle: +50.4° Horizon Angle: +06.4° Zoom: 1X silt fence not properly trenched</p>
