Visual Site Inspection Report

Project Name	H-600 Pipeline Spread G	AFE	124300137	Spread	H-600 Pipeline Spread G
Contractor	Precision			Report #	3821
Inspector	Brian Shields			Date/Time	6/29/2018 12:39 PM
Permit #	TBD	Inspection Type	VA SWPP	Station Begin	11670+00
State	VA	Inspection Area	Partial	Station End	11553+66
County	Montgomery	Ground	Dry	Temperature (°F)	85.00
Municipality	N/A	Weather	Sunny	Rain Gauge (in)	0.00
GPS Location	37.2681085579444, -80.320183932856			Rain Accumulation Time (days)	1.00

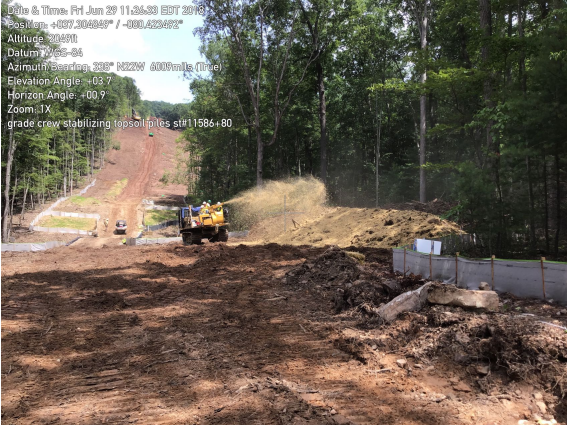
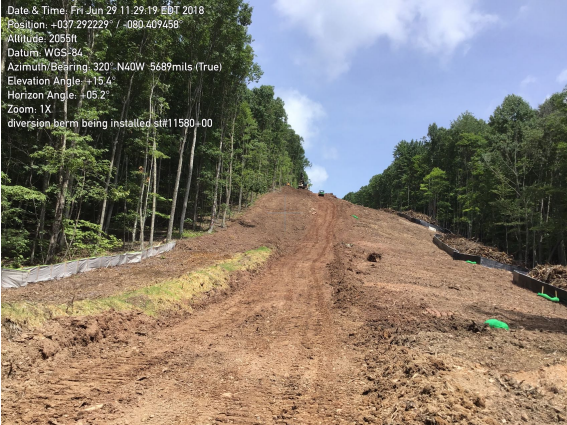
GPS Location	37.2680363897581, -80.3201644030216	GPS Location	37.2680498008032, -80.3202523291859		
Description	Grade crew applying temporary stabilization to topsoil stockpile. GPS coordinates in photo above.	Description	Grade crew installing diversion berm st#11580+09. GPS coordinates in photo above.

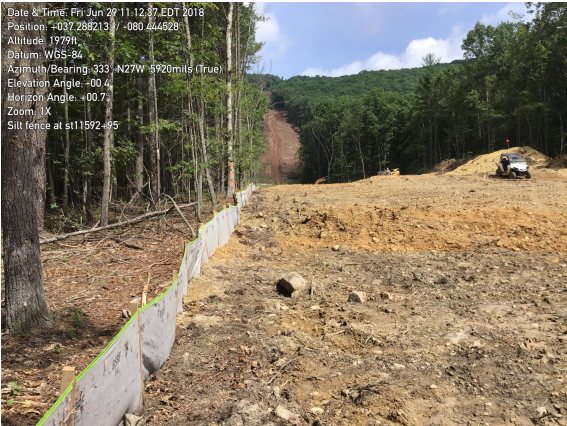
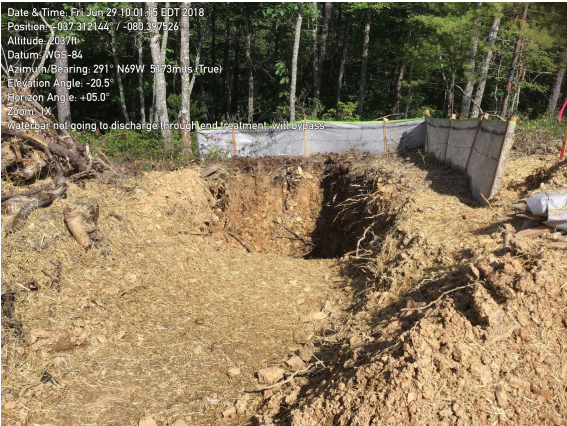
GPS Location	37.2680498008032, -80.3202523291859	GPS Location	37.2680498008032, -80.3202523291859		
Description	Installed silt fence near 11592+95. No maintenance needed.	Description	Improperly installed end treatment. Water will bypass. Crews on site making repairs. GPS coordinates in photo above.

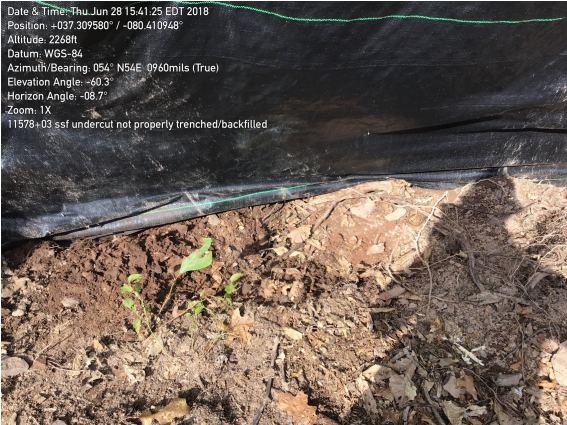
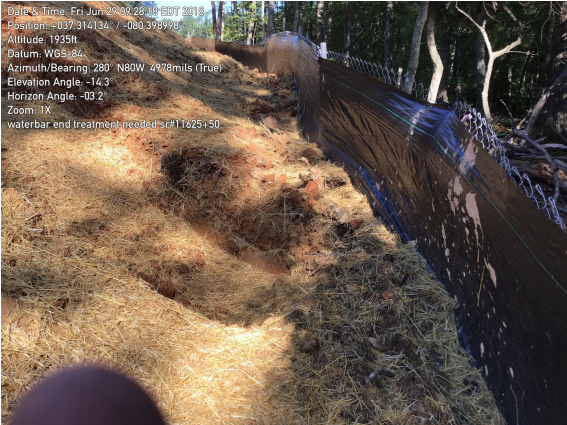
GPS Location	37.2680498008032, -80.3202523291859	GPS Location	37.2680498008032, -80.3202523291859		
Description	Super silt fence from previous day inspection improperly installed. Crews on site to make repairs. GPS coordinates in photo above.	Description	Waterbar with no end treatment. Crew on site repairing/installing end treatments. GPS coordinates in photo above.
