Visual Site Inspection Report

Project Name	H-600 Pipeline Spread G	AFE	124300137	Spread	H-600 Pipeline Spread G
Contractor	Precision			Report #	4464
Inspector	Brian Shields			Date/Time	7/12/2018 11:47 AM
Permit #	TBD	Inspection Type	VA SWPP	Station Begin	11770+00
State	VA	Inspection Area	Partial	Station End	11618+91
County	Montgomery	Ground	Dusty	Temperature (°F)	82.00
Municipality	N/A	Weather	Sunny	Rain Gauge (in)	0.00
GPS Location	37.2960650129591, -80.3677293565873			Rain Accumulation Time (days)	1.00

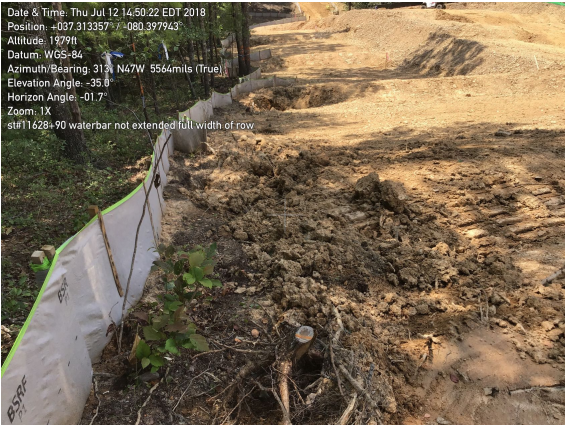
A/E	124300137	Date/Time	7/12/2018 11:47 AM	Report #	4464
Pictures					
<p>Date & Time: Thu Jul 12 14:50:22 EDT 2018 Position: +037.313357° / -080.397943° Altitude: 1979ft Datum: WGS-84 Azimuth/Bearing: 313° N47W 5564mils (True) Elevation Angle: -35.8° Horizon Angle: -01.7° Zoom: 1X st#11628+90 waterbar not extended full width of row</p>

GPS Location	37.2961389832546, -80.368114672676	GPS Location	37.2959215566863, -80.3676244151596		
Description	Waterbar does not extend fully across row. GPS coordinates in photo above.	Description	Waterbar not extended full width of row. GPS coordinates in photo above.		
<p>Date & Time: Thu Jul 12 15:17:56 EDT 2018 Position: +037.311836° / -080.39851° Altitude: 1924ft Datum: WGS-84 Azimuth/Bearing: 059° N36E 1657mils (True) Elevation Angle: -18.0° Horizon Angle: +06.3° Zoom: 1X st#11626+53 waterbar maintenance needed: clean, firm, compaction</p>

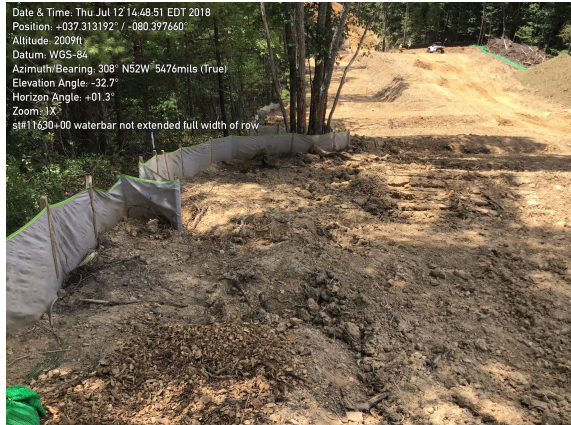
<p>Date & Time: Thu Jul 12 14:48:51 EDT 2018 Position: +037.313192° / -080.397660° Altitude: 2009ft Datum: WGS-84 Azimuth/Bearing: 308° N52W 5476mils (True) Elevation Angle: -32.7° Horizon Angle: +01.3° Zoom: 1X st#11630+00 waterbar not extended full width of row</p>

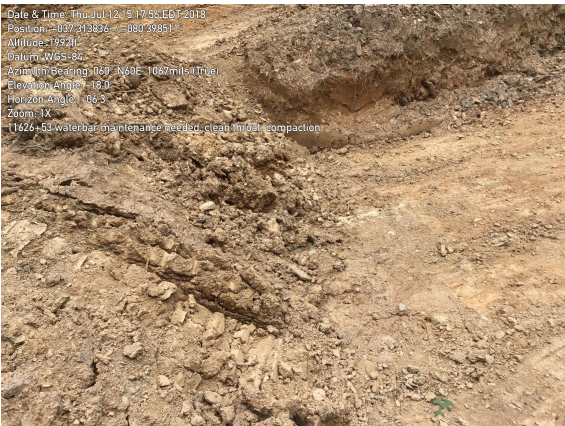
GPS Location	37.2961004265, -80.3679916263375	GPS Location	37.2961004265, -80.3679916263375		
Description	Waterbar in need of reshaping, cleaning, compaction. GPS coordinates in photo above.	Description	Cfs full from topsoil pile. GPS coordinates in photo above.		
<p>Date & Time: Thu Jul 12 14:32:31 EDT 2018 Position: +037.307463° / -080.401493° Altitude: 2224ft Datum: WGS-84 Azimuth/Bearing: 320° N40W 5689mils (True) Elevation Angle: -61.3° Horizon Angle: +03.5° Zoom: 1X st#11644+20 cfs full</p>

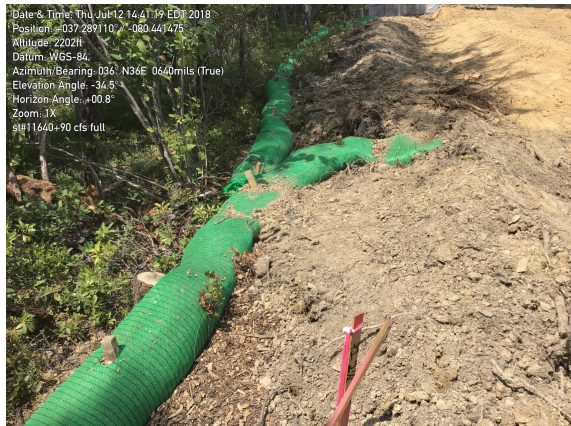
<p>Date & Time: Thu Jul 12 14:41:19 EDT 2018 Position: +037.289110° / -080.441475° Altitude: 2202ft Datum: WGS-84 Azimuth/Bearing: 036° N36E 0640mils (True) Elevation Angle: -34.5° Horizon Angle: +00.8° Zoom: 1X st#11640+90 cfs full</p>

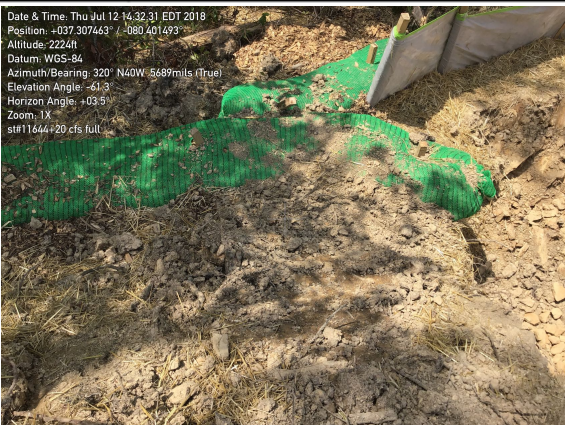
GPS Location	37.2961004265, -80.3679916263375	GPS Location	37.2961004265, -80.3679916263375		
Description	Cfs full from topsoil pile. GPS coordinates in photo above.	Description	Silt fence full from topsoil pile. GPS coordinates in photo above.
