# Visual Site Inspection Report

<b>Project Name</b>	H-600 Pipeline Spread G	<b>AFE</b>	124300137	<b>Spread</b>	H-600 Pipeline Spread G
<b>Contractor</b>	Precision			<b>Report #</b>	4768
<b>Inspector</b>	Brian Shields			<b>Date/Time</b>	7/18/2018 6:26 AM
<b>Permit #</b>	TBD	<b>Inspection Type</b>	VA SWPP	<b>Station Begin</b>	11788+43
<b>State</b>	VA	<b>Inspection Area</b>	Partial	<b>Station End</b>	11770+00
<b>County</b>	Montgomery	<b>Ground</b>	Dusty	<b>Temperature (°F)</b>	80.00
<b>Municipality</b>	N/A	<b>Weather</b>	Sunny	<b>Rain Gauge (in)</b>	0.00
<b>GPS Location</b>	37.3194600488228, -80.6576299050463			<b>Rain Accumulation Time (days)</b>	1.00

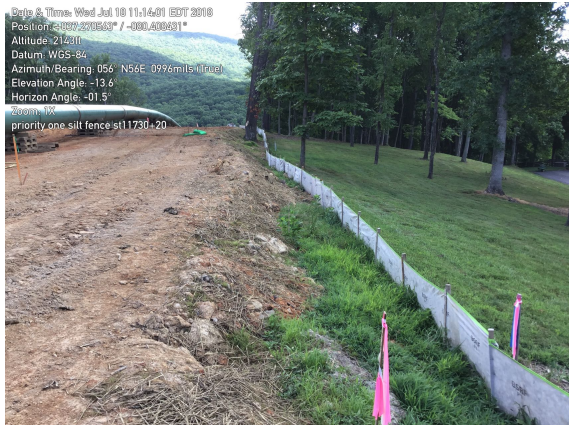
A/E	124300137	Date/Time	7/18/2018 6:26 AM	Report #	4768
Pictures					
<p>Date &amp; Time: Wed Jul 18 11:44:01 EDT 2018 Position: +037.296631° / -080.658431° Altitude: 2120ft Datum: WGS-84 Azimuth/Bearing: 056° N56E 0998mils (True) Elevation Angle: -13.6° Horizon Angle: -01.5° Zoom: 1X priority one silt fence st11730+20</p>

GPS Location	37.3193685897042, -80.6579308771348	GPS Location	37.3194073140969, -80.6579086650914		
Description	Installed priority one silt fence st11730+20. GPS coordinates in photo above.	Description	Installed priority one silt fence and topsoil stabilization. GPS coordinates in photo above.

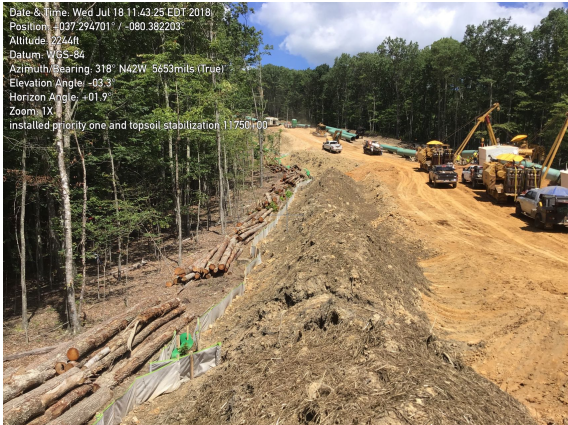
<p>Date &amp; Time: Wed Jul 18 11:43:25 EDT 2018 Position: +037.294701° / -080.382203° Altitude: 2244ft Datum: WGS-84 Azimuth/Bearing: 316° N42W 5853mils (True) Elevation Angle: -43.9° Horizon Angle: -01.9° Zoom: 1X installed priority one and topsoil stabilization 11750+00</p>

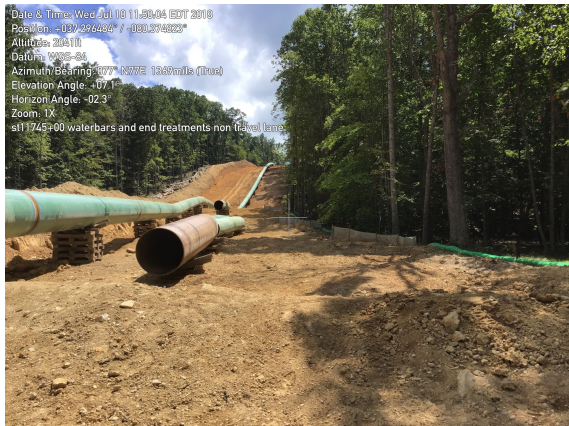
<p>Date &amp; Time: Wed Jul 18 11:50:14 EDT 2018 Position: +037.296376° / -080.374702° Altitude: 2053ft Datum: WGS-84 Azimuth/Bearing: 077° N07E 1345mils (True) Elevation Angle: -07.1° Horizon Angle: -02.3° Zoom: 1X st11745+00 waterbars and end treatments non travel lane</p>

GPS Location	37.3194073140969, -80.6579086650914	GPS Location	37.3194073140969, -80.6579086650914		
Description	Waterbars and end treatments non travel lane side at st11745+00. GPS coordinates in photo above.	Description	Installed compost filter sock. GPS coordinates in photo above.		
<p>Date &amp; Time: Wed Jul 18 12:03:24 EDT 2018 Position: +037.296558° / -080.363591° Altitude: 2167ft Datum: WGS-84 Azimuth/Bearing: 227° S47W 4036mils (True) Elevation Angle: -15.5° Horizon Angle: -04.9° Zoom: 1X new end treatment on diversion pipe</p>

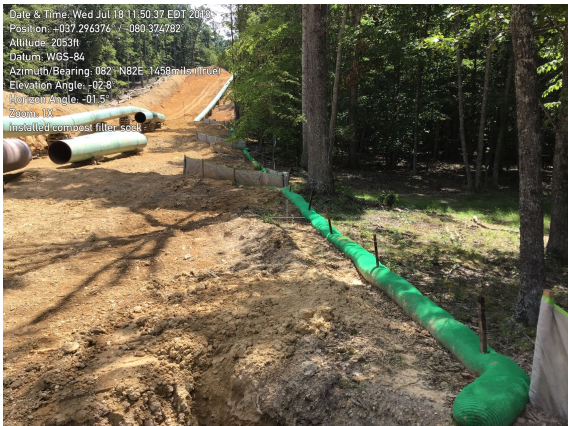
<p>Date &amp; Time: Wed Jul 18 11:50:37 EDT 2018 Position: +037.296376° / -080.374702° Altitude: 2053ft Datum: WGS-84 Azimuth/Bearing: 082° N82E 1458mils (True) Elevation Angle: -07.8° Horizon Angle: -01.5° Zoom: 1X Installed compost filter sock</p>

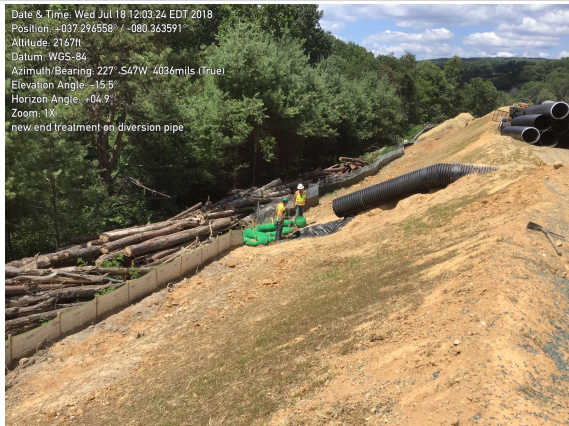
GPS Location	37.3194073140969, -80.6579086650914	GPS Location	37.3194073140969, -80.6579086650914		
Description	End treatment on clean water diversion pipe. GPS coordinates in photo above.	Description	Slope drain and end treatment. GPS coordinates in photo above.

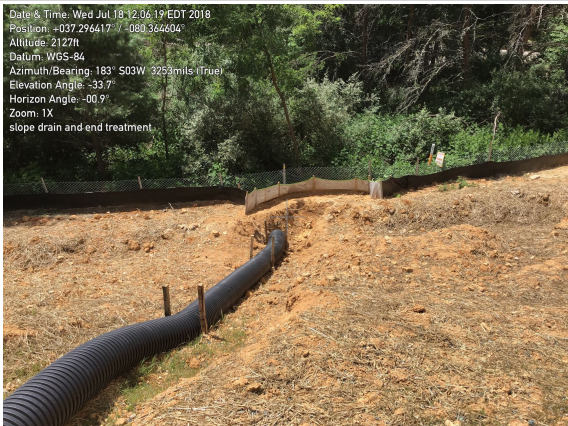
<p>Date &amp; Time: Wed Jul 18 12:06:19 EDT 2018 Position: +037.296417° / -080.364604° Altitude: 2127ft Datum: WGS-84 Azimuth/Bearing: 183° S03W 3253mils (True) Elevation Angle: -33.7° Horizon Angle: -00.9° Zoom: 1X slope drain and end treatment</p>
