Visual Site Inspection Report

Project Name	H-600 Pipeline Spread G		A/E	124300137	Spread	H-600 Pipeline Spread G	
Contractor	Precision				Report #	4769	
Inspector	Brian Shields				Date/Time	7/18/2018 6:26 AM	
Permit #	TBD	Inspection Type	VA SWPP		Station Begin	11770+00	
State	VA	Inspection Area	Partial		Station End	11553+66	
County	Montgomery	Ground	Dusty		Temperature (°F)	80.00	
Municipality	N/A	Weather	Sunny		Rain Gauge (in)	0.00	
GPS Location	37.3192831459908, -80.657827308885				Rain Accumulation Time (days)	1.00

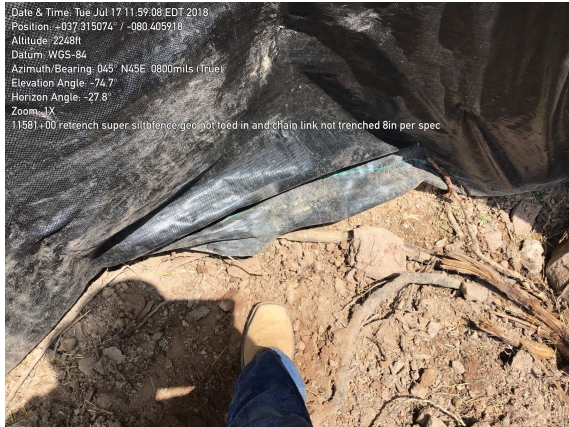
A/E	124300137	Date/Time	7/18/2018 6:26 AM	Report #	4769
Pictures					
<p>Date & Time: Tue Jul 17 11:59:08 EDT 2018 Position: +037.315074° / -080.405918° Altitude: 2248ft Datum: WGS-84 Azimuth/Bearing: 045° N45E 0800mils (True) Elevation Angle: -74.7° Horizon Angle: -27.8° Zoom: 1X 11581+00 retrench super silt fence geo not tied in and chain link not trenched Bin per spec</p>

GPS Location	37.3193898797383, -80.6577632390714	GPS Location	37.3193898797383, -80.6577632390714		
Description	Improperly installed super silt fence identified during previous day inspection. GPS coordinates in photo above.	Description	Waterbar lacking end treatment identified during previous day inspection. GPS coordinates in photo above.

7. Identify all remedial measures that have been taken since the previous inspection was conducted.					
Comments (Reference above questions as appropriate.)					
VA SWPPP inspection, brush mt to sinking creek mountain. MP 218.7 to 220.7 Installed compost sock is in good working condition with no maintenance needed. Installed priority one silt fence is in good working condition with no maintenance needed. Multiple areas of super silt fence have been identified as being improperly installed during previous day inspection. Items have been punch listed and environmental crew is on site making repairs. No rains have occurred since previous SWPPP sumps are clean and dry. Installed diversion berms have been stabilized and appear to be functioning as designed. All areas requiring temporary stabilization have been stabilized. Waterbars are being knocked out along the travel lane daily and being put back, dry conditions are making proper compaction difficult. Waterbars are being put back to spec. Multiple waterbars have been identified during previous day inspection as lacking outlet protection, or improperly installed end treatments. Items have been punch listed and environmental crew is on site making repairs.

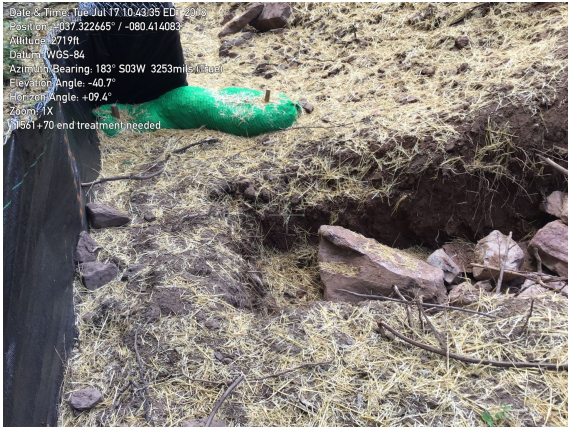
<p>Date & Time: Tue Jul 17 10:43:35 EDT 2018 Position: +037.322665° / -080.414083° Altitude: 2719ft Datum: WGS-84 Azimuth/Bearing: 183° S03W 3253mils (True) Elevation Angle: -40.7° Horizon Angle: +09.4° Zoom: 1X 11561+70 end treatment needed</p>

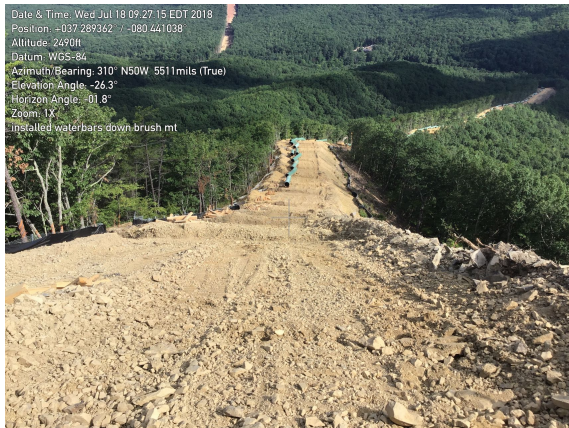
<p>Date & Time: Wed Jul 18 09:27:15 EDT 2018 Position: +037.289362° / -080.441038° Altitude: 2490ft Datum: WGS-84 Azimuth/Bearing: 310° N50W 5511mils (True) Elevation Angle: -26.3° Horizon Angle: -01.8° Zoom: 1X Installed waterbars down brush mt</p>

GPS Location	37.3193916399379, -80.6578663364804	GPS Location	37.3193916399379, -80.6578663364804		
Description	Installed waterbars down brush mountain. GPS coordinates in photo above.	Description	Temporary stabilization on topsoil piles st11655+00. GPS coordinates in photo above.		
<p>Date & Time: Wed Jul 18 09:49:36 EDT 2018 Position: +037.305544° / -080.396629° Altitude: 2575ft Datum: WGS-84 Azimuth/Bearing: 355° N62W 5476mils (True) Elevation Angle: -19.9° Horizon Angle: -02.5° Zoom: 1X waterbar end treatment</p>

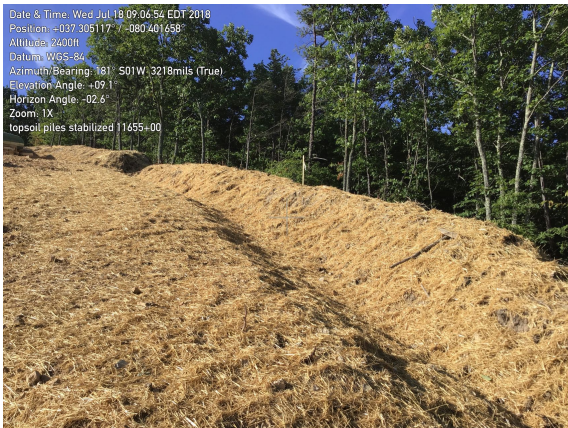
<p>Date & Time: Wed Jul 18 09:06:54 EDT 2018 Position: +037.305117° / -080.401458° Altitude: 2420ft Datum: WGS-84 Azimuth/Bearing: 181° S01W 3218mils (True) Elevation Angle: +09.1° Horizon Angle: -02.6° Zoom: 1X topsoil piles stabilized 11655+00</p>

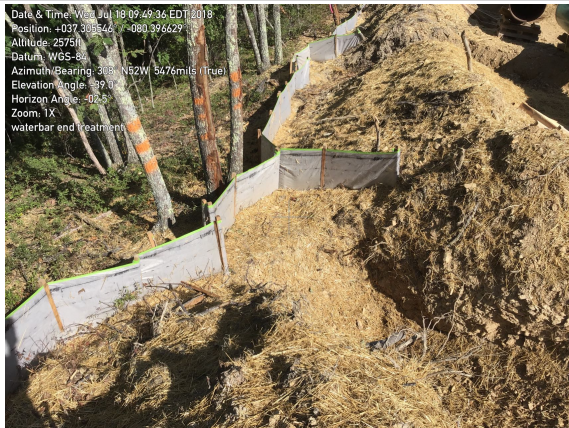
GPS Location	37.3193916399379, -80.6578663364804	GPS Location	37.3193916399379, -80.6578663364804		
Description	Installed waterbar end treatment on brush mountain. GPS coordinates in photo above.	Description	Installed compost sock and topsoil stabilization down brush mountain. GPS coordinates in photo above.

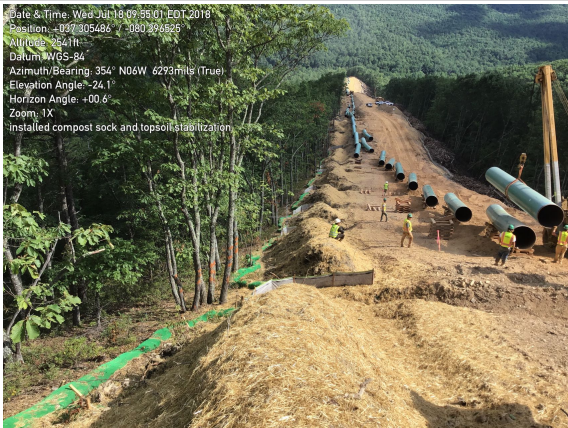
<p>Date & Time: Wed Jul 18 09:55:01 EDT 2018 Position: +037.305484° / -080.396625° Altitude: 2541ft Datum: WGS-84 Azimuth/Bearing: 354° N64W 6293mils (True) Elevation Angle: -24.1° Horizon Angle: +00.6° Zoom: 1X Installed compost sock and topsoil stabilization</p>
