Visual Site Inspection Report

Project Name	H-600 Pipeline Spread G	AFE	124300137	Spread	H-600 Pipeline Spread G
Contractor	Precision			Report #	5080
Inspector	Brian Shields			Date/Time	7/24/2018 10:25 AM
Permit #	TBD	Inspection Type	VA SWPP	Station Begin	11788+43
State	VA	Inspection Area	Partial	Station End	11770+00
County	Montgomery	Ground	Muddy	Temperature (°F)	75.00
Municipality	N/A	Weather	Cloudy	Rain Gauge (in)	0.27
GPS Location	37.2968590306465, -80.3721393273029			Rain Accumulation Time (days)	1.00

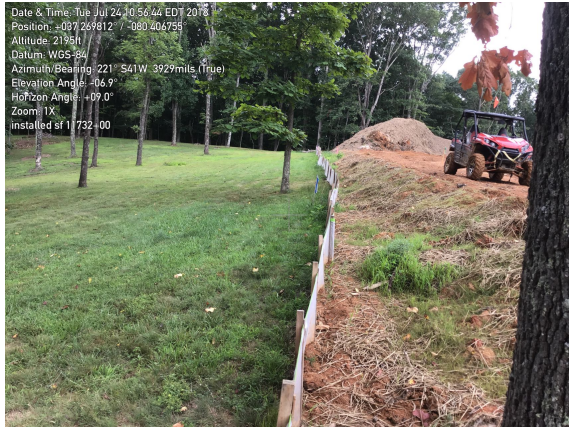
A/E	124300137	Date/Time	7/24/2018 10:25 AM	Report #	5080
Pictures					
<p>Date & Time: Tue Jul 24 10:56:44 EDT 2018 Position: -037.269812 / -080.406795 Altitude: 2195ft Datum: WGS-84 Azimuth/Bearing: 221° S41W 3929mils (True) Elevation Angle: -06.9° Horizon Angle: -09.0° Zoom: 1X Installed silt fence at 11732-00</p>

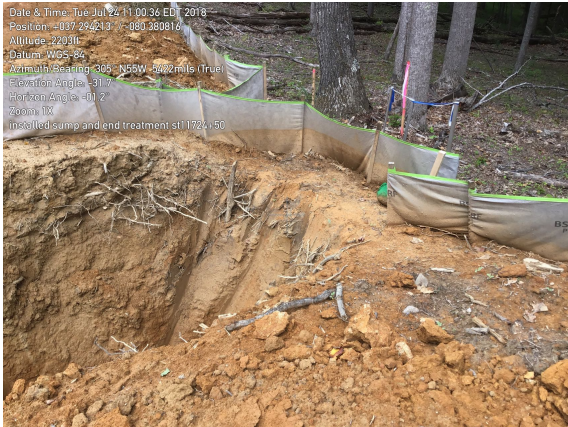
<p>Date & Time: Tue Jul 24 11:00:36 EDT 2018 Position: -037.292413 / -080.380816 Altitude: 1723ft Datum: WGS-84 Azimuth/Bearing: 308° N58W 5002mils (True) Elevation Angle: -01.7° Horizon Angle: -01.2° Zoom: 1X Installed sump and end treatment at 11724-50</p>

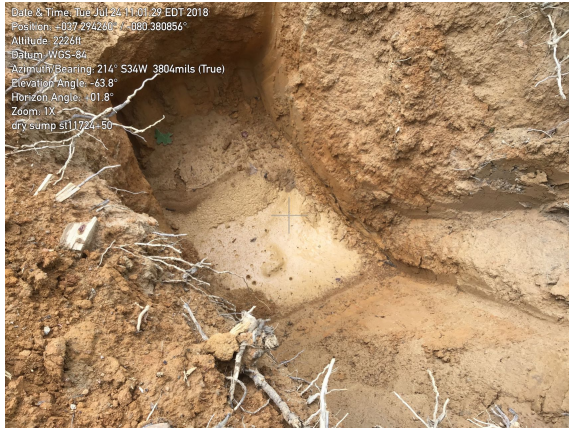
GPS Location	37.2970067616899, -80.3720360622558	GPS Location	37.2970067616899, -80.3720360622558		
Description	Installed priority one silt fence. GPS coordinates in photo above.	Description	Installed sump and end treatment. GPS coordinates in photo above.		
<p>Date & Time: Tue Jul 24 11:03:11 EDT 2018 Position: -037.296892 / -080.380896 Altitude: 2226ft Datum: WGS-84 Azimuth/Bearing: 214° S34W 3804mils (True) Elevation Angle: -63.8° Horizon Angle: -01.8° Zoom: 1X dry sump at 11724-50</p>

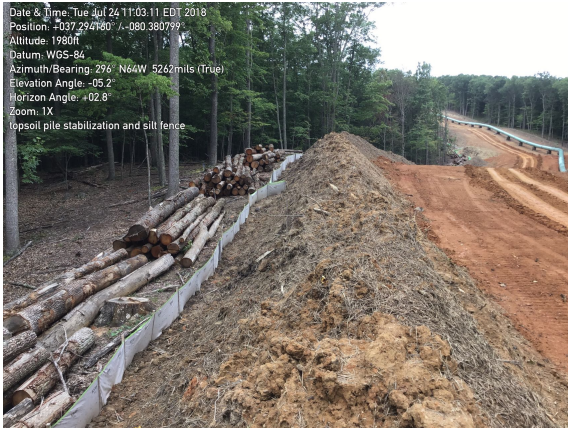
<p>Date & Time: Tue Jul 24 11:03:11 EDT 2018 Position: -037.296892 / -080.380799 Altitude: 1980ft Datum: WGS-84 Azimuth/Bearing: 296° N64W 5262mils (True) Elevation Angle: -05.2° Horizon Angle: -02.8° Zoom: 1X topsoil pile stabilization and silt fence</p>

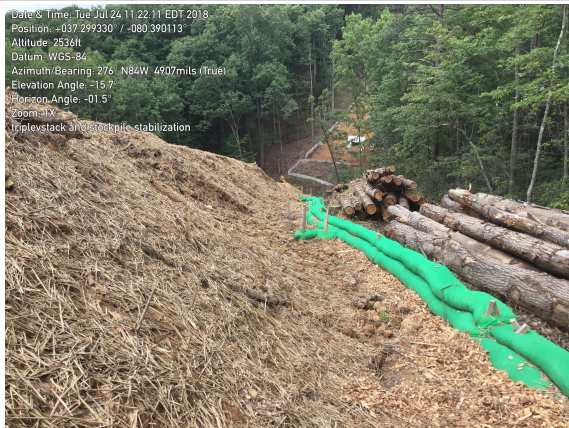
GPS Location	37.2968920972546, -80.3720014449957	GPS Location	37.2968920972546, -80.3720014449957		
Description	Sump functioning as designed. GPS coordinates in photo above.	Description	Installed priority one silt fence and topsoil stabilization. GPS coordinates in photo above.		
<p>Date & Time: Tue Jul 24 11:22:11 EDT 2018 Position: -037.299330 / -080.390113 Altitude: 2536ft Datum: WGS-84 Azimuth/Bearing: 276° N84W 4907mils (True) Elevation Angle: -15.5° Horizon Angle: -01.5° Zoom: 1X triple stack and drainage stabilization</p>

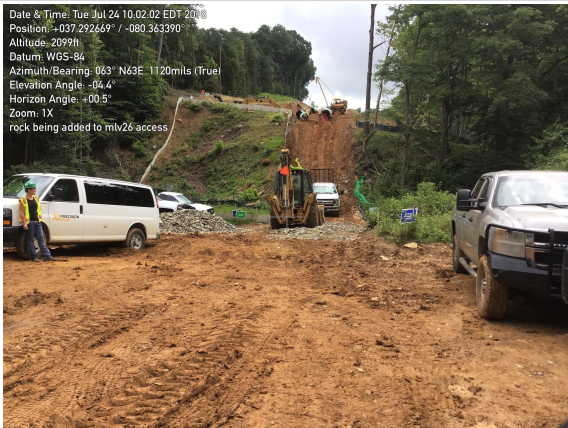
<p>Date & Time: Tue Jul 24 10:02:02 EDT 2018 Position: -037.292669 / -080.363390 Altitude: 2099ft Datum: WGS-84 Azimuth/Bearing: 083° N63E 1120mils (True) Elevation Angle: -04.4° Horizon Angle: -00.5° Zoom: 1X rock being added to mlv26 access</p>
