# Visual Site Inspection Report

<b>Project Name</b>	H-600 Pipeline Spread G		<b>AFE</b>	124300137	<b>Spread</b>	H-600 Pipeline Spread G	
<b>Contractor</b>	Precision				<b>Report #</b>	5082	
<b>Inspector</b>	Brian Shields				<b>Date/Time</b>	7/24/2018 10:38 AM	
<b>Permit #</b>	TBD	<b>Inspection Type</b>	VA SWPP		<b>Station Begin</b>	11770+00	
<b>State</b>	VA	<b>Inspection Area</b>	Partial		<b>Station End</b>	11553+66	
<b>County</b>	Montgomery	<b>Ground</b>	Muddy		<b>Temperature (°F)</b>	75.00	
<b>Municipality</b>	N/A	<b>Weather</b>	Cloudy		<b>Rain Gauge (in)</b>	0.03	
<b>GPS Location</b>	37.2968920972546, -80.3720014449957				<b>Rain Accumulation Time (days)</b>	1.00

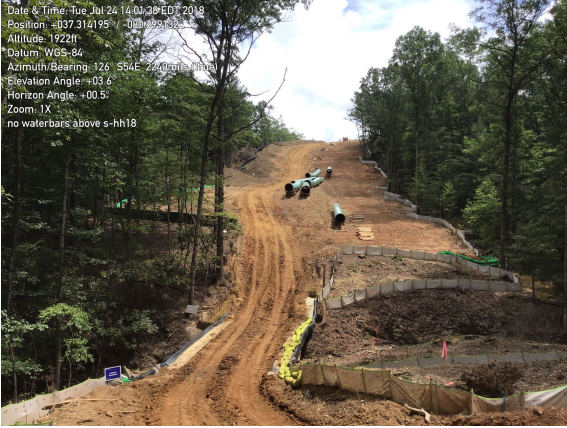
<b>A/E</b>	124300137	<b>Date/Time</b>	7/24/2018 10:38 AM	<b>Report #</b>	5082
<b>6. PCSM BMPs</b> (List BMPs and note if installed and maintained as per the plan. If corrective action is needed, a picture is required.)					
<b>PCSM BMPs</b>		<b>Compliance Level</b>	<b>Corrective Action</b>	<b>Corrective Time Frame</b>	
<b>7. Identify all remedial measures that have been taken since the previous inspection was conducted.</b>					
<b>Comments</b> (Reference above questions as appropriate.)					
VA SWPPP inspection MP 220.7 to 218.6  Installed compost sock is in good working condition with no maintenance needed. Due to muddy conditions of ROW and additional expected rains, all rock construction entrances will need refreshed by end of day. Bore foreman to address Craig creek rd access per Dylan Suckow. Installed silt fence is in good working condition with no maintenance needed. Super silt fence appears to be in good working condition with no maintenance needed. Installed sumps are functioning as designed, most are dry after previous days ran. Installed temporary diversion berms are stabilized and appear to be functioning as designed. All areas requiring temporary stabilization measures have been stabilized. Waterbars are being knocked out daily along the travel lane and put back at end of day. Waterbar outlets appear to be functioning as designed.

<b>A/E</b>	124300137	<b>Date/Time</b>	7/24/2018 10:38 AM	<b>Report #</b>	5082
<b>Pictures</b>					
<p>Date &amp; Time: Tue Jul 24 14:00:39 EDT 2018  Position: +037.314195° / -080.397471°  Altitude: 1922ft  Datum: WGS-84  Azimuth/Bearing: 126° S54E 2496mils (True)  Elevation Angle: +03.6°  Horizon Angle: +00.5°  Zoom: 1X  no waterbars above s-hh18</p>

<b>GPS Location</b>	37.2968501877387, -80.3719053883854	<b>GPS Location</b>	37.2968501877387, -80.3719053883854		
<b>Description</b>	Waterbars knocked out along travel lane above s-hh18. GPS coordinates in photo above.	<b>Description</b>	Installed silt fence in good working condition.		
<p>Date &amp; Time: Tue Jul 24 14:00:15 EDT 2018  Position: +037.311677° / -080.397471°  Altitude: 2063ft  Datum: WGS-84  Azimuth/Bearing: 250° S70W 4444mils (True)  Elevation Angle: +10.1°  Horizon Angle: +02.5°  Zoom: 1X  diversion berm</p>

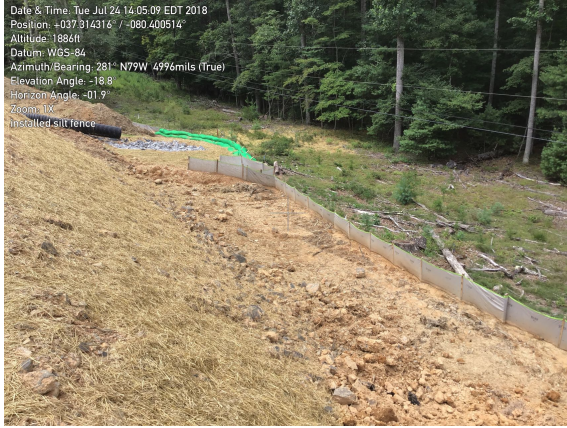
<p>Date &amp; Time: Tue Jul 24 14:05:09 EDT 2018  Position: +037.314316° / -080.400514°  Altitude: 1886ft  Datum: WGS-84  Azimuth/Bearing: 281° N79W 4996mils (True)  Elevation Angle: -18.8°  Horizon Angle: -01.9°  Zoom: 1X  installed silt fence</p>

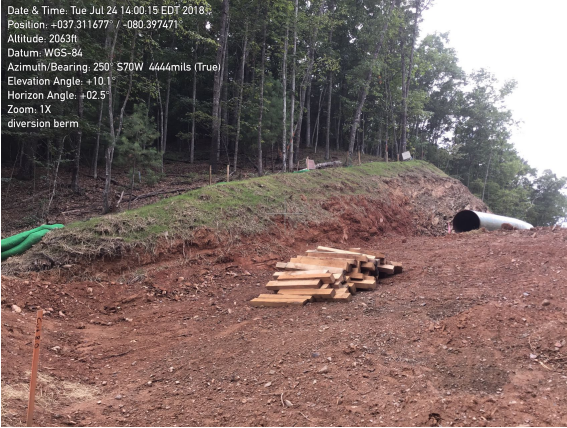
<b>GPS Location</b>	37.2968806978662, -80.3720567655567	<b>GPS Location</b>	37.2969323303898, -80.3721006029103		
<b>Description</b>	Installed temporary diversion berm. GPS coordinates in photo above.	<b>Description</b>	Installed compost sock along Brush mt. GPS coordinates in photo above.		
<p>Date &amp; Time: Tue Jul 24 13:49:58 EDT 2018  Position: +037.313530° / -080.397750°  Altitude: 2089ft  Datum: WGS-84  Azimuth/Bearing: 288° N72W 5120mils (True)  Elevation Angle: -80.3°  Horizon Angle: +00.5°  Zoom: 1X  sump and end treatment st11636+00</p>

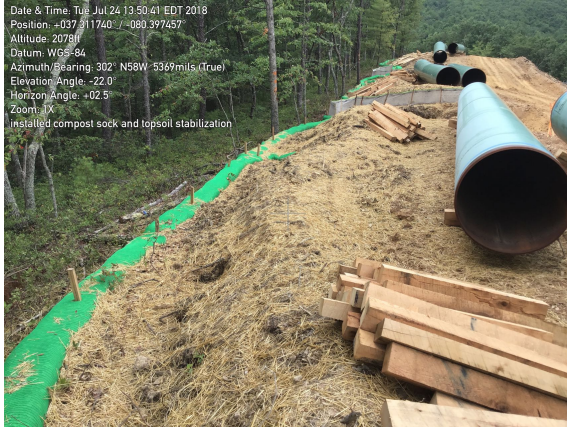
<p>Date &amp; Time: Tue Jul 24 13:50:41 EDT 2018  Position: +037.311740° / -080.397457°  Altitude: 2078ft  Datum: WGS-84  Azimuth/Bearing: 302° N58W 5369mils (True)  Elevation Angle: -22.0°  Horizon Angle: +02.5°  Zoom: 1X  installed compost sock and topsoil stabilization</p>

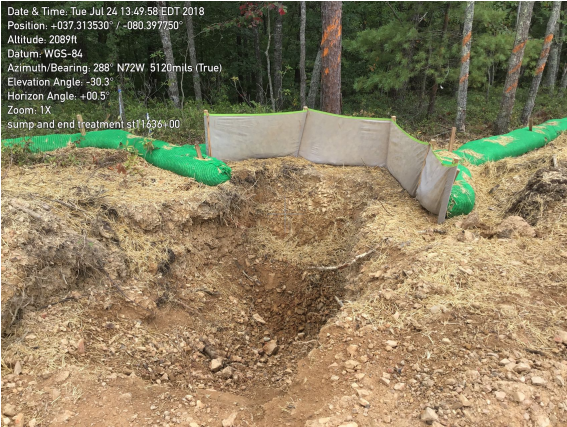
<b>Description</b>	Installed sump and end treatment st11636+00. Sumps are dry. GPS coordinates in photo above.	<b>Description</b>	Installed super silt fence along Brush mountain. GPS coordinates in photo above.

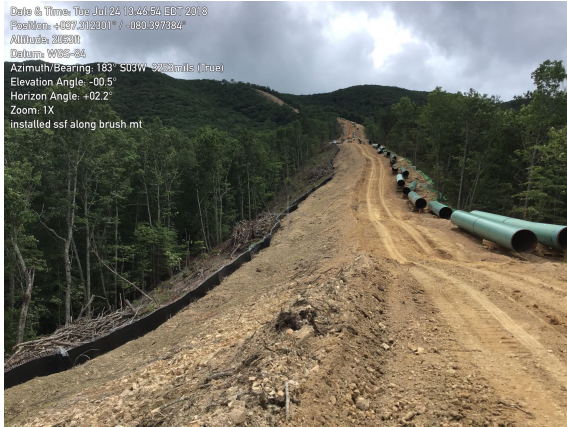
<p>Date &amp; Time: Tue Jul 24 13:46:54 EDT 2018  Position: +037.3132017° / -080.397834°  Altitude: 2050ft  Datum: WGS-84  Azimuth/Bearing: 183° S53W 5028mils (True)  Elevation Angle: -00.5°  Horizon Angle: +02.2°  Zoom: 1X  installed sst along brush mt</p>
