Visual Site Inspection Report

Project Name	H-600 Pipeline Spread G	AFE	124300137	Spread	H-600 Pipeline Spread G
Contractor	Precision			Report #	5738
Inspector	Brian Shields			Date/Time	8/3/2018 11:52 AM
Permit #	TBD	Inspection Type	VA SWPP	Station Begin	11788+43
State	VA	Inspection Area	Partial	Station End	11760+00
County	Montgomery	Ground	Muddy	Temperature (°F)	70.00
Municipality	N/A	Weather	Light Rain	Rain Gauge (in)	1.75
GPS Location	37.2961462336008, -80.3610912245515			Rain Accumulation Time (days)	1.00

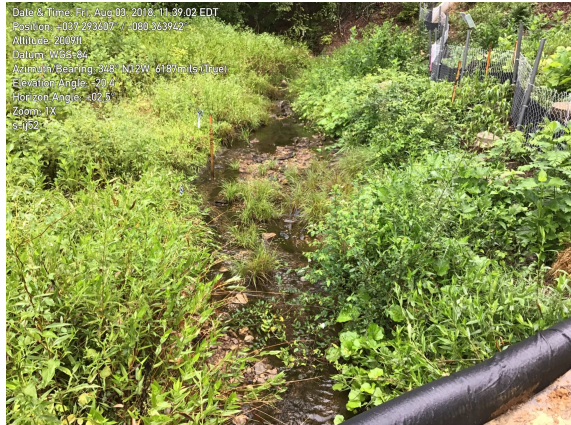
A/E	124300137	Date/Time	8/3/2018 11:52 AM	Report #	5738
Pictures					
<p>Date & Time: Fri, Aug 03, 2018, 11:37:42 EDT Position: +037.296112 / -080.367527 Altitude: 2028ft Datum: WGS-84 Azimuth/Bearing: 149° S31E 2649mils (True) Elevation Angle: -32.0° Horizon Angle: -07.0° Zoom: 1X silt damaged at mlv26</p>  		<p>Date & Time: Fri, Aug 03, 2018, 11:39:02 EDT Position: +037.296007 / -080.363922 Altitude: 2029ft Datum: WGS-84 Azimuth/Bearing: 188° N12W 6189mils (True) Elevation Angle: -24.0° Horizon Angle: -10.1° Zoom: 1X s-j52</p>

GPS Location	37.2961334511985, -80.3609256819639	GPS Location	37.2961334511985, -80.3609256819639		
Description	Damaged silt fence at s-j52. GPS coordinates in photo above.	Description	S-ij52, no impact observed. GPS coordinates in photo above.		
<p>Date & Time: Fri, Aug 03, 2018, 11:40:18 EDT Position: +037.296115 / -080.367701 Altitude: 1900ft Datum: WGS-84 Azimuth/Bearing: 269° S69W 4782mils (True) Elevation Angle: -07.6° Horizon Angle: -00.6° Zoom: 1X additional concrete installed across row at mlv26 access</p>

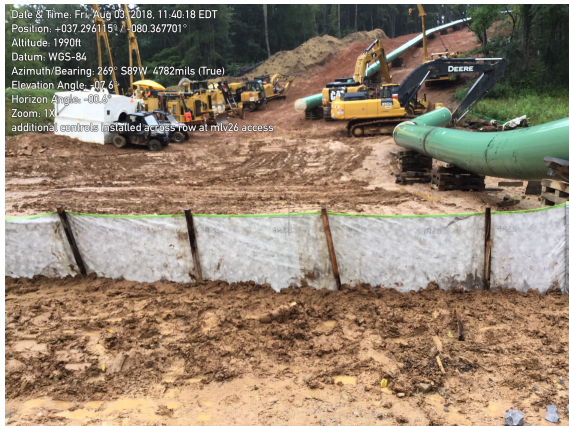
GPS Location	37.2962265741427, -80.3609267716113	GPS Location	37.2962376801644, -80.3609123547378		
Description	Additional silt fence installed at mlv26 access across travel lane. GPS coordinates in photo above.	Description	Waterbar full and not draining. GPS coordinates in photo above.		
<p>Date & Time: Fri, Aug 03, 2018, 11:41:35 EDT Position: +037.296039 / -080.368145 Altitude: 2005ft Datum: WGS-84 Azimuth/Bearing: 181° S81W 3218mils (True) Elevation Angle: -15.1° Horizon Angle: -03.3° Zoom: 1X waterbar and sump maintenance needed</p>  		<p>Date & Time: Fri, Aug 03, 2018, 11:43:14 EDT Position: +037.295959 / -080.368441 Altitude: 2041ft Datum: WGS-84 Azimuth/Bearing: 144° S36E 2360mils (True) Elevation Angle: -20.0° Horizon Angle: -01.0° Zoom: 1X installed super silt fence</p>

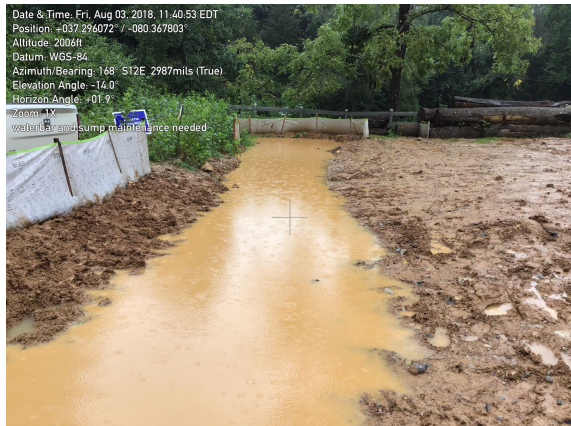
<p>Date & Time: Fri, Aug 03, 2018, 11:40:53 EDT Position: +037.296072 / -080.367803 Altitude: 2006ft Datum: WGS-84 Azimuth/Bearing: 168° S12E 2987mils (True) Elevation Angle: -14.0° Horizon Angle: -01.9° Zoom: 1X waterbar and sump maintenance needed</p>

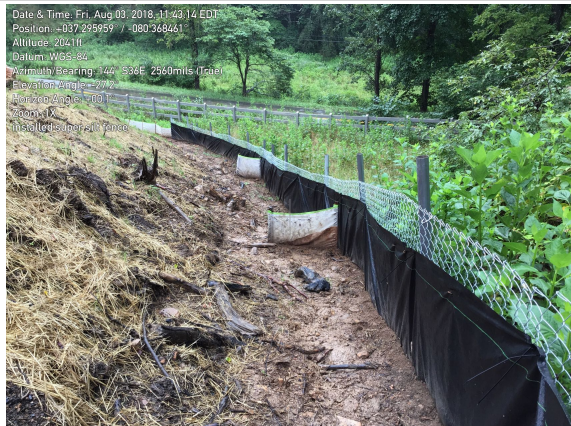
GPS Location	37.2961995844145, -80.3608789109442	GPS Location	37.2961995844145, -80.3608789109442		
Description	End treatments full and in need of maintenance.	Description	Installed super silt fence. No maintenance needs observed. GPS coordinates in photo above.
