# Visual Site Inspection Report

<b>Project Name</b>	H-600 Pipeline Spread G	<b>AFE</b>	124300137	<b>Spread</b>	H-600 Pipeline Spread G
<b>Contractor</b>	Precision			<b>Report #</b>	5739
<b>Inspector</b>	Brian Shields			<b>Date/Time</b>	8/3/2018 11:54 AM
<b>Permit #</b>	TBD	<b>Inspection Type</b>	VA SWPP	<b>Station Begin</b>	11626+04
<b>State</b>	VA	<b>Inspection Area</b>	Partial	<b>Station End</b>	11580+00
<b>County</b>	Montgomery	<b>Ground</b>	Muddy	<b>Temperature (°F)</b>	79.00
<b>Municipality</b>	N/A	<b>Weather</b>	Light Rain	<b>Rain Gauge (in)</b>	0.60
<b>GPS Location</b>	37.2961995844145, -80.3608789109442			<b>Rain Accumulation Time (days)</b>	1.00

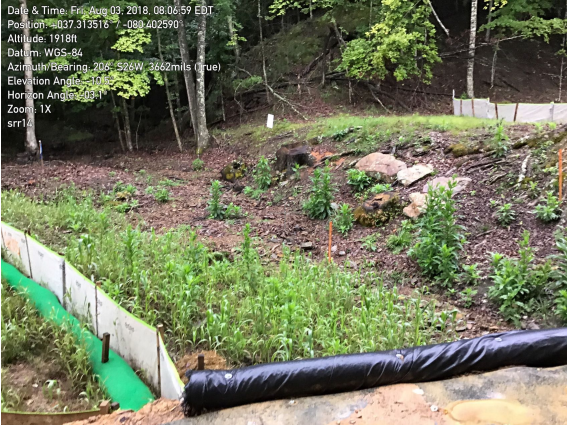
<p>Date &amp; Time: Fri, Aug 03, 2018, 08:06:59 EDT Position: -037.313518° / -080.402590° Altitude: 1918ft Datum: WGS-84 Azimuth/Bearing: 204° S84W 342mils (True) Elevation Angle: -07.3° Horizon Angle: -02.6° Zoom: 1X srr14</p>

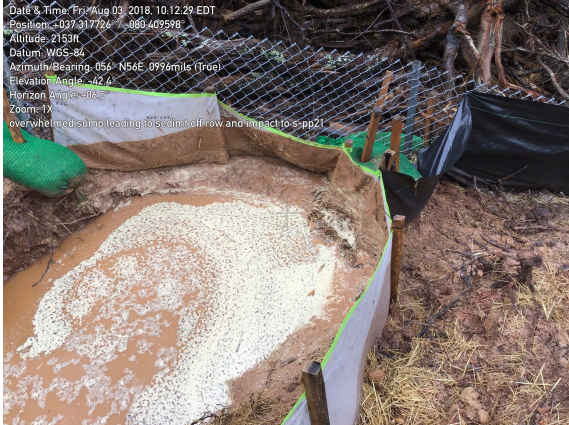
<p>Date &amp; Time: Fri, Aug 03, 2018, 10:12:29 EDT Position: -037.317724° / -080.409598° Altitude: 2139ft Datum: WGS-84 Azimuth/Bearing: 056° N56E 099mils (True) Elevation Angle: -02.6° Horizon Angle: -02.6° Zoom: 1X overwhelmed sump leading to sump overflow and impact to spp21</p>			
<b>GPS Location</b>	37.2961268714045, -80.3609026317302	<b>GPS Location</b>	37.2961781267424, -80.3610388376567		
<b>Description</b>	Srr14, no impact observed. GPS coordinates in photo above.	<b>Description</b>	Overwhelmed end treatment at 11583+22. GPS coordinates in photo above.

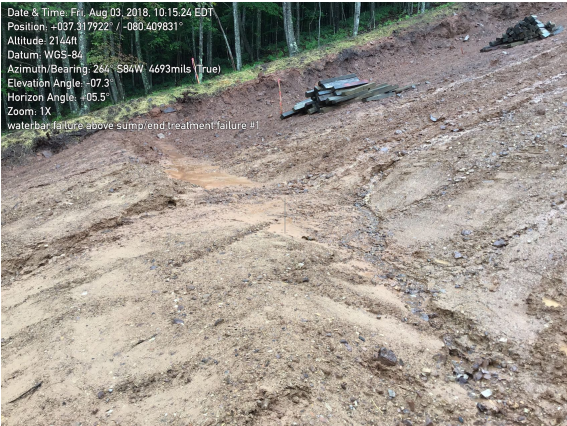
<p>Date &amp; Time: Fri, Aug 03, 2018, 10:15:24 EDT Position: -037.317922° / -080.409831° Altitude: 2144ft Datum: WGS-84 Azimuth/Bearing: 264° S84W 469mils (True) Elevation Angle: -07.3° Horizon Angle: -05.5° Zoom: 1X waterbar failure above sump/end treatment failure #1</p>

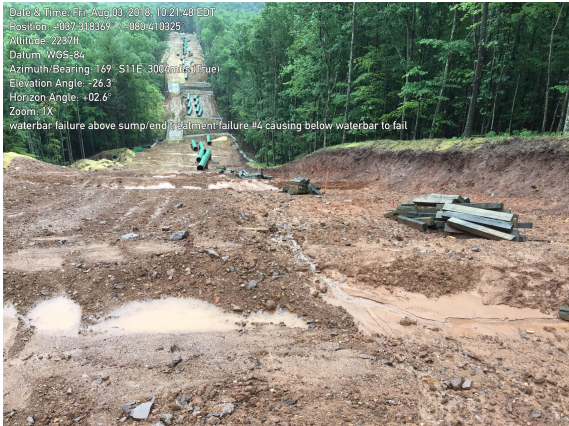
<p>Date &amp; Time: Fri, Aug 03, 2018, 10:21:01 EDT Position: -037.310389° / -080.410325° Altitude: 2237ft Datum: WGS-84 Azimuth/Bearing: 169° S11E 300mils (True) Elevation Angle: -26.3° Horizon Angle: -02.6° Zoom: 1X waterbar failure above sump/end treatment failure #4 causing below waterbar to fail</p>			
<b>GPS Location</b>	37.2961728880529, -80.3610967566076	<b>GPS Location</b>	37.2961728880529, -80.3610967566076		
<b>Description</b>	Overloaded waterbar at st 11582+70. GPS coordinates in photo above.	<b>Description</b>	View of overloaded waterbars to st11583+22. GPS coordinates in photo above.

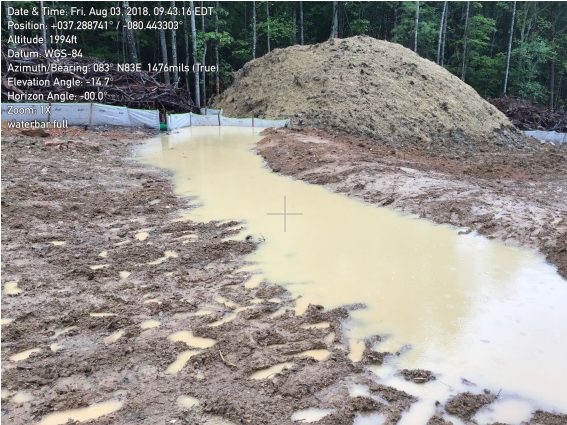
<p>Date &amp; Time: Fri, Aug 03, 2018, 09:43:16 EDT Position: -037.288741° / -080.443303° Altitude: 1994ft Datum: WGS-84 Azimuth/Bearing: 083° N83E 147mils (True) Elevation Angle: -14.7° Horizon Angle: -00.0° Zoom: 1X waterbar full</p>				<p>Insert image here</p>

<b>GPS Location</b>	37.2961728880529, -80.3610967566076	<b>GPS Location</b>	37.2961728880529, -80.3610967566076		
<b>Description</b>	Waterbar and end treatment full at 11597+20. GPS coordinates in photo above.	<b>Description</b>
