# Visual Site Inspection Report

<b>Project Name</b>	H-600 Pipeline Spread G	<b>AFE</b>	124300137	<b>Spread</b>	H-600 Pipeline Spread G
<b>Contractor</b>	Precision			<b>Report #</b>	6082
<b>Inspector</b>	Brian Shields			<b>Date/Time</b>	8/9/2018 5:36 PM
<b>Permit #</b>	TBD	<b>Inspection Type</b>	VA SWPP	<b>Station Begin</b>	11553+66
<b>State</b>	VA	<b>Inspection Area</b>	Partial	<b>Station End</b>	11618+91
<b>County</b>	Montgomery	<b>Ground</b>	Dry	<b>Temperature (°F)</b>	85.00
<b>Municipality</b>	N/A	<b>Weather</b>	Sunny	<b>Rain Gauge (in)</b>	0.00
<b>GPS Location</b>	37.2960399510686, -80.3678589408103			<b>Rain Accumulation Time (days)</b>	1.00

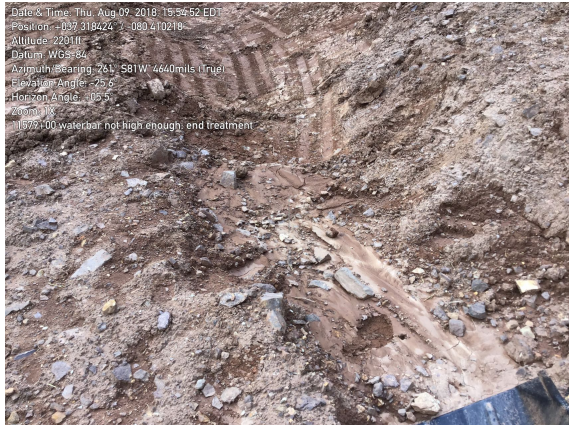
A/E	124300137	Date/Time	8/9/2018 5:36 PM	Report #	6082
Pictures					
<p>Date &amp; Time: Thu, Aug 09, 2018, 15:46:52 EDT Position: +037.318424° / -080.410218° Altitude: 2201ft Datum: WGS-84 Azimuth/Bearing: 261° S81W 4440mils (True) Elevation Angle: +05.5° Horizon Angle: -06.5° Zoom: 1X 11560+00 waterbar not high enough, end treatment</p>

GPS Location	37.2960166493778, -80.3678827454153		GPS Location	37.2960166493778, -80.3678827454153	
Description	Waterbar maintenance needed.		Description	Waterbar maintenance needed.	
<p>Date &amp; Time: Thu, Aug 09, 2018, 15:33:41 EDT Position: +037.322981° / -080.414342° Altitude: 2779ft Datum: WGS-84 Azimuth/Bearing: 101° S79E 1796mils (True) Elevation Angle: -07.6° Horizon Angle: -06.3° Zoom: 1X 11560+00 end treatment undercut</p>

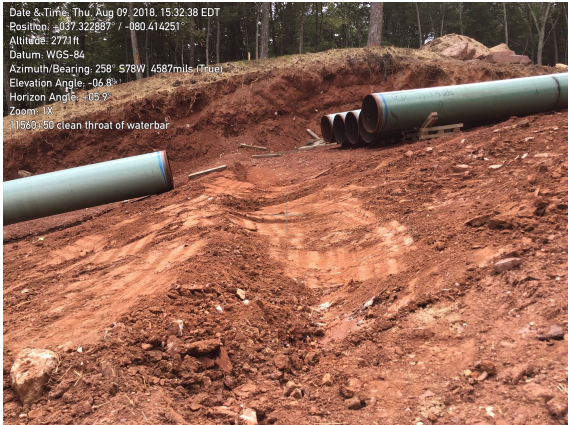
<p>Date &amp; Time: Thu, Aug 09, 2018, 15:32:38 EDT Position: +037.322887° / -080.414251° Altitude: 2771ft Datum: WGS-84 Azimuth/Bearing: 258° S78W 4587mils (True) Elevation Angle: +06.8° Horizon Angle: -08.9° Zoom: 1X 11560+50 clean throat of waterbar</p>

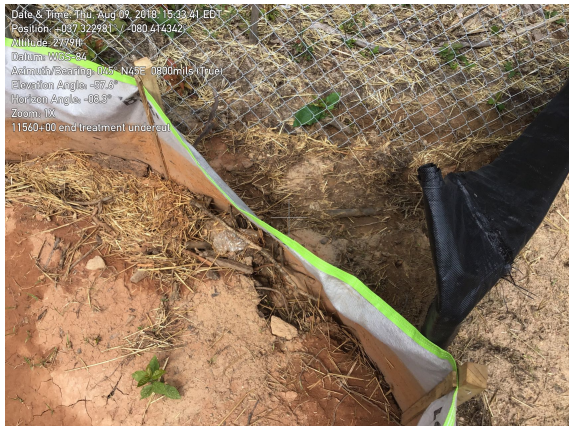
GPS Location	37.2960166493778, -80.3678827454153		GPS Location	37.2960166493778, -80.3678827454153	
Description	Undercut end treatment. Upgrade needed.		Description	End treatment adjustment needed.	
<p>Date &amp; Time: Thu, Aug 09, 2018, 15:21:19 EDT Position: +037.321859° / -080.413543° Altitude: 2623ft Datum: WGS-84 Azimuth/Bearing: 258° S78W 4587mils (True) Elevation Angle: -04.8° Horizon Angle: +08.0° Zoom: 1X 11564+50 waterbar full pipe side, slope drain berm needed, end treatment needs adjusted to allow water to discharge</p>

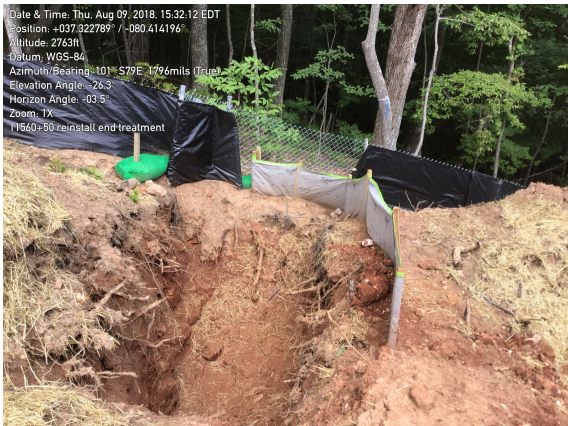
<p>Date &amp; Time: Thu, Aug 09, 2018, 15:32:12 EDT Position: +037.322789° / -080.414196° Altitude: 2743ft Datum: WGS-84 Azimuth/Bearing: 101° S79E 1796mils (True) Elevation Angle: -06.3° Horizon Angle: -03.5° Zoom: 1X 11560+50 re-install end treatment</p>

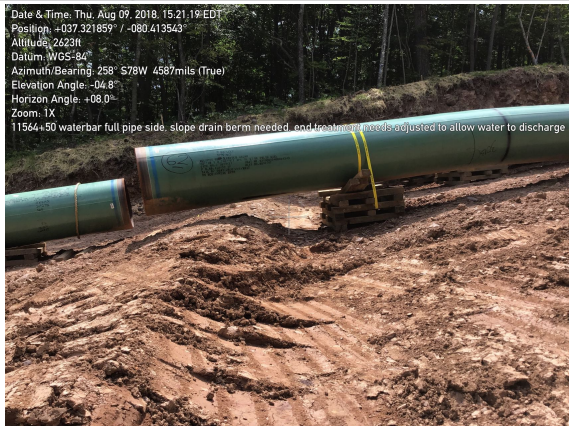
Description	Waterbar maintenance needed.		Description	Sump full and in need of clean out.

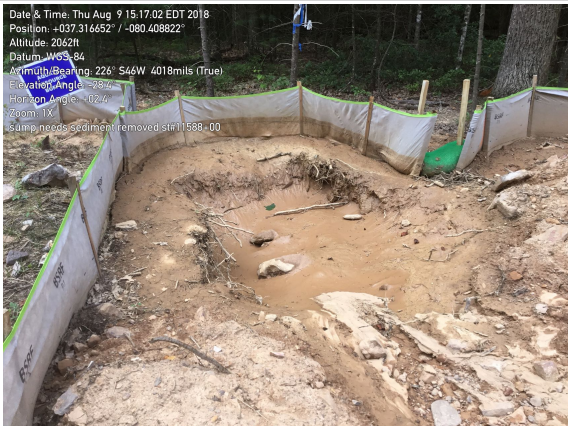
<p>Date &amp; Time: Thu Aug 9 15:17:02 EDT 2018 Position: +037.316452° / -080.408822° Altitude: 2062ft Datum: WGS-84 Azimuth/Bearing: 225° S46W 4018mils (True) Elevation Angle: -05.8° Horizon Angle: -02.7° Zoom: 1X Sump needs additional removed stn 1588+00</p>
