Visual Site Inspection Report

Project Name	H-600 Pipeline Spread G	AFE	124300137	Spread	H-600 Pipeline Spread G
Contractor	Precision	Report #	6378		
Inspector	Brian Shields	Date/Time	8/15/2018 4:14 PM		
Permit #	TBD	Inspection Type	VA SWPP	Station Begin	11788+43
State	VA	Inspection Area	Partial	Station End	11669+08
County	Montgomery	Ground	Dry	Temperature (°F)	85.00
Municipality	N/A	Weather	Sunny	Rain Gauge (in)	0.00
GPS Location	37.1638010487165, -80.4174020297496			Rain Accumulation Time (days)	1.00

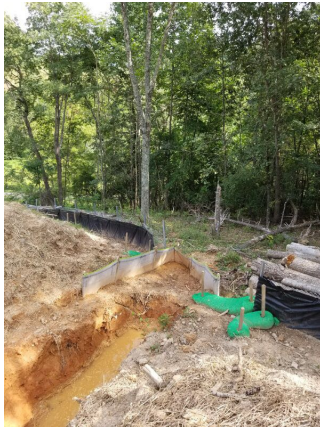
GPS Location	37.1638137350195, -80.4174091768547	GPS Location	37.163823986477, -80.4174580730426		
Description	Installed waterbar and end treatment.	Description	Refreshed RCE at mlv26.

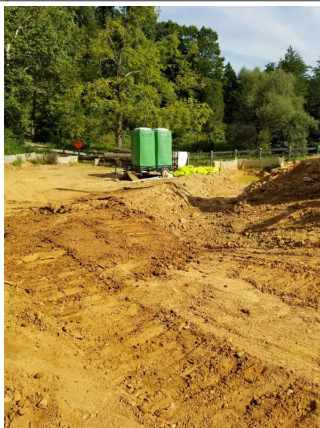
GPS Location	37.1638362270774, -80.4175165006859	GPS Location	37.1638370098186, -80.4175239590438		
Description	Reworked waterbar.	Description	Hydroseeding occurring between mt tabor and mlv26.	<div>Insert image here</div>

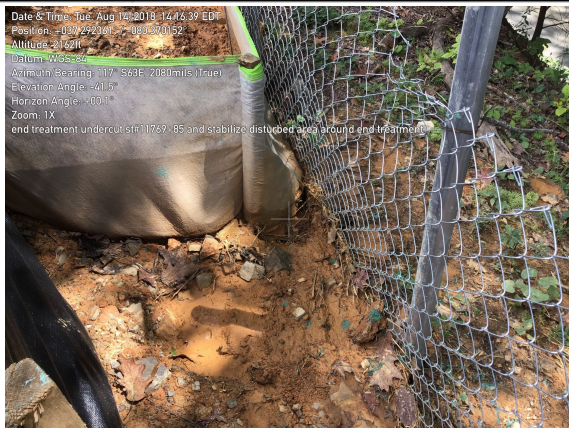
GPS Location	37.1638255170001, -80.4175686237758	GPS Location			
Description	Undercut end treatment that has since been repaired,	Description

7. Identify all remedial measures that have been taken since the previous inspection was conducted.					
Comments (Reference above questions as appropriate.)					
VA SWPPP inspection MP 223.2 to 220.7 Installed compost filter sock is in good working condition with no maintenance needed. Rock construction entrances have been refreshed since last rain event and are functioning as designed. Installed silt fence is in good working condition with no maintenance needed. Installed super silt fence is in good working condition with no maintenance needed. Sumps on site have been dipped out since last rain event Temporary diversion berms are in good working condition and appear to be functioning as designed. Areas requiring temporary stabilization have been stabilized and all areas where growth was scarce have recently been reseeded. Hydroseeding has begun. Waterbars are in good working condition and are functioning as designed. All waterbars reworked since last rain event Multiple end treatments have been undercut crews have been made aware, and repairs have been made.
