Visual Site Inspection Report

Project Name	H-600 Pipeline Spread G	AFE	124300137	Spread	H-600 Pipeline Spread G
Contractor	Precision	Report #	6999		
Inspector	Brian Shields	Date/Time	8/27/2018 12:04 PM		
Permit #	TBD	Inspection Type	VA SWPP	Station Begin	11768+00
State	VA	Inspection Area	Partial	Station End	11669+08
County	Montgomery	Ground	Dry	Temperature (°F)	82.00
Municipality	N/A	Weather	Sunny	Rain Gauge (in)	0.00
GPS Location	37.2771067411406, -80.3942077590691			Rain Accumulation Time (days)	1.00

VA SWPPP inspection MP 222.8 to 220.7

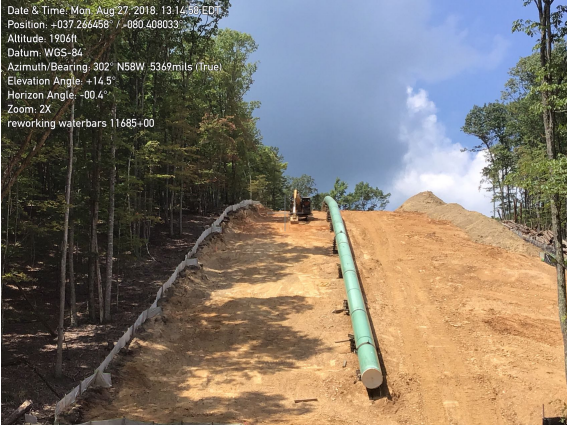
A/E	124300137	Date/Time	8/27/2018 12:04 PM	Report #	6999
Pictures					
<p>Date & Time: Mon, Aug 27, 2018, 13:14:55 EDT Position: +037.266458° / -080.408033° Altitude: 1906ft Datum: WGS-84 Azimuth/Bearing: 302° N58W 536ftmils (True) Elevation Angle: +14.5° Horizon Angle: -00.4° Zoom: 2X reworking waterbars 11685+00</p>

GPS Location	37.2771067411406, -80.3942077590691	GPS Location	37.2771067411406, -80.3942077590691		
Description	Trackhoe reworking waterbars on pipe side in preparation for stabilization.	Description	Changing direction of waterbar above stream s-mn21 to lessen amount of water discharged above the stream.		
<p>Date & Time: Mon, Aug 27, 2018, 16:27:54 EDT Position: +037.299096° / -080.339941° Altitude: 1906ft Datum: WGS-84 Azimuth/Bearing: 289° N71W 5138mils (True) Elevation Angle: -25.7° Horizon Angle: +01.0° Zoom: 1X installed triple stack</p>

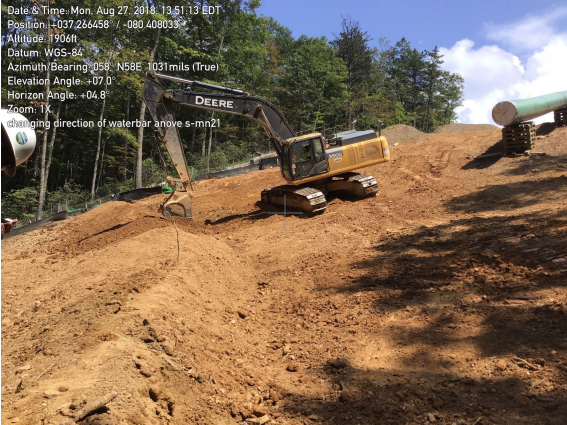
<p>Date & Time: Mon, Aug 27, 2018, 13:51:13 EDT Position: +037.266458° / -080.408033° Altitude: 1906ft Datum: WGS-84 Azimuth/Bearing: 058° N58E 1031mils (True) Elevation Angle: +07.0° Horizon Angle: +04.8° Zoom: 1X changing direction of waterbar above s-mn21</p>

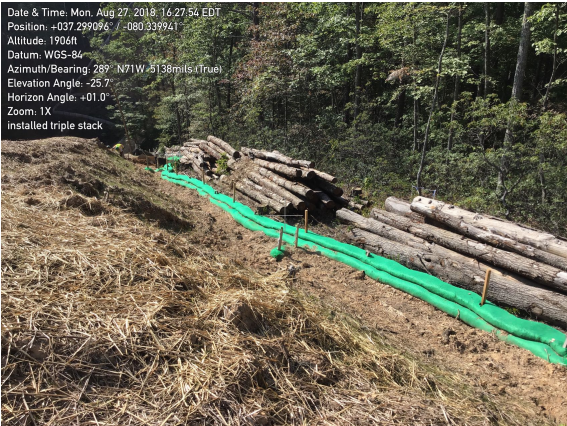
GPS Location	37.2771067411406, -80.3942077590691	GPS Location	37.2771067411406, -80.3942077590691		
Description	Installed triple stack compost filter sock in good working condition.	Description	Installed silt fence in good working condition.		
<p>Date & Time: Mon, Aug 27, 2018, 16:37:37 EDT Position: +037.299096° / -080.339941° Altitude: 1906ft Datum: WGS-84 Azimuth/Bearing: 208° S26W 3498mils (True) Elevation Angle: -23.2° Horizon Angle: +03.4° Zoom: 1X installed sump and end treatment</p>

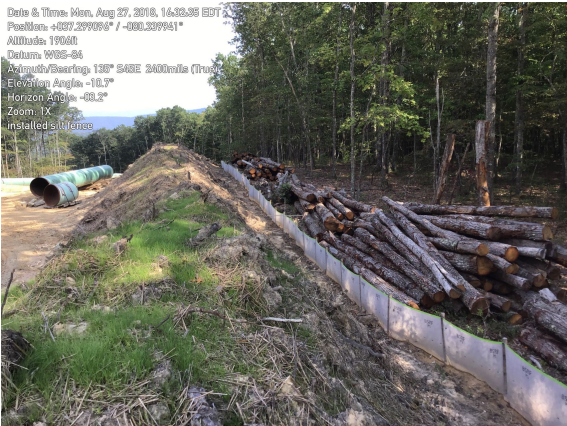
<p>Date & Time: Mon, Aug 27, 2018, 16:33:36 EDT Position: +037.299096° / -080.339941° Altitude: 1906ft Datum: WGS-84 Azimuth/Bearing: 130° S48E 2400mils (True) Elevation Angle: -18.7° Horizon Angle: -08.2° Zoom: 1X installed silt fence</p>

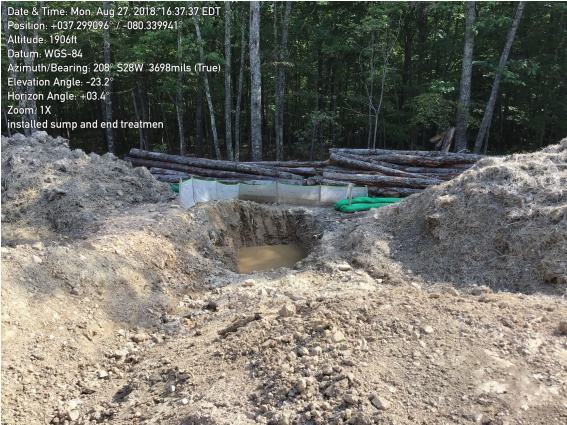
GPS Location	37.2771067411406, -80.3942077590691	GPS Location	37.2771067411406, -80.3942077590691		
Description	Installed sump and waterbar end treatment, no maintenance needed.	Description	Rock construction entrance at mlv26, functioning as designed.

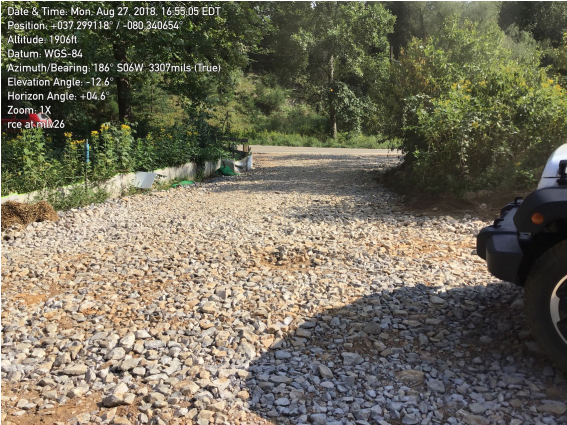
<p>Date & Time: Mon, Aug 27, 2018, 16:59:05 EDT Position: +037.299118° / -080.340654° Altitude: 1906ft Datum: WGS-84 Azimuth/Bearing: 186° S06W 3307mils (True) Elevation Angle: -12.6° Horizon Angle: +04.6° Zoom: 1X rock at mlv26</p>
