Visual Site Inspection Report

Project Name	H-600 Pipeline Spread G	AFE	124300137	Spread	H-600 Pipeline Spread G
Contractor	Precision	Report #	7230		
Inspector	Brian Shields	Date/Time	8/31/2018 5:34 PM		
Permit #	TBD	Inspection Type	VA SWPP	Station Begin	11669+00
State	VA	Inspection Area	Partial	Station End	11600+00
County	Montgomery	Ground	Muddy	Temperature (°F)	88.00
Municipality	N/A	Weather	Sunny	Rain Gauge (in)	1.25
GPS Location	37.1361329627592, -80.3941691382374			Rain Accumulation Time (days)	1.00

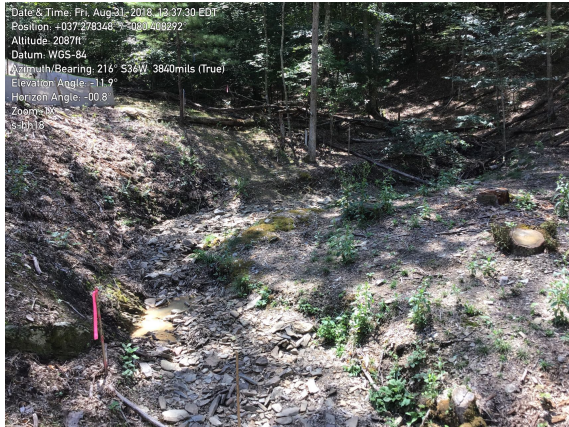
A/E	124300137	Date/Time	8/31/2018 5:34 PM	Report #	7230
Pictures					
<p>Date & Time: Fri, Aug 31, 2018, 13:37:30 EDT Position: +037.28346° / -080.46292° Altitude: 2087ft Datum: WGS-84 Azimuth/Bearing: 216° S34W 3840mils (True) Elevation Angle: +11.9° Horizon Angle: -00.8° Zoom: 1X s-hh18</p>

GPS Location	37.136051181789, -80.3941949118526	GPS Location	37.136156077648, -80.3941774459274		
Description	Stream s-hh18 after storm event. GPS coordinates in photo above.	Description	Sump and end treatment along Brush mountain. Sump in need of clean out.		
<p>Date & Time: Fri, Aug 31, 2018, 13:57:22 EDT Position: +037.286987° / -080.444767° Altitude: 2087ft Datum: WGS-84 Azimuth/Bearing: 323° N37W 5742mils (True) Elevation Angle: -32.6° Horizon Angle: +02.0° Zoom: 1X sump and end treatment along brush mt 11647+00</p>

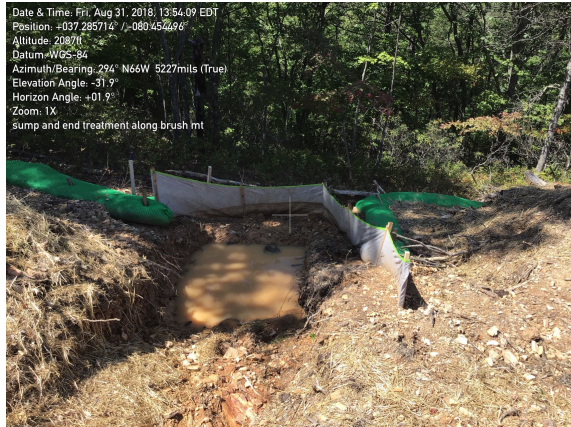
<p>Date & Time: Fri, Aug 31, 2018, 13:54:09 EDT Position: +037.285714° / -080.454496° Altitude: 2087ft Datum: WGS-84 Azimuth/Bearing: 294° N66W 5227mils (True) Elevation Angle: -31.9° Horizon Angle: +01.9° Zoom: 1X sump and end treatment along brush mt</p>

E&S BMPs	Compliance Level	Corrective Action	Corrective Time Frame
Compost Filter Sock	Acceptable		
Rock Construction Entrance	Acceptable		
Silt Fence (Filter Fabric Fence)	Acceptable		
Silt Fence (Reinforced Filter Fabric Fence)	Acceptable		
Sump Pit	Communication	Dip out as needed	
Temporary Diversion Berm	Acceptable		
Waterbar	Communication	Maintenance needed	
Waterbar Outlet Protection	Acceptable

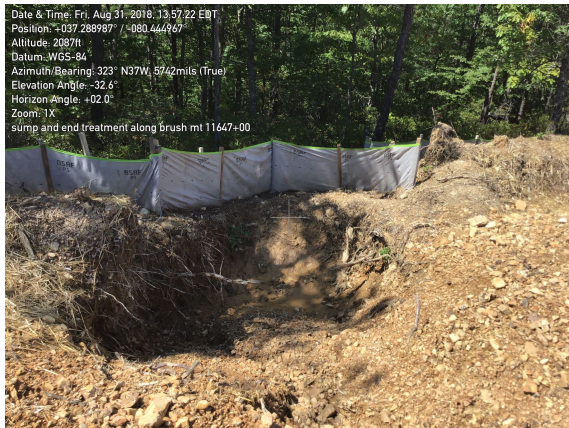
GPS Location	37.1361560029858, -80.394177344614	GPS Location	37.1361554152057, -80.394177399999		
Description	Sump and end treatment along Brush mountain st#11647+00. No water within sump.	Description	Perimeter controls st st#11645+00. No maintenance needed.		
<p>Date & Time: Fri, Aug 31, 2018, 14:05:00 EDT Position: +037.287581° / -080.447675° Altitude: 2087ft Datum: WGS-84 Azimuth/Bearing: 017° N17E 0302mils (True) Elevation Angle: -09.8° Horizon Angle: -00.2° Zoom: 1X waterbars at 11638</p>

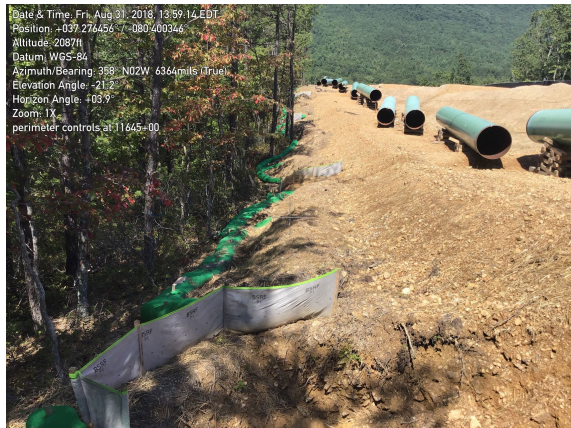
<p>Date & Time: Fri, Aug 31, 2018, 13:59:14 EDT Position: +037.274454° / -080.400346° Altitude: 2087ft Datum: WGS-84 Azimuth/Bearing: 358° N02W 6364mils (True) Elevation Angle: -21.2° Horizon Angle: +03.9° Zoom: 1X perimeter controls at 11645+00</p>

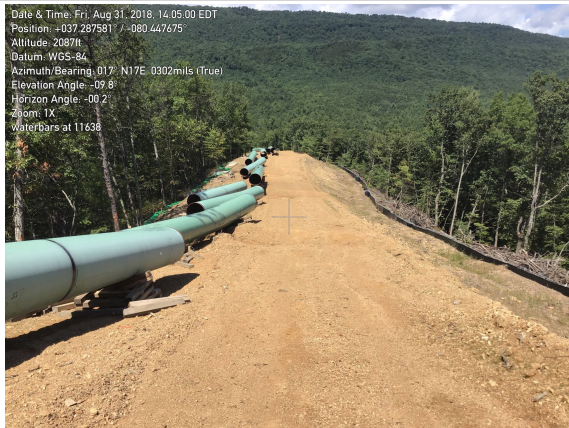
GPS Location	37.1361554166377, -80.3941774038699	GPS Location	37.1361209013733, -80.3941815992938		
Description	Waterbars along Brush mountain st#11638+00.	Description	Stream S-006 after rain event.

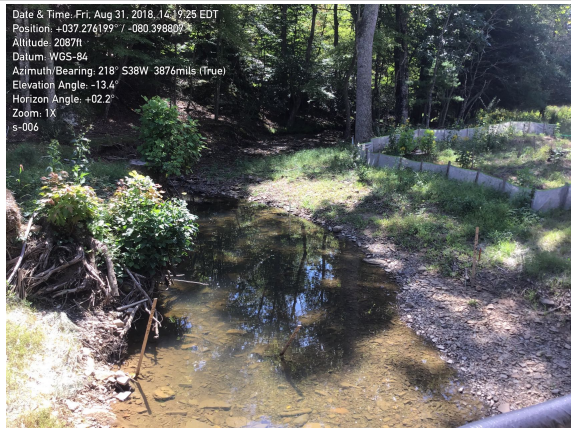
<p>Date & Time: Fri, Aug 31, 2018, 14:19:25 EDT Position: +037.276199° / -080.398807° Altitude: 2087ft Datum: WGS-84 Azimuth/Bearing: 218° S38W 3876mils (True) Elevation Angle: -13.4° Horizon Angle: +02.2° Zoom: 1X s-006</p>
