Visual Site Inspection Report

Project Name	H-600 Pipeline Spread G	AFE	124300137	Spread	H-600 Pipeline Spread G
Contractor	Precision	Report #	7438		
Inspector	Brian Shields	Date/Time	9/6/2018 3:40 PM		
Permit #	TBD	Inspection Type	VA SWPP	Station Begin	11669+00
State	VA	Inspection Area	Partial	Station End	11596+94
County	Montgomery	Ground	Dry	Temperature (°F)	86.00
Municipality	N/A	Weather	Sunny	Rain Gauge (in)	0.00
GPS Location	37.2830759724183, -80.3725539700095			Rain Accumulation Time (days)	1.00

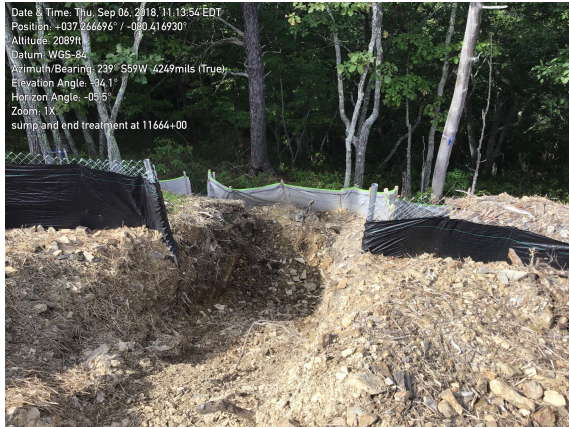
A/E	124300137	Date/Time	9/6/2018 3:40 PM	Report #	7438
Pictures					
<p>Date & Time: Thu, Sep 06, 2018, 11:13:54 EDT Position: +037.26696° / -080.416930° Altitude: 2089ft Datum: WGS-84 Azimuth/Bearing: 239° S59W 4249mils (True) Elevation Angle: -34.1° Horizon Angle: -05.3° Zoom: 1X Sump and end treatment at 11664+00</p>

GPS Location	37.2830759724183, -80.3725539700095	GPS Location	37.2830759724183, -80.3725539700095		
Description	Installed Sump and end treatment in good working condition, st#11664+00.	Description	Waterbars down brush mountain at st#11662+00.		
<p>Date & Time: Thu, Sep 06, 2018, 11:29:43 EDT Position: +037.26696° / -080.416930° Altitude: 2089ft Datum: WGS-84 Azimuth/Bearing: 189° S59W 3360mils (True) Elevation Angle: -28.7° Horizon Angle: -07.8° Zoom: 1X Installed silt at 11656+00</p>

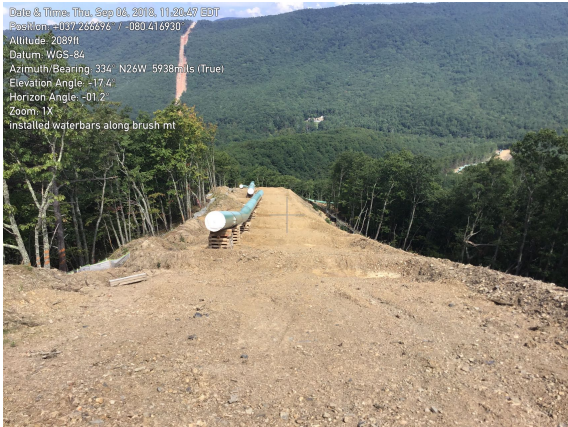
<p>Date & Time: Thu, Sep 06, 2018, 11:20:47 EDT Position: +037.26696° / -080.416930° Altitude: 2089ft Datum: WGS-84 Azimuth/Bearing: 334° N26W 5938mils (True) Elevation Angle: -17.4° Horizon Angle: -01.2° Zoom: 1X Installed waterbars along brush mt</p>

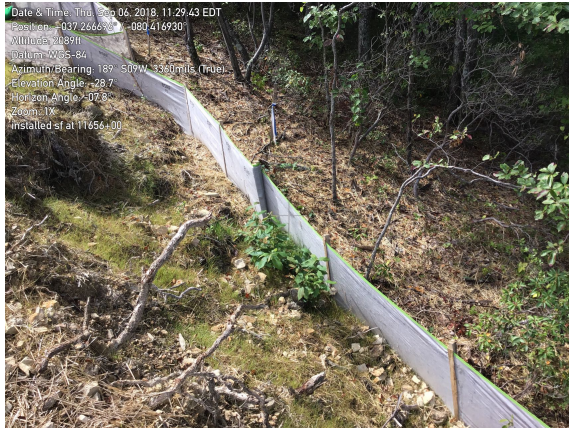
GPS Location	37.2830759724183, -80.3725539700095	GPS Location	37.2830759724183, -80.3725539700095		
Description	Installed silt fence at st#11656+00. No maintenance needed.	Description	Sump full at st#11653+60. Maintenance needed.		
<p>Date & Time: Thu, Sep 06, 2018, 11:35:54 EDT Position: +037.26424° / -080.273714° Altitude: 2089ft Datum: WGS-84 Azimuth/Bearing: 180° S90E 2844mils (True) Elevation Angle: -21.2° Horizon Angle: -04.4° Zoom: 1X Sump full at 11653-11659+60</p>

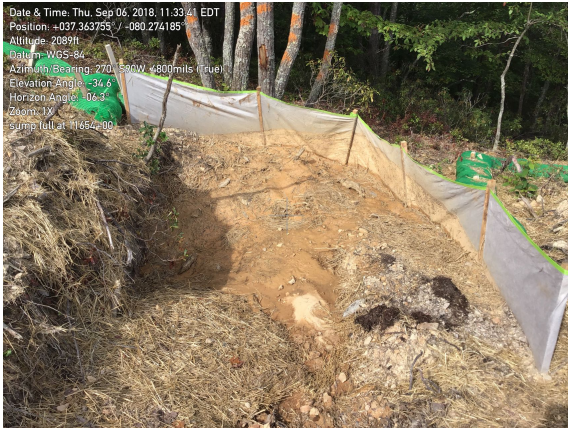
<p>Date & Time: Thu, Sep 06, 2018, 11:33:41 EDT Position: +037.26375° / -080.274165° Altitude: 2089ft Datum: WGS-84 Azimuth/Bearing: 270° S90W 4800mils (True) Elevation Angle: -34.6° Horizon Angle: -06.3° Zoom: 1X Sump full at 11653+00</p>

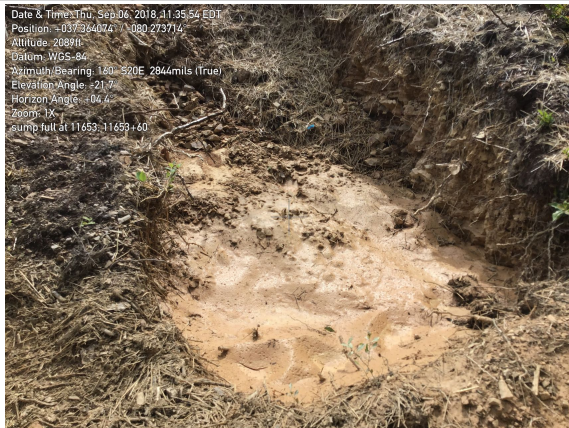
GPS Location	37.2830759724183, -80.3725539700095	GPS Location	37.2830759724183, -80.3725539700095		
Description	Sump full at st#11653+00. Maintenance needed.	Description	Installed silt fence along Brush mountain. No maintenance needed.

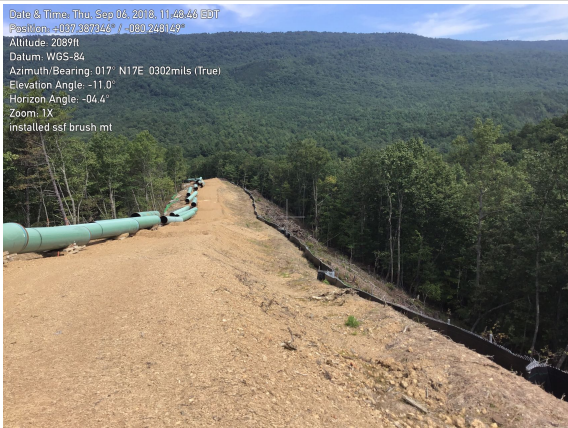
<p>Date & Time: Thu, Sep 06, 2018, 11:43:46 EDT Position: +037.267042° / -080.248142° Altitude: 2089ft Datum: WGS-84 Azimuth/Bearing: 017° N17E 0302mils (True) Elevation Angle: -11.0° Horizon Angle: -04.4° Zoom: 1X Installed silt brush mt</p>
