Visual Site Inspection Report

Project Name	H-600 Pipeline Spread G	AFE	124300137	Spread	H-600 Pipeline Spread G
Contractor	Precision			Report #	7439
Inspector	Brian Shields			Date/Time	9/6/2018 3:51 PM
Permit #	TBD	Inspection Type	VA SWPP	Station Begin	11788+43
State	VA	Inspection Area	Partial	Station End	11669+00
County	Montgomery	Ground	Dry	Temperature (°F)	86.00
Municipality	N/A	Weather	Sunny	Rain Gauge (in)	0.00
GPS Location	37.2830759724183, -80.3725539700095			Rain Accumulation Time (days)	1.00

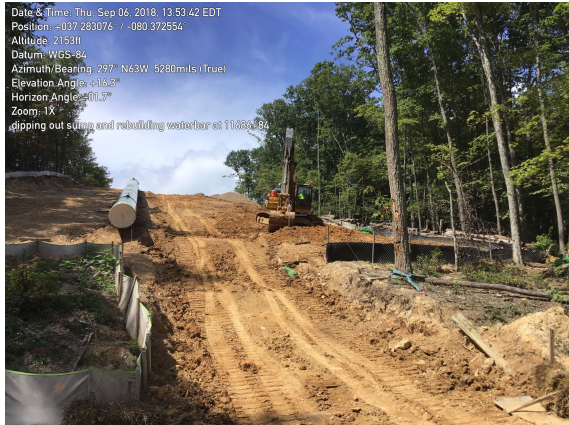
A/E	124300137	Date/Time	9/6/2018 3:51 PM	Report #	7439
Pictures					
<p>Date & Time: Thu, Sep 06, 2018, 13:53:42 EDT Position: -037.283076 / -080.372554 Altitude: 2153ft Datum: WGS-84 Azimuth/Bearing: 297° N63W 5280mils (True) Elevation Angle: +18.2° Horizon Angle: +00.3° Zoom: 1X dipping out sump and rebuilding waterbar at 11686+84.</p>

GPS Location	37.1361197555147, -80.3941901855919	GPS Location	37.1360709399327, -80.3942017978384		
Description	Trackhoe dipping out sump and rebuilding waterbar at st#11686+84.	Description	Installed sump and end treatment at st#11710+20. No maintenance needed.		
<p>Date & Time: Thu, Sep 06, 2018, 14:51:01 EDT Position: -037.283076 / -080.372554 Altitude: 2153ft Datum: WGS-84 Azimuth/Bearing: 152° S28E 2702mils (True) Elevation Angle: -27.4° Horizon Angle: -04.2° Zoom: 1X installed at 11711+20.</p>

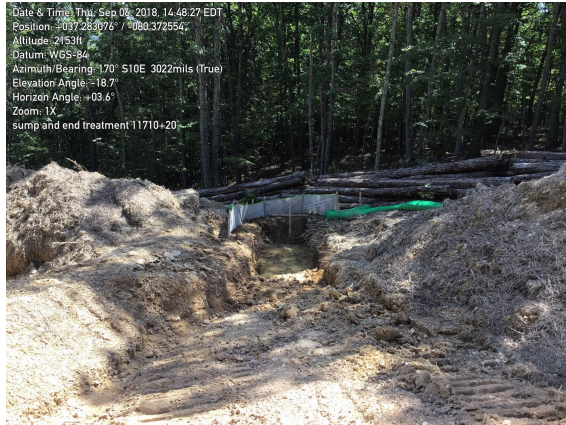
<p>Date & Time: Thu, Sep 06, 2018, 14:48:27 EDT Position: -037.283076 / -080.372554 Altitude: 2153ft Datum: WGS-84 Azimuth/Bearing: 120° S10E 3022mils (True) Elevation Angle: -18.7° Horizon Angle: +03.6° Zoom: 1X sump and end treatment 11710+20.</p>

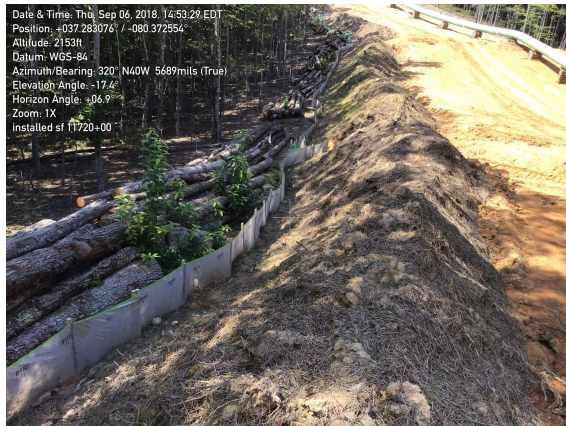
<p>Date & Time: Thu, Sep 06, 2018, 14:50:29 EDT Position: -037.283076 / -080.372554 Altitude: 2153ft Datum: WGS-84 Azimuth/Bearing: 320° N40W 5689mils (True) Elevation Angle: -17.4° Horizon Angle: +06.9° Zoom: 1X installed at 11720+00.</p>

GPS Location	37.1360709512661, -80.3942016467493	GPS Location	37.1360709652794, -80.3942016428652		
Description	Installed compost filter sock at st#11711+20. No maintenance needed.	Description	Installed silt fence at st#11720+00. No maintenance needed.		
<p>Date & Time: Thu, Sep 06, 2018, 15:04:41 EDT Position: -037.283076 / -080.372554 Altitude: 2153ft Datum: WGS-84 Azimuth/Bearing: 180° S80E 2311mils (True) Elevation Angle: -08.6° Horizon Angle: -02.7° Zoom: 1X stockpile stabilization</p>

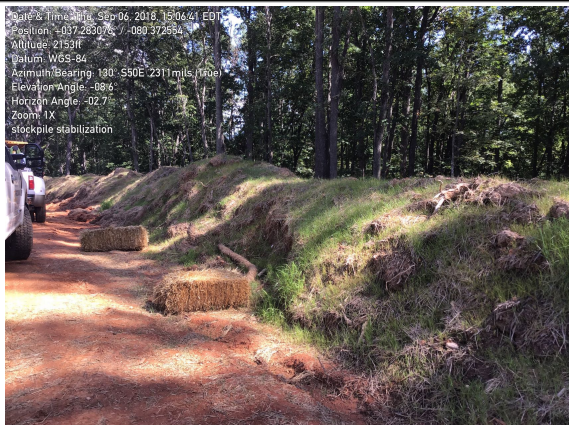
GPS Location	37.1360709701904, -80.3942016417222	GPS Location	37.1361337907521, -80.3941827816584		
Description	Stockpile stabilization at st#11754+00.	Description	Installed waterbars at st#11752+00.

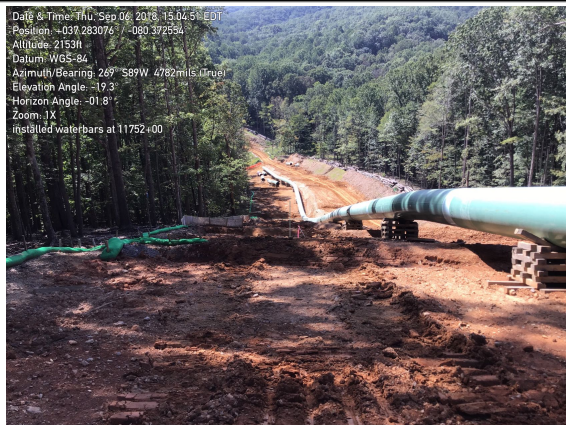
<p>Date & Time: Thu, Sep 06, 2018, 15:04:51 EDT Position: -037.283076 / -080.372554 Altitude: 2153ft Datum: WGS-84 Azimuth/Bearing: 209° S89W 4782mils (True) Elevation Angle: -19.3° Horizon Angle: -01.8° Zoom: 1X installed waterbars at 11752+00.</p>
