Visual Site Inspection Report

Project Name	H-600 Pipeline Spread G	AFE	124300137	Spread	H-600 Pipeline Spread G
Contractor	Precision			Report #	8049
Inspector	Brian Shields			Date/Time	9/18/2018 1:37 PM
Permit #	TBD	Inspection Type	VA SWPP	Station Begin	11768+00
State	VA	Inspection Area	Partial	Station End	11669+00
County	Montgomery	Ground	Muddy	Temperature (°F)	82.00
Municipality	N/A	Weather	Cloudy	Rain Gauge (in)	0.40
GPS Location	37.3034781854831, -80.5286549752633			Rain Accumulation Time (days)	1.00

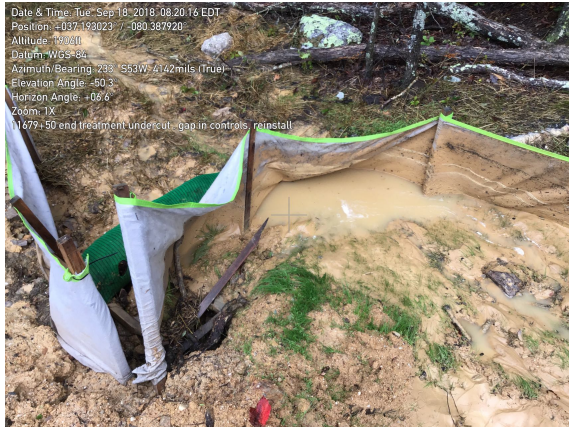
A/E	124300137	Date/Time	9/18/2018 1:37 PM	Report #	8049
Pictures					
<p>Date & Time: Tue, Sep 18, 2018, 08:20:16 EDT Position: +037.193023 / -080.387920 Altitude: 1906ft Datum: WGS-84 Azimuth Bearing: +23.553W 2142mils (true) Elevation Angle: -60.3 Horizon Angle: +08.6 Zoom: 1X 11679+50 end treatment undercut - gap in controls, reinstall</p>

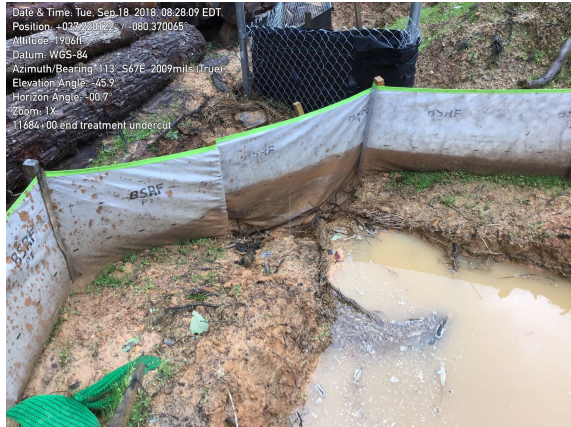
<p>Date & Time: Tue, Sep 18, 2018, 08:28:09 EDT Position: +037.200624 / -080.370045 Altitude: 1906ft Datum: WGS-84 Azimuth Bearing: +13.567E 2009mils (true) Elevation Angle: -45.9 Horizon Angle: -00.7 Zoom: 1X 11684+00 end treatment undercut</p>

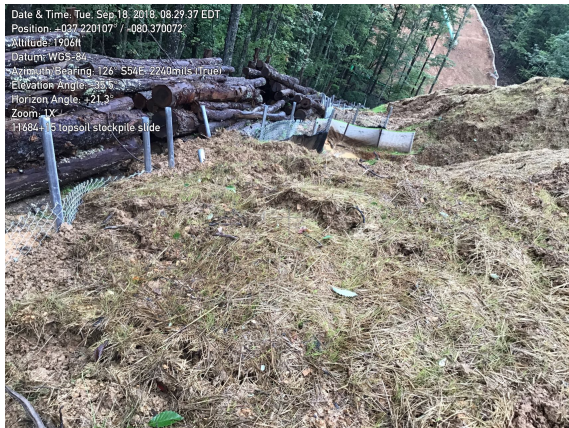
GPS Location	37.2890167236328, -80.4453582763672	GPS Location	37.2890167236328, -80.4453582763672		
Description	End treatment undercut at st#11679+50.	Description	End treatment undercut at st#11684+00		
<p>Date & Time: Tue, Sep 18, 2018, 08:29:37 EDT Position: +037.220107 / -080.370072 Altitude: 1906ft Datum: WGS-84 Azimuth Bearing: +126.554E 2200mils (true) Elevation Angle: -31.4 Horizon Angle: +21.3 Zoom: 1X 11685+15 topsoil stockpile slide</p>

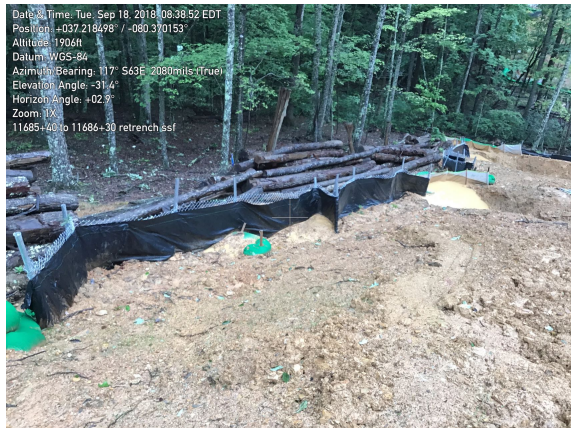
<p>Date & Time: Tue, Sep 18, 2018, 08:38:52 EDT Position: +037.218498 / -080.370153 Altitude: 1906ft Datum: WGS-84 Azimuth Bearing: +177.563E 2080mils (true) Elevation Angle: -31.4 Horizon Angle: +02.7 Zoom: 1X 11685+40 to 11686+30 retrenches</p>

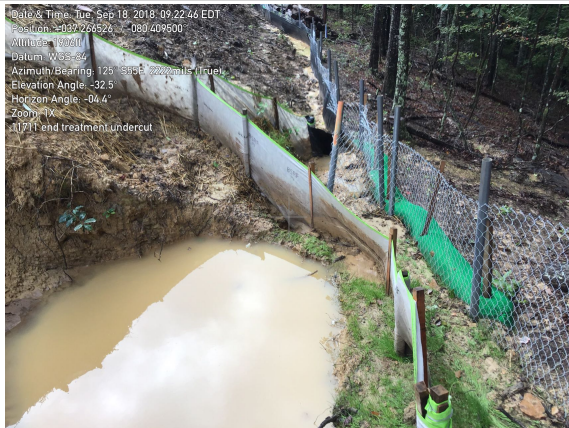
GPS Location	37.2890167236328, -80.4453582763672	GPS Location	37.2890167236328, -80.4453582763672		
Description	Topsoil stockpile slide overtopping super silt fence at st#11685+15.	Description	Silt fence untrenched due to channeling of water along perimeter control. St#11685+40 to 11686+30		
<p>Date & Time: Tue, Sep 18, 2018, 09:22:44 EDT Position: +037.226526 / -080.409500 Altitude: 1906ft Datum: WGS-84 Azimuth Bearing: +126.553E 2200mils (true) Elevation Angle: -32.5 Horizon Angle: -04.4 Zoom: 1X 11711 end treatment undercut</p>

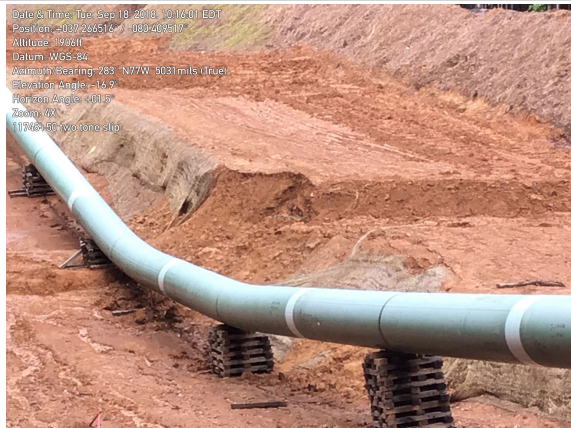
<p>Date & Time: Tue, Sep 18, 2018, 10:16:01 EDT Position: +037.226512 / -080.409517 Altitude: 1906ft Datum: WGS-84 Azimuth Bearing: +285.177W 5031mils (true) Elevation Angle: +14.9 Horizon Angle: -480.5 Zoom: 1X 11748+50 two tone slide</p>

GPS Location	37.2890167236328, -80.4453582763672	GPS Location	37.2890167236328, -80.4453582763672		
Description	End treatment undercut at st#11711+00.	Description	Two tone slide at st#11748+50.
