Visual Site Inspection Report

Project Name	H-600 Pipeline Spread G		AFE	124300137	Spread	H-600 Pipeline Spread G	
Contractor	Precision				Report #	8050	
Inspector	Brian Shields				Date/Time	9/18/2018 1:59 PM	
Permit #	TBD	Inspection Type	VA SWPP		Station Begin	11669+00	
State	VA	Inspection Area	Partial		Station End	11600+00	
County	Montgomery	Ground	Muddy		Temperature (°F)	82.00	
Municipality	N/A	Weather	Cloudy		Rain Gauge (in)	1.00	
GPS Location	37.2890167236328, -80.4453582763672				Rain Accumulation Time (days)	1.00

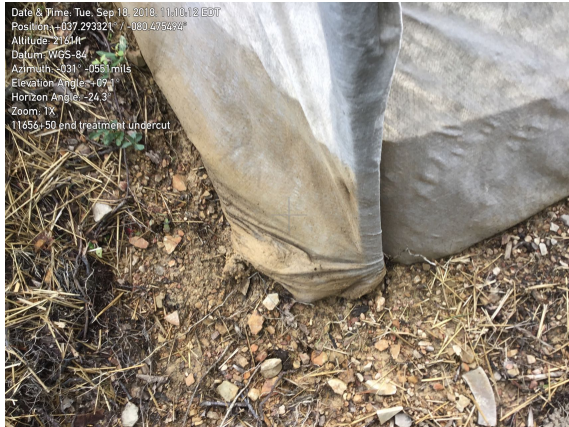
A/E	124300137	Date/Time	9/18/2018 1:59 PM	Report #	8050
Pictures					
<p>Date & Time: Tue, Sep 18, 2018, 11:06:13 EDT Position: -037.293225 / -080.476838 Altitude: 216 ft Datum: WGS-84 Azimuth: -115 -2084mils Elevation Angle: -40.0 Horizon Angle: -24.3 Zoom: 1X 11656+50 end treatment undercut</p>

GPS Location	37.2890167236328, -80.4453582763672	GPS Location	37.2890167236328, -80.4453582763672		
Description	End treatment undercut at st#11656+50.	Description	Sump full at st#11655+14		
<p>Date & Time: Tue, Sep 18, 2018, 11:14:55 EDT Position: -037.285236 / -080.455388 Altitude: 216 ft Datum: WGS-84 Azimuth: -088 -1564mils Elevation Angle: -40.7 Horizon Angle: -30.4 Zoom: 1X 11652+50 sump full</p>

4. E&S BMPs (List BMPs and note if installed and maintained as per the plan. If corrective action is needed, a picture is required.)							
E&S BMPs		Compliance Level	Corrective Action		Corrective Time Frame	Date Repaired	
Compost Filter Sock		Acceptable					
Rock Construction Entrance		Acceptable					
Silt Fence (Filter Fabric Fence)		Acceptable					
Silt Fence (Reinforced Filter Fabric Fence)		Acceptable					
Sump Pit		Communication	Sumps full and in need of clean out		24 Hours		
Temporary Diversion Berm		Acceptable					
Vegetative Stabilization (Temporary)		Communication	See comments				
Waterbar		Communication	Maintenance needed		24 Hours		
Waterbar Outlet Protection		Problem Area	Reinstall/Repair where failed		24 Hours

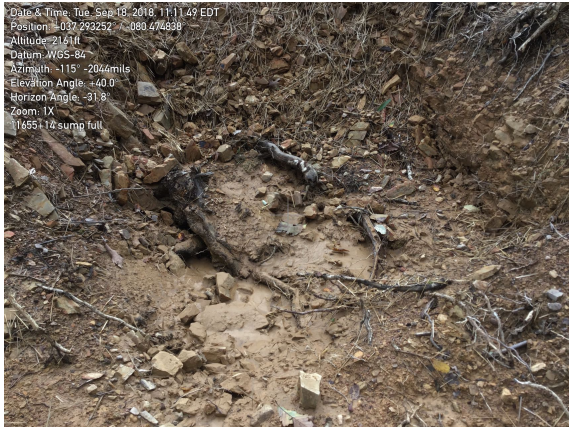
<p>Date & Time: Tue, Sep 18, 2018, 11:11:49 EDT Position: -037.293225 / -080.476838 Altitude: 216 ft Datum: WGS-84 Azimuth: -115 -2084mils Elevation Angle: -40.0 Horizon Angle: -31.8 Zoom: 1X 11655+12 sump full</p>

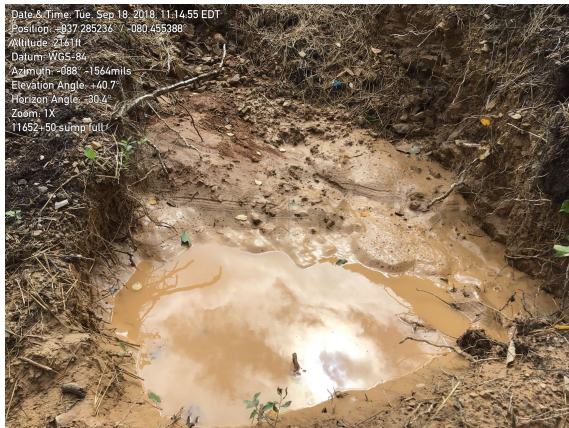
GPS Location	37.2890167236328, -80.4453582763672	GPS Location	37.2890167236328, -80.4453582763672		
Description	Sump full at st#11652+50.	Description	End treatment undercut at st#11620+62 resulting in sediment off ROW.		
<p>Date & Time: Tue, Sep 18, 2018, 11:44:20 EDT Position: -037.278106 / -080.401944 Altitude: 216 ft Datum: WGS-84 Azimuth: -153 -2341mils Elevation Angle: -22.8 Horizon Angle: -42.8 Zoom: 1X 11620+62 end treatment undercut, sed off</p>

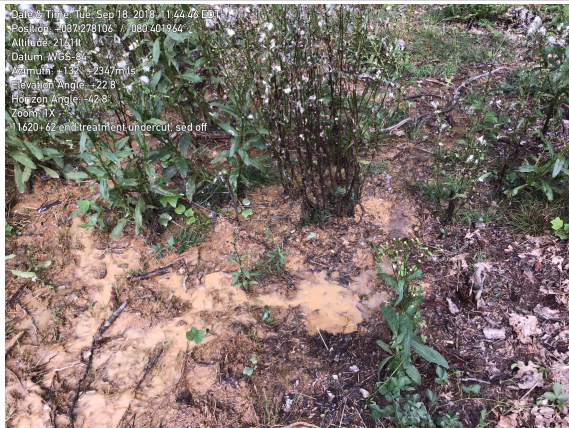
GPS Location	37.2890167236328, -80.4453582763672	GPS Location	37.2890167236328, -80.4453582763672		
Description	Sediment off ROW at st#11620+62.	Description	Stream s-hh18; no impact observed.

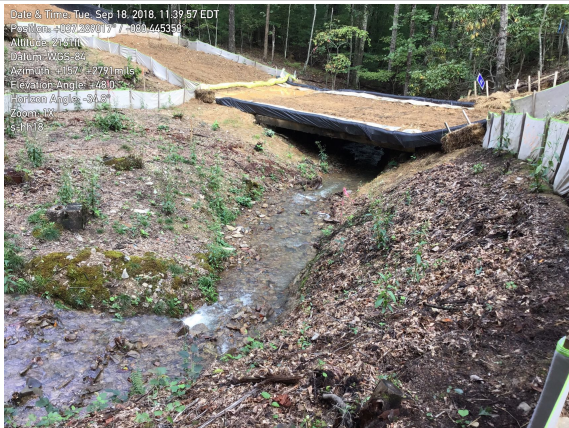
<p>Date & Time: Tue, Sep 18, 2018, 11:39:57 EDT Position: -037.283617 / -080.445358 Altitude: 216 ft Datum: WGS-84 Azimuth: -064 -2721mils Elevation Angle: -30.0 Horizon Angle: -34.8 Zoom: 1X 11618</p>
