Visual Site Inspection Report

Project Name	H-600 Pipeline Spread G	AFE	124300137	Spread	H-600 Pipeline Spread G
Contractor	Precision			Report #	3314
Inspector	Clinton Banks			Date/Time	6/20/2018 9:36 AM
Permit #	TBD	Inspection Type	VA SWPP	Station Begin	+28
State	VA	Inspection Area	Full	Station End	+26
County	Giles	Ground	Dry	Temperature (°F)	78.00
Municipality	N/A	Weather	Sunny	Rain Gauge (in)	0.00
GPS Location	37.4172580656202, -80.7418093032659			Rain Accumulation Time (days)	6.00

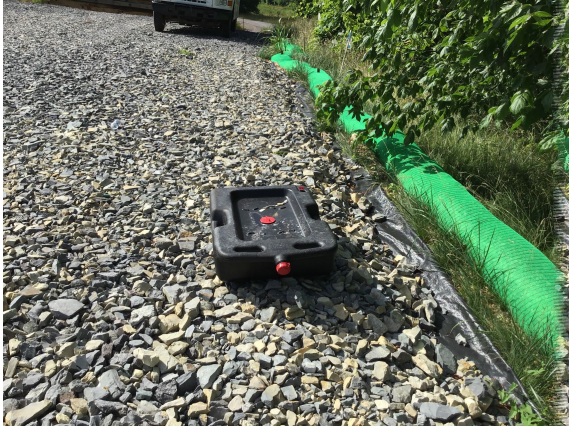
7. Identify all remedial measures that have been taken since the previous inspection was conducted.					
Comments (Reference above questions as appropriate.)					
Conducted weekly SWPP Inspection at L28 observed oil drain pan next Compost Filter Sock, also Skids next to Sock. Precision Lube truck arrived on site to removed oil drain pan, Mechanic on site stated that he would removed Skids away from Sock. Also conducted weekly SWPP Inspection at Precision L 26					
Note: It is a condition of National Pollutant Discharge Elimination System and Erosion and Sediment permits that a maintenance program be conducted to provide for the operation and maintenance of all BMPs to be inspected on a weekly basis and after each stormwater event. Please list in the space provided comments to note if repairs or replacement are needed or have been made for BMPs as a result of the inspection. Failure to conduct the required inspection may result in permit suspension or the imposition of civil penalties. If supplemental monitoring is required as part of a permit condition this form may be used to meet those monitoring requirements.

GPS Location	37.335867192631, -80.8081270382561	GPS Location	37.3361090943565, -80.8081729710855		
Description	Oil Drain Pan next to at L 28	Description	Skids right next to Sock Yard L 28		
<p>Insert image here</p>		<p>Insert image here</p>			
GPS Location		GPS Location			
Description		Description			
<p>Insert image here</p>		<p>Insert image here</p>			
GPS Location		GPS Location			
Description		Description
