# Visual Site Inspection Report

<b>Project Name</b>	H-600 Pipeline Spread G	<b>AFE</b>	124300137	<b>Spread</b>	H-600 Pipeline Spread G
<b>Contractor</b>	Precision			<b>Report #</b>	6078
<b>Inspector</b>	Clinton Banks			<b>Date/Time</b>	8/9/2018 10:05 AM
<b>Permit #</b>	TBD	<b>Inspection Type</b>	VA SWPP	<b>Station Begin</b>	11552+77
<b>State</b>	VA	<b>Inspection Area</b>	Full	<b>Station End</b>	11524+16
<b>County</b>	Craig	<b>Ground</b>	Damp	<b>Temperature (°F)</b>	76.00
<b>Municipality</b>	N/A	<b>Weather</b>	Sunny	<b>Rain Gauge (in)</b>	0.00
<b>GPS Location</b>	37.3193291754243, -80.6577943140835			<b>Rain Accumulation Time (days)</b>	1.00

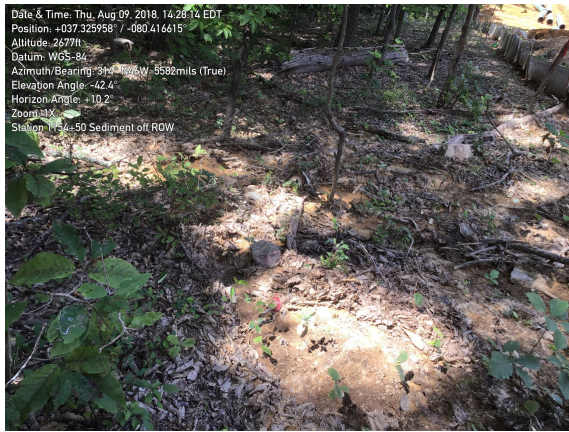
AFE	124300137	Date/Time	8/9/2018 10:05 AM	Report #	6078
Pictures					
  <p>Date &amp; Time: Thu Aug 09 2018 12:42:01 EDT Position: +037.325743 / -080.415953 Altitude: 2751ft Datum: WGS-84 Azimuth/Bearing: 304° N17.2W 6189mils (True) Elevation Angle: -37.3° Horizon Angle: -87.2° Zoom: 1X Repairing Waterbar at Station 11551+11</p>		  <p>Date &amp; Time: Thu Aug 09 2018 14:23:35 EDT Position: +037.326727 / -080.415953 Altitude: 2844ft Datum: WGS-84 Azimuth/Bearing: 325° N35W 5478mils (True) Elevation Angle: -24.8° Horizon Angle: -405.7° Zoom: 1X Station 1154+50 Sediment off ROW</p>			
GPS Location	37.3249228159313, -80.415944745839	GPS Location	37.3260834580635, -80.4167022184286		
Description	Crew repairing Water Bar on Sinking Creek Station 11551+11	Description	P-1 Was overwhelmed at Station 1154+50
