Visual Site Inspection Report

Project Name	H-600 Pipeline Spread G		A/E	124300137	Spread	H-600 Pipeline Spread G	
Contractor	Precision				Report #	6388	
Inspector	Clinton Banks				Date/Time	8/15/2018 5:11 AM	
Permit #	TBD	Inspection Type	VA SWPP		Station Begin	11436+00	
State	VA	Inspection Area	Full		Station End	11524+16	
County	Craig	Ground	Wet		Temperature (°F)	80.00	
Municipality	N/A	Weather	Sunny		Rain Gauge (in)	0.00	
GPS Location	37.3268713569616, -80.4257224035267				Rain Accumulation Time (days)	1.00

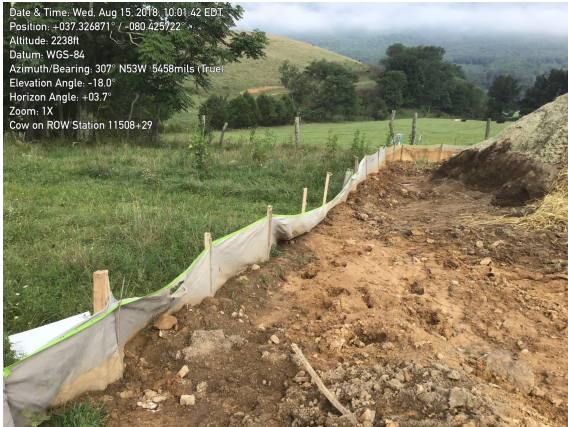
GPS Location	37.3269174993386, -80.425789291114	GPS Location	37.3269415134912, -80.4259895347808		
Description	Cow on ROW at Station 11508+29	Description	Where Cow went across P-1 Silt Fence at Station 11508+29		
<p>Date & Time: Wed Aug 15, 2018, 10:22:17 EDT Position: +037.326919° / -080.426025° Altitude: 2173ft Datum: WGS-84 Azimuth/Bearing: 299° N67W 5312mils (True) Elevation Angle: -19.0° Horizon Angle: +01.3° Zoom: 1X Looks like where Cow came onto ROW</p>

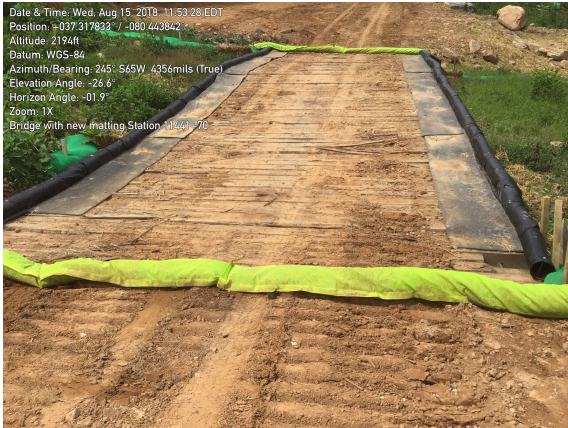
<p>Date & Time: Wed Aug 15, 2018, 11:53:28 EDT Position: +037.317833° / -080.443842° Altitude: 2194ft Datum: WGS-84 Azimuth/Bearing: 245° S45W 4356mils (True) Elevation Angle: -26.6° Horizon Angle: -01.9° Zoom: 1X Bridge with new matting Station 11441+70</p>

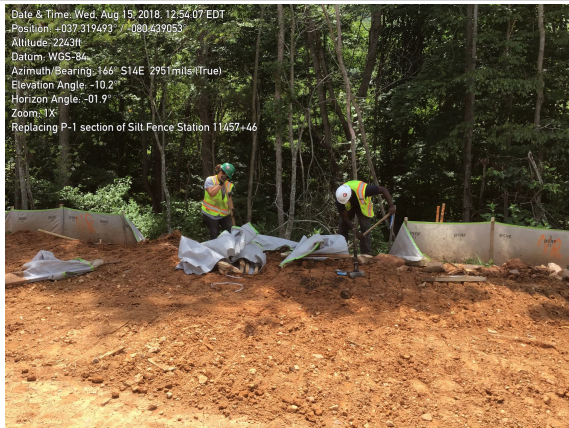
GPS Location	37.3268102528875, -80.4260766227547	GPS Location	37.3177818116148, -80.4438906815652		
Description	Looks like where Cow came onto ROW near Station 11507+05	Description	Bridge with new matting Station 11441+70		
<p>Date & Time: Wed Aug 15, 2018, 12:54:07 EDT Position: +037.319493° / -080.439053° Altitude: 2243ft Datum: WGS-84 Azimuth/Bearing: 166° S14E 2957mils (True) Elevation Angle: -10.2° Horizon Angle: -01.9° Zoom: 1X Replacing P-1 section of Silt Fence Station 11457+46</p>

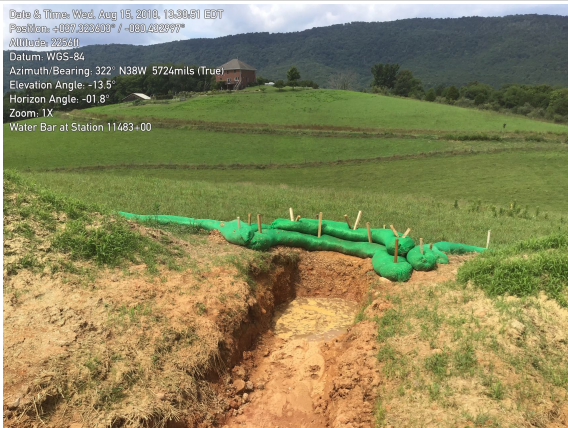
<p>Date & Time: Wed Aug 15, 2018, 13:30:01 EDT Position: +037.323503° / -080.432977° Altitude: 2231ft Datum: WGS-84 Azimuth/Bearing: 322° N38W 5724mils (True) Elevation Angle: -13.5° Horizon Angle: -01.8° Zoom: 1X Water Bar at Station 11483+00</p>
