# Visual Site Inspection Report

<b>Project Name</b>	H-600 Pipeline Spread G	<b>AFE</b>	124300137	<b>Spread</b>	H-600 Pipeline Spread G
<b>Contractor</b>	Precision			<b>Report #</b>	6981
<b>Inspector</b>	Clinton Banks			<b>Date/Time</b>	8/27/2018 4:01 AM
<b>Permit #</b>	TBD	<b>Inspection Type</b>	VA SWPP	<b>Station Begin</b>	11524+16
<b>State</b>	VA	<b>Inspection Area</b>	Full	<b>Station End</b>	11436+00
<b>County</b>	Craig	<b>Ground</b>	Dry	<b>Temperature (°F)</b>	71.00
<b>Municipality</b>	N/A	<b>Weather</b>	Sunny	<b>Rain Gauge (in)</b>	0.00
<b>GPS Location</b>	37.3217431409632, -80.4358016420905			<b>Rain Accumulation Time (days)</b>	1.00

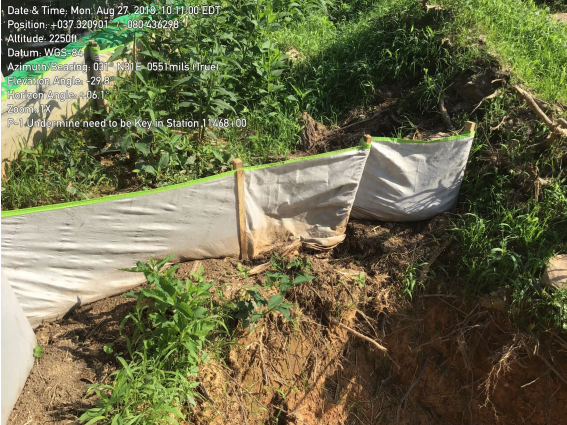
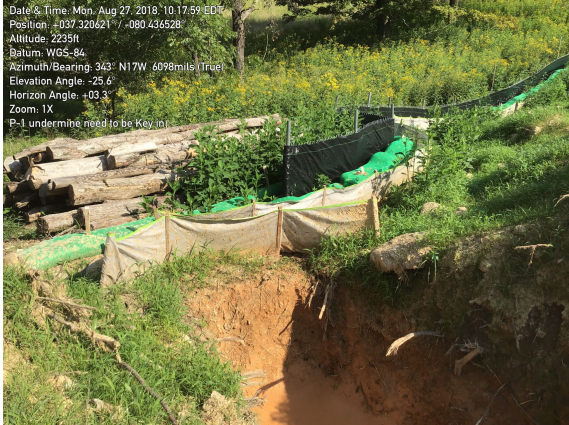
4. E&S BMPs (List BMPs and note if installed and maintained as per the plan. If corrective action is needed, a picture is required.)					
<b>E&amp;S BMPs</b>	<b>Compliance Level</b>	<b>Corrective Action</b>		<b>Corrective Time Frame</b>	<b>Date Repaired</b>
Silt Fence (Filter Fabric Fence)	Problem Area	P-1 Need to be Key in undermine		Addressed	
Silt Fence (Filter Fabric Fence)	Problem Area	P-1 Need to be Key in undermine		Addressed	
Sump Pit	Acceptable				
Compost Filter Sock	Acceptable				
Silt Fence (Reinforced Filter Fabric Fence)	Acceptable				
Rock Construction Entrance	Acceptable				
Bridge	Acceptable				
Plunge Poole	Acceptable				
Sump Pit	Acceptable	Up graded EndTreatment Triple Soc		Addressed	
<b>5. Site Conditions</b>					
Is an unauthorized discharge (such as sediment, gravel, oil, HDD fluid, etc.) occurring to waters, wetlands, or beyond defined limits of disturbance resulting from earth disturbance activity or ineffective BMP? If yes, take a photo and immediately contact MVP Environmental Permitting Coordinator.					No

<b>GPS Location</b>	37.3208804335793, -80.4363324680183	<b>GPS Location</b>	37.3206847999592, -80.4364864435796		
<b>Description</b>	P-1 Silt Fence undermine need to be Key in Station 11468+00	<b>Description</b>	P-1 undermine need to be Key in Station 11466+79

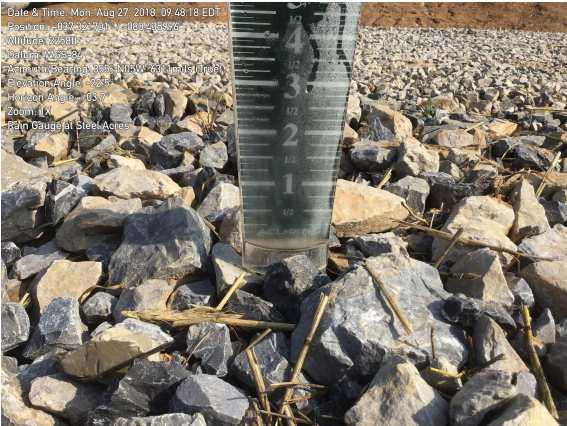
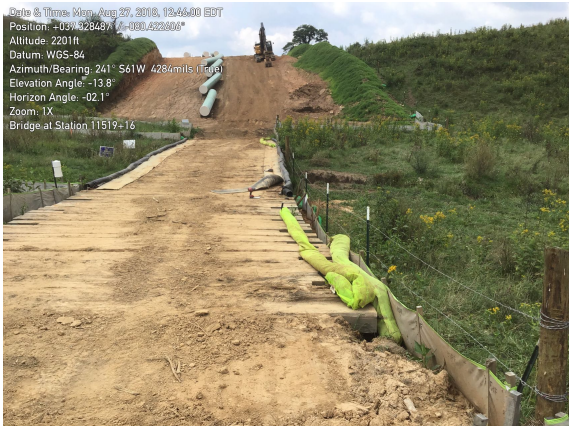
<b>GPS Location</b>	37.3191375844528, -80.4405953363333	<b>GPS Location</b>	37.3285603942697, -80.4226167407636		
<b>Description</b>	Rain Gauge at Steel Acres	<b>Description</b>	Bridge being repair

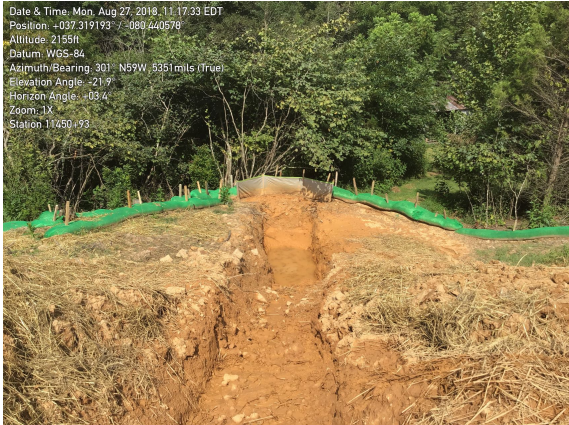
<b>GPS Location</b>	37.3247356480335, -80.4313755781208	<b>GPS Location</b>	37.3285450131867, -80.4226184102725		
<b>Description</b>	Added Rock to Plunge Poole at Station 11488+81 Stevers Gap Trail	<b>Description</b>	Clean out Sump at Station 11450+93
