Visual Site Inspection Report

| Project Name | H-600 Pipeline Spread G | AFE | 124300137 | Spread | H-600 Pipeline Spread G |
| Inspector | Clinton Banks | | | Date/Time | 9/6/2018 4:41 AM |

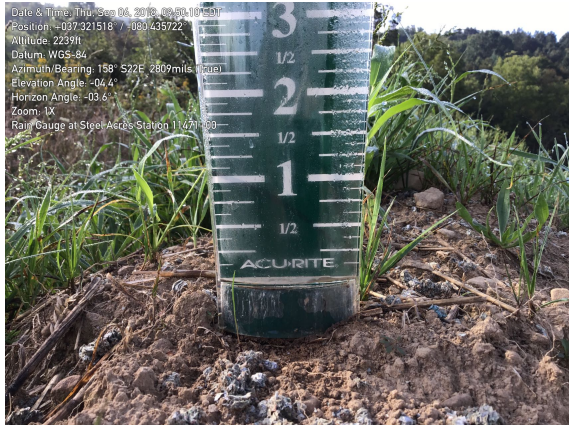
| Description | Rain Gauge at Steel Acres Station 11471+00 | Description | Super Silt Fence at Station 11436+00 | | |

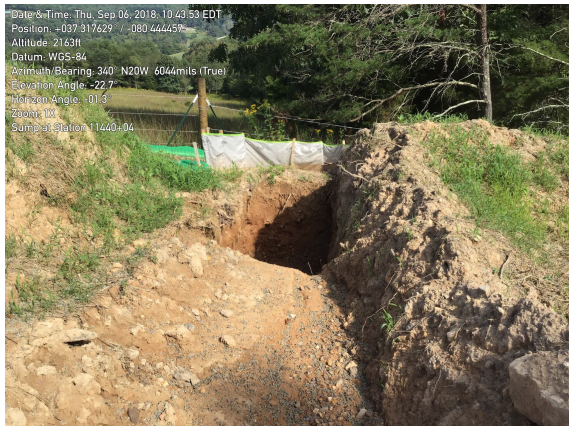
| Description | Sump at Station 11440+04 | Description | WaterBar at Station 11438+50 | | |

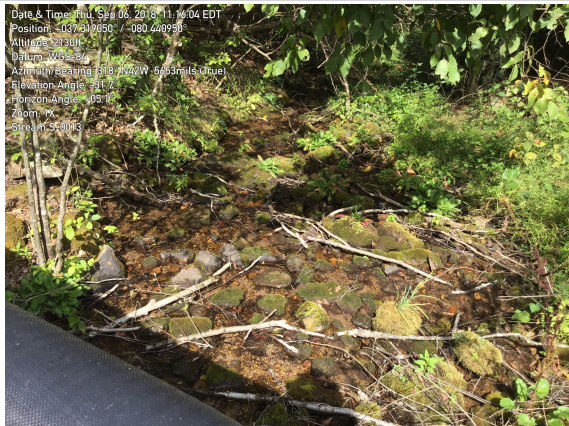
| Description | Stream S-0013 no Sediment in Stream Station 11451+28 | Description | Plunge Pool at Station 11465+10 | | |
