# Visual Site Inspection Report

<b>Project Name</b>	H-600 Pipeline Spread G	<b>AFE</b>	124300137	<b>Spread</b>	H-600 Pipeline Spread G	
<b>Contractor</b>	Precision			<b>Report #</b>	7798	
<b>Inspector</b>	Clinton Banks			<b>Date/Time</b>	9/13/2018 8:15 AM	
<b>Permit #</b>	TBD	<b>Inspection Type</b>	VA SWPP	<b>Station Begin</b>	+28	
<b>State</b>	VA	<b>Inspection Area</b>	Full	<b>Station End</b>	+26	
<b>County</b>	Giles	<b>Ground</b>	Wet	<b>Temperature (°F)</b>	66.00	
<b>Municipality</b>	N/A	<b>Weather</b>	Cloudy	<b>Rain Gauge (in)</b>	0.00	
<b>GPS Location</b>	37.4170164277981, -80.7423691721895			<b>Rain Accumulation Time (days)</b>	1.00

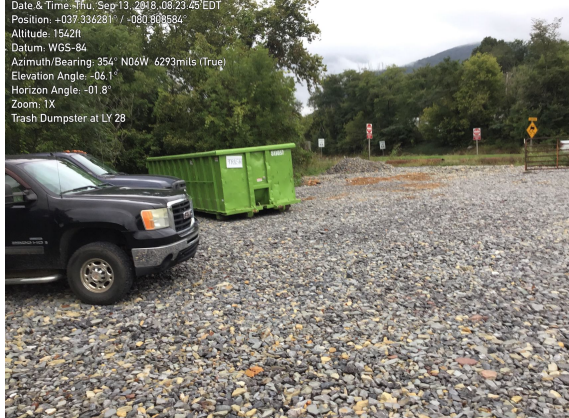
<b>A/E</b>	124300137	<b>Date/Time</b>	9/13/2018 8:15 AM	<b>Report #</b>	7798
<b>Pictures</b>					
<div><div><div>Date &amp; Time: Thu, Sep 13, 2018, 08:23:25 EDT Position: +037.336281° / -80.808664° Altitude: 1542ft Datum: WGS-84 Azimuth/Bearing: 354° N06W 6293mils (True) Elevation Angle: -06.1° Horizon Angle: -01.8° Zoom: 1X Trash Dumpster at LY 28</div>

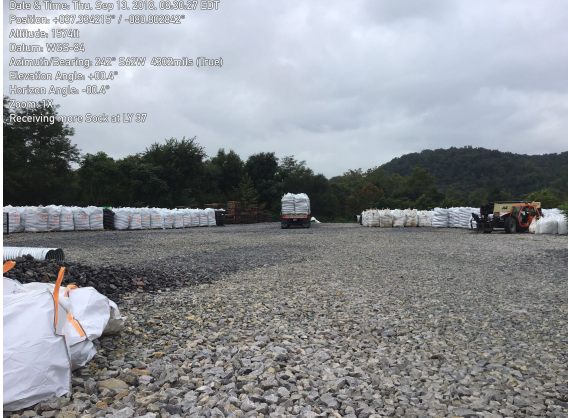
</div></div>		<div><div><div>Date &amp; Time: Thu, Sep 13, 2018, 08:30:37 EDT Position: +037.334184° / -80.802905° Altitude: 1574ft Datum: WGS-84 Azimuth/Bearing: 342° N42W 4302mils (True) Elevation Angle: -08.4° Horizon Angle: -08.4° Zoom: 1X Receiving more Sock at LY 28</div>

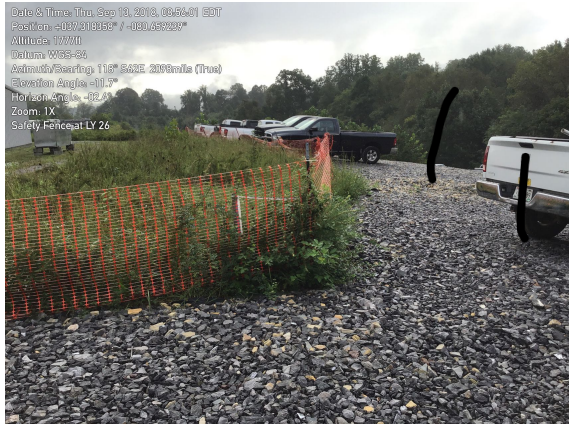
</div></div>			
<b>GPS Location</b>	37.3361989483585, -80.8086645697065	<b>GPS Location</b>	37.3341847770264, -80.8029053640373		
<b>Description</b>	Trash Dumpster at LY 28	<b>Description</b>	Receiving more Sock in LY 28		
<div><div><div>Date &amp; Time: Thu, Sep 13, 2018, 08:44:01 EDT Position: +037.318285° / -80.659209° Altitude: 1770ft Datum: WGS-84 Azimuth/Bearing: 116° S45E 2007mils (True) Elevation Angle: -11.7° Horizon Angle: -02.4° Zoom: 1X Safety Fence at LY 26</div>

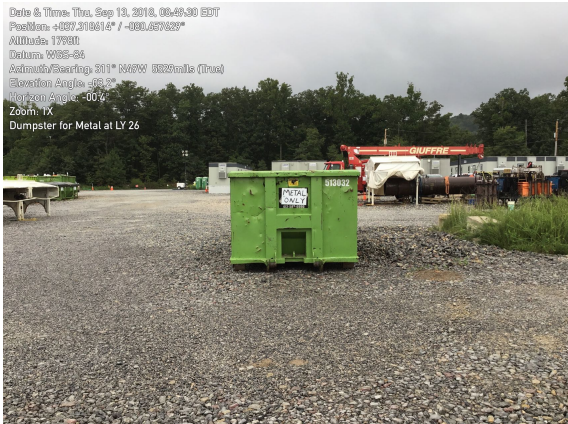
</div></div>		<div><div><div>Date &amp; Time: Thu, Sep 13, 2018, 08:49:30 EDT Position: +037.318557° / -80.657540° Altitude: 1790ft Datum: WGS-84 Azimuth/Bearing: 311° N47W 6322mils (True) Elevation Angle: -08.3° Horizon Angle: -00.9° Zoom: 1X Dumpster for Metal at LY 26</div>
