Visual Site Inspection Report

Project Name	H-600 Pipeline Spread G	AFE	124300137	Spread	H-600 Pipeline Spread G
Contractor	Precision			Report #	1339
Inspector	Frank Weaver			Date/Time	4/30/2018 5:34 PM
Permit #	TBD	Inspection Type	Weekly	Station Begin	+0
State	WV	Inspection Area	Full	Station End	+0
County	Monroe	Ground	Dry	Temperature (°F)	71.00
Municipality	N/A	Weather	Sunny	Rain Gauge (in)	0.00
GPS Location	37.1857567686108, -80.4224082282852			Rain Accumulation Time (days)	2.00

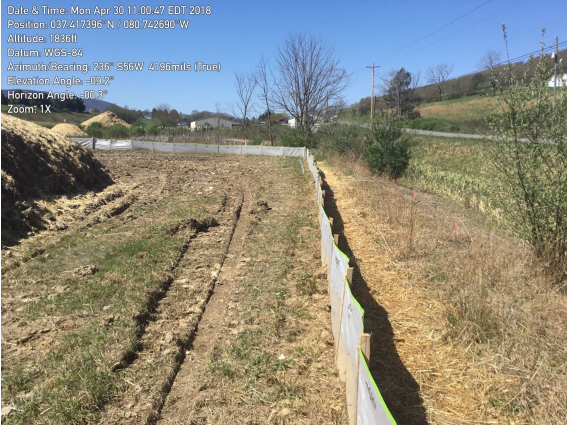
GPS Location	37.185866602036, -80.4224719117955	GPS Location	37.1858522614632, -80.4223994210618		
Description	Priority 1 silt fence functioning as intended on west side of Yard. See photo for gps location.	Description	Priority 1 silt fence on north side of site. No issues at time of inspection. See photo for gps location.

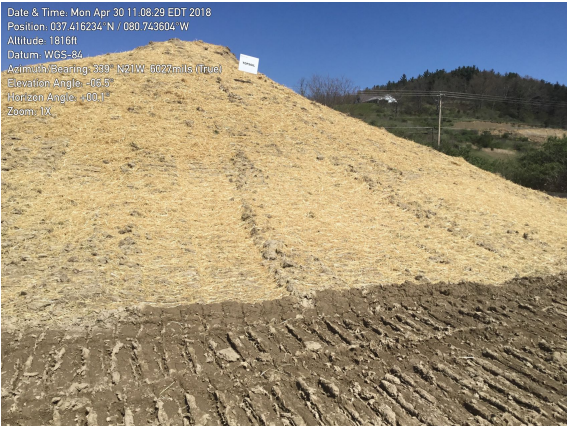
Insert image here			
GPS Location	37.1859821470456, -80.422414546146	GPS Location			
Description	Stabilized topsoil stockpile.	Description			
Insert image here		Insert image here			
GPS Location		GPS Location			
Description		Description
