# Visual Site Inspection Report

| <b>Project Name</b> | H-600 Pipeline Spread G | <b>AFE</b> | 124300137 | <b>Spread</b> | H-600 Pipeline Spread G |
| <b>Contractor</b> | Precision | | | <b>Report #</b> | 1332 |
| <b>Inspector</b> | Garrett Barclay | | | <b>Date/Time</b> | 4/30/2018 2:12 PM |

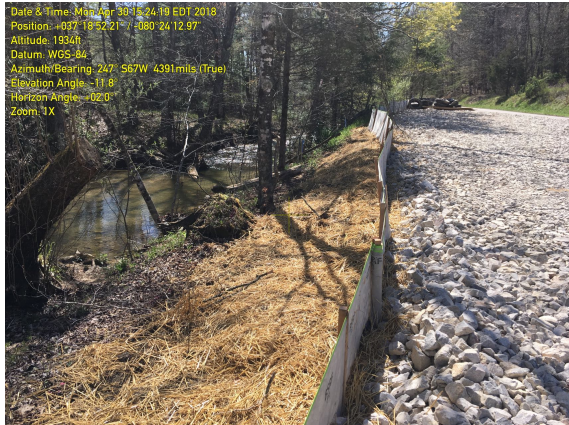
| Description | ECD's @ AR 258.05 | Description | ECD's & Top Soil @ AR MN258.05 | | |

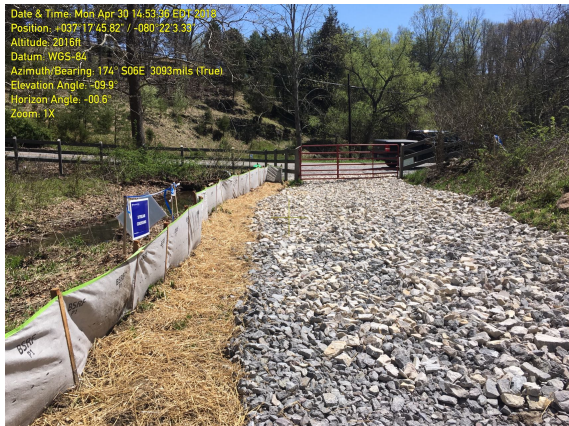
| Description | ECD's @ MLV 26 | Description | ECD's & Top Soil @ MP 223 | | |

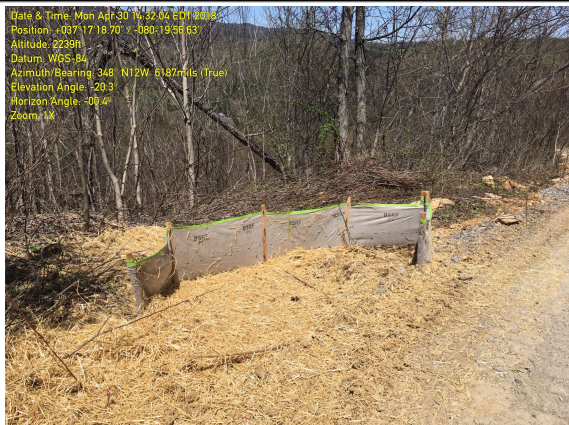
| Inspected the areas of ROW where we have ground disturbance and ECD's installed<br><br>Inspected MP 219.5 - MP 220, ECD's installed per plans and show no sign of damage to ECD' and are in compliance, area still under construction<br><br>Inspected AR MN 266.03 where end treatments were added to pre existing water bars. ECD's show no sign of damage and are in good working condition<br><br>Inspected MP 223 - 223.5, ECD's installed per plans and show no sign of damage, ECD's are in compliance<br><br>Inspected MP 224 - MP 227.3, ECD's installed per plans and show no sign of damages and are in compliance, area is still under construction<br><br>No compliance issues at this time | | | | | |

| Description | End treatments for pre existing water bars @ MN 266.03 | Description | ECD's installed @ MP 226 | | |
