# Visual Site Inspection Report

<b>Project Name</b>	H-600 Pipeline Spread G	<b>A/E</b>	124300137	<b>Spread</b>	H-600 Pipeline Spread G
<b>Contractor</b>	Precision			<b>Report #</b>	1439
<b>Inspector</b>	Garrett Barclay			<b>Date/Time</b>	5/4/2018 5:06 PM
<b>Permit #</b>	TBD	<b>Inspection Type</b>	Weekly	<b>Station Begin</b>	11602+44
<b>State</b>	VA	<b>Inspection Area</b>	Full	<b>Station End</b>	12000+00
<b>County</b>	Montgomery	<b>Ground</b>	Dry	<b>Temperature (°F)</b>	80.00
<b>Municipality</b>	N/A	<b>Weather</b>	Sunny	<b>Rain Gauge (in)</b>	0.00
<b>GPS Location</b>	37.2682105237965, -80.3199210763726			<b>Rain Accumulation Time (days)</b>	1.00

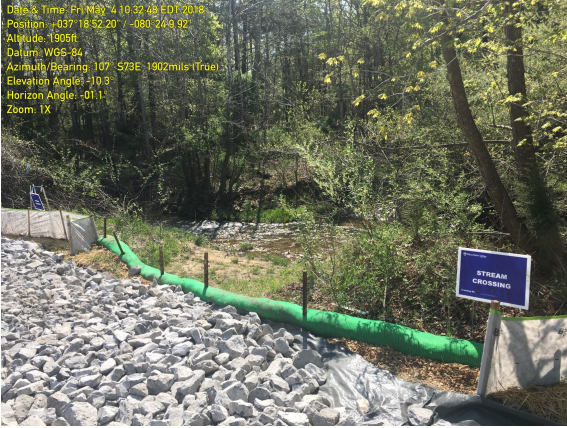
<p>Date &amp; Time: Fri May 4 10:51:09 EDT 2018 Position: +037°18'54.21" / -080°24'5.06" Altitude: 1712ft Datum: WGS-84 Azimuth/Bearing: 228° 548W 4053mils (True) Elevation Angle: +12.0° Horizon Angle: -00.3° Zoom: 1X</p>		<b>GPS Location</b> 37.2681755293508, -80.3199848626557	
<b>Description</b> ECD's installed @ SRR13		<b>Description</b> ECD's installed @ AR 258.05

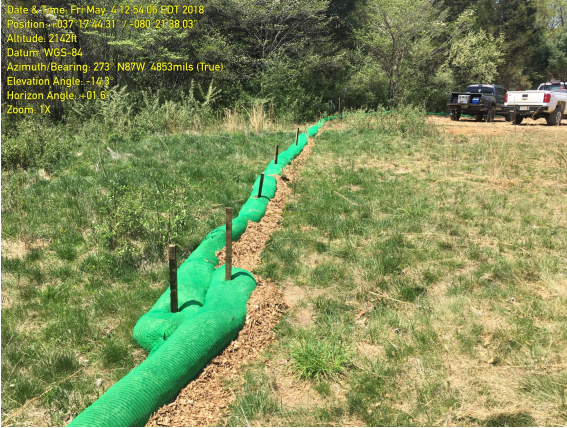
<b>Description</b> ECD's installed @ MP 223		<b>Description</b> ECD's installed for pre existing water bars @ 266.03

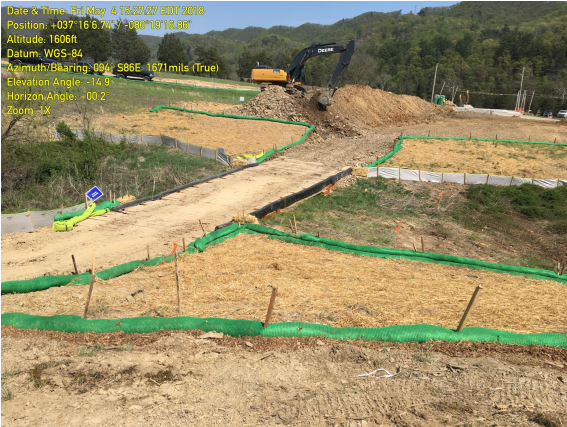
<p>Date &amp; Time: Fri May 4 15:47:51 EDT 2018 Position: +037°15'50.65" / -080°19'19.17" Altitude: 1584ft Datum: WGS-84 Azimuth/Bearing: 095° N09E 1308mils (True) Elevation Angle: -00.8° Horizon Angle: -00.2° Zoom: 1X</p>		<b>GPS Location</b> 37.2681755293508, -80.3199848626557	
<b>Description</b> ECD's installed @ MP 226		<b>Description</b> ECD's and stabilization for top soil @ MP 226.5
