Visual Site Inspection Report

Project Name	H-600 Pipeline Spread G		AFE	124300137	Spread	H-600 Pipeline Spread G	
Contractor	Precision				Report #	1615	
Inspector	Garrett Barclay				Date/Time	5/10/2018 2:41 PM	
Permit #	TBD	Inspection Type	Weekly		Station Begin	+0	
State	VA	Inspection Area	Full		Station End	+0	
County	Giles	Ground	Dry		Temperature (°F)	74.00	
Municipality	N/A	Weather	Cloudy		Rain Gauge (in)	0.00	
GPS Location	37.3103345780919, -80.5156275464645				Rain Accumulation Time (days)	1.00

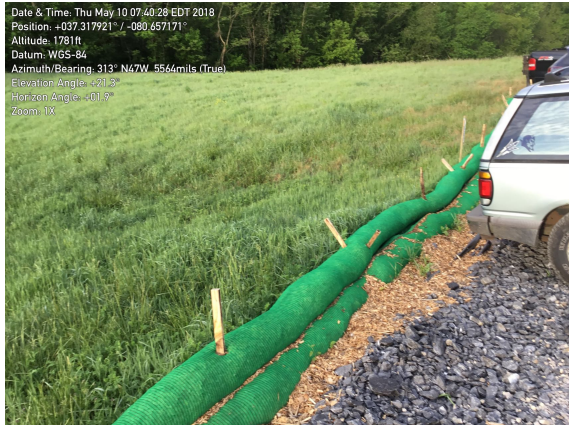
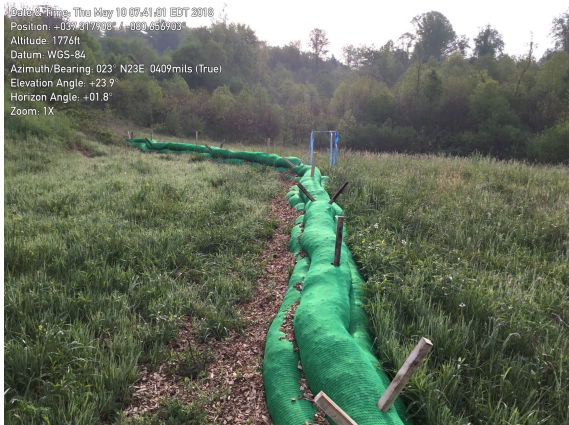
GPS Location	37.3104253504773, -80.5156266131257		GPS Location	37.3102612328132, -80.5156166386609	
Description	ECD's @ Yard 26		Description	ECD's @ Yard 26	
<p>Date & Time: Thu May 10 09:49:36 EDT 2018 Position: +037°19'3.97" / -080°48'29.83" Altitude: 1731ft Datum: WGS-84 Azimuth/Bearing: 233° S53W 4142mils (True) Elevation Angle: -09.9° Horizon Angle: +03.7° Zoom: 2X</p>

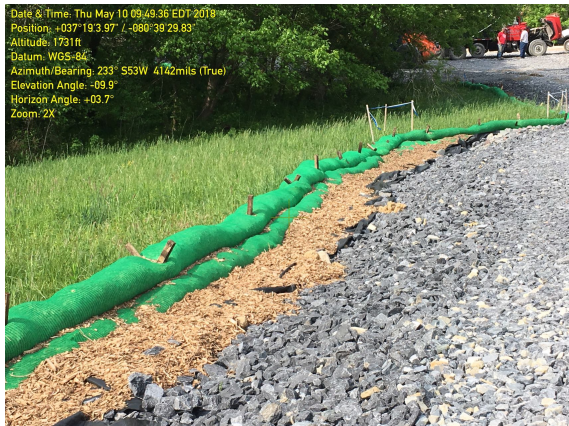
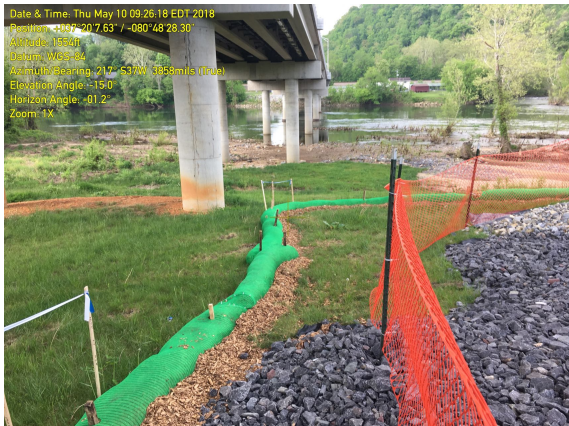
GPS Location	37.3102612328132, -80.5156166386609		GPS Location	37.3102612328132, -80.5156166386609	
Description	ECD's @ Yard 26		Description	ECD's @ Yard 28	
<p>Date & Time: Thu May 10 06:35:23 EDT 2018 Position: +037°20'3.51" / -080°48'11.11" Altitude: 1572ft Datum: WGS-84 Azimuth/Bearing: 314° N46W 5582mils (True) Elevation Angle: +05.1° Horizon Angle: -00.1° Zoom: 2X</p>

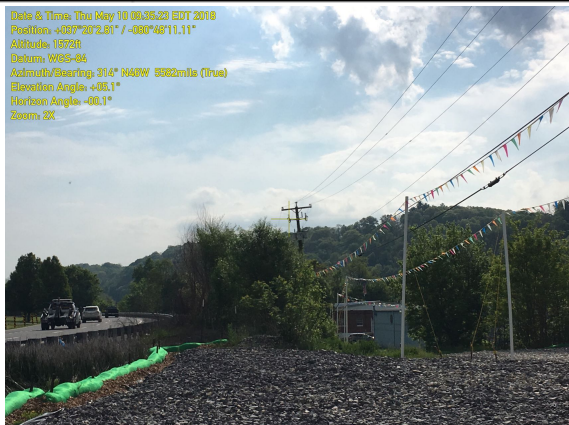
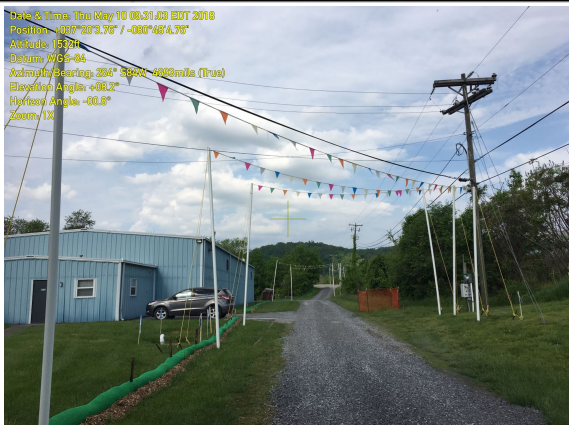
GPS Location	37.3102612328132, -80.5156166386609		GPS Location	37.3102612328132, -80.5156166386609	
Description	ECD's @ Yard 28		Description	ECD's @ Yard 28
