Visual Site Inspection Report

Project Name	H-600 Pipeline Spread G		AFE	124300137	Spread	H-600 Pipeline Spread G	
Contractor	Precision				Report #	1823	
Inspector	Garrett Barclay				Date/Time	5/16/2018 4:15 PM	
Permit #	TBD	Inspection Type	VA SWPP		Station Begin	+0	
State	VA	Inspection Area	Full		Station End	+0	
County	Giles	Ground	Wet		Temperature (°F)	67.00	
Municipality	N/A	Weather	Light Rain		Rain Gauge (in)	0.05	
GPS Location	37.1835081708938, -80.4096972167846				Rain Accumulation Time (days)	1.00

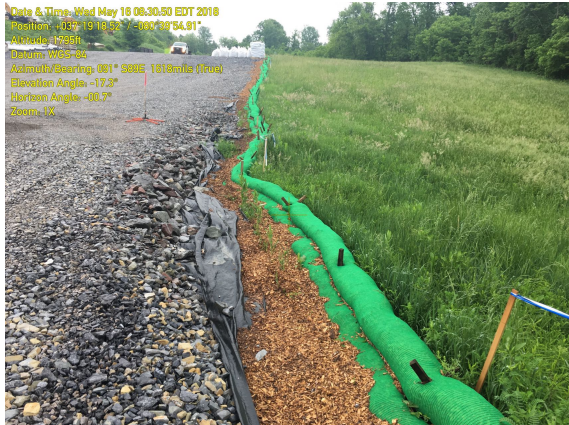
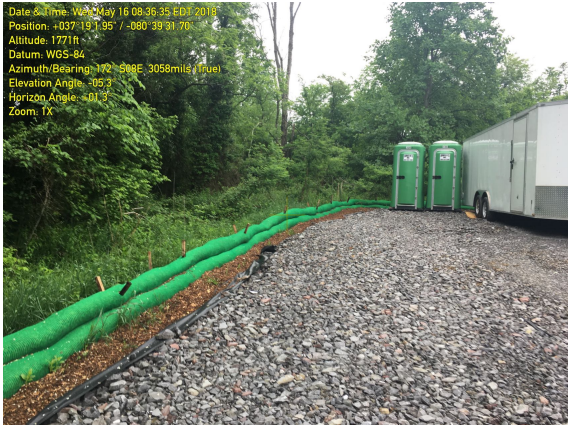
GPS Location	37.1836629789669, -80.4094993975762		GPS Location	37.1835565064067, -80.4096830267524	
Description	CFS @ Yard 26		Description	CFS @ Yard 26	
<p>Date & Time: Wed May 16 08:07:53 EDT 2018 Position: +037°19'9.85" / -080°39'28.31" Altitude: 1807ft Datum: WGS-84 Azimuth/Bearing: 168° S12E 2987mils (True) Elevation Angle: -10.0° Horizon Angle: -00.4° Zoom: 1X</p>

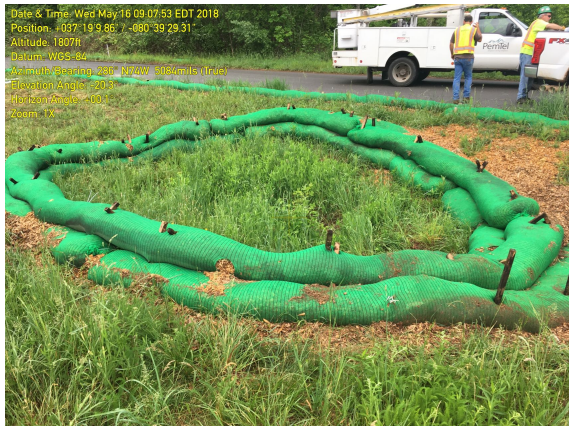
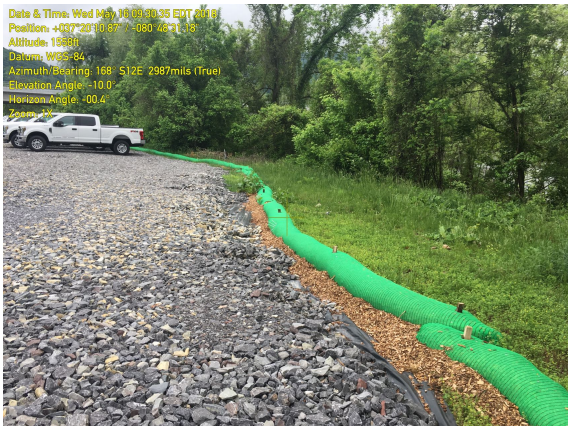
GPS Location	37.1837343508724, -80.4094171711061		GPS Location	37.1837574011061, -80.4093595874313	
Description	CFS @ Yard 26		Description	CFS @ Yard 28	
<p>Date & Time: Wed May 16 09:40:59 EDT 2018 Position: +037°20'4.58" / -080°48'5.50" Altitude: 1524ft Datum: WGS-84 Azimuth/Bearing: 283° S87W 4741mils (True) Elevation Angle: +01.4° Horizon Angle: -08.3° Zoom: 1X</p>

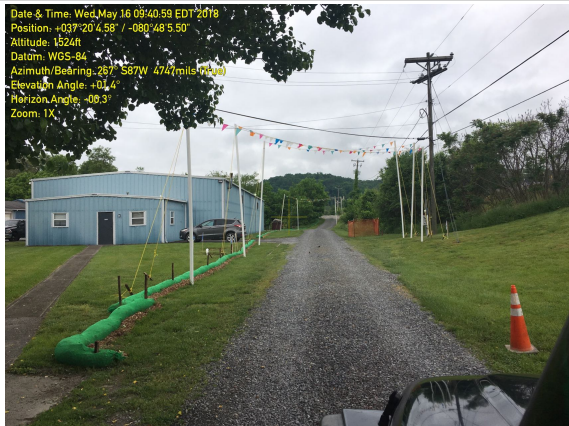
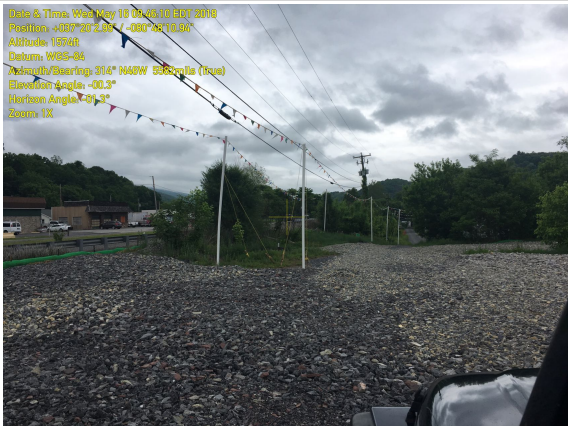
GPS Location	37.1837574011061, -80.4093595874313		GPS Location	37.1837835107345, -80.4094342701886	
Description	CFS @ Yard 28		Description	CFS @ Yard 28
