Visual Site Inspection Report

Project Name	H-600 Pipeline Spread G	AFE	124300137	Spread	H-600 Pipeline Spread G
Contractor	Precision			Report #	2359
Inspector	Garrett Barclay			Date/Time	5/29/2018 2:54 PM
Permit #	TBD	Inspection Type	VA SWPP	Station Begin	10890+00
State	VA	Inspection Area	Full	Station End	11620+00
County	Giles	Ground	Damp	Temperature (°F)	67.00
Municipality	N/A	Weather	Cloudy	Rain Gauge (in)	0.01
GPS Location	37.2882195515905, -80.4583708383892			Rain Accumulation Time (days)	1.00

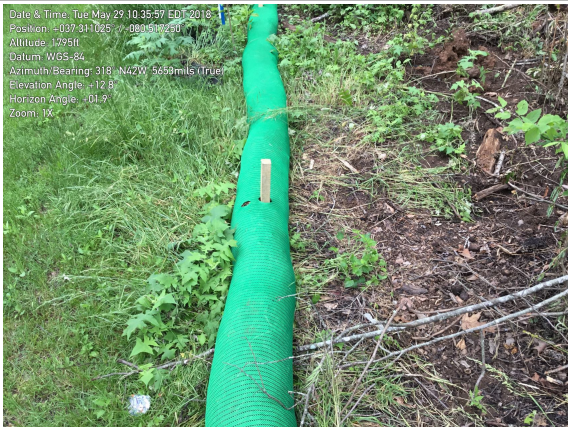
GPS Location	37.2879863251348, -80.458507631049	GPS Location	37.287934022059, -80.4585761950169		
Description	Waterbar needed and CFS at entrance @ AR 256.02	Description	CFS needs to be chinked @ AR 249.01		
<p>Date & Time: Tue May 29 11:10:55 EDT 2018 Position: +037.31406 / -080.503408 Altitude: 1940ft Datum: WGS-84 Azimuth/Bearing: 316 N45W 5582mils (True) Elevation Angle: +26.4 Horizon Angle: -00.7 Zoom: 1X</p>  		<p>Date & Time: Tue May 29 12:12:50 EDT 2018 Position: +037.314406 / -080.402824 Altitude: 1894ft Datum: WGS-84 Azimuth/Bearing: 342 N18W 6080mils (True) Elevation Angle: +26.4 Horizon Angle: -01.7 Zoom: 1X</p>

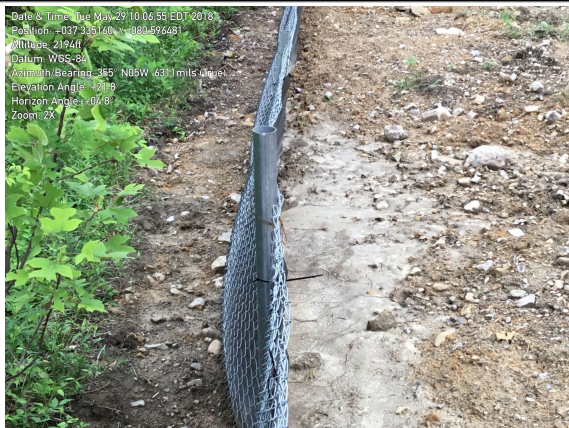
GPS Location	37.2881853115161, -80.4585478641842	GPS Location	37.2881853115161, -80.4585478641842		
Description	CWD @ MLV 25	Description	Bridge crossing @ S-RR13		
<p>Date & Time: Tue May 29 10:06:55 EDT 2018 Position: +037.335160 / -080.596481 Altitude: 2194ft Datum: WGS-84 Azimuth/Bearing: 385 N85W 6311mils (True) Elevation Angle: +21.0 Horizon Angle: -04.8 Zoom: 2X</p>
