Visual Site Inspection Report

Project Name	H-600 Pipeline Spread G	AFE	124300137	Spread	H-600 Pipeline Spread G
Contractor	Precision			Report #	4111
Inspector	Garrett Barclay			Date/Time	7/6/2018 6:35 AM
Permit #	TBD	Inspection Type	VA SWPP	Station Begin	11260+00
State	VA	Inspection Area	Full	Station End	11550+00
County	Giles	Ground	Dusty	Temperature (°F)	82.00
Municipality	N/A	Weather	Sunny	Rain Gauge (in)	0.00
GPS Location	37.3193250038077, -80.6579211541271			Rain Accumulation Time (days)	1.00

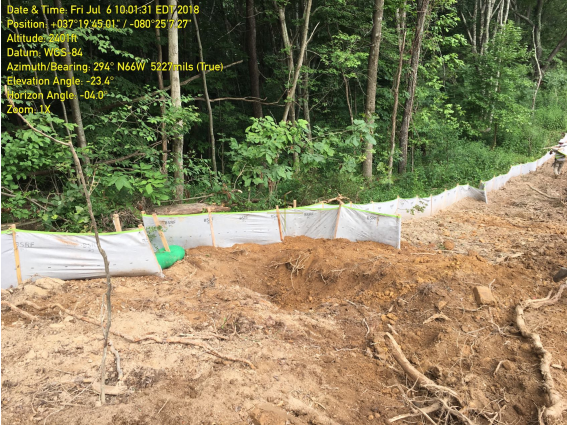
GPS Location	37.3192473035653, -80.6579597108817	GPS Location	37.3193081561824, -80.6579062343395		
Description	Crew installed new end treatments @ MP 218.5	Description	Problem area end treatments @ MP 218.5		
<p>Date & Time: Fri Jul 6 10:01:31 EDT 2018 Position: +037°19'45.01" / -080°25'52.27" Altitude: 2401ft Datum: WGS-84 Azimuth/Bearing: 322° N88W 572mils (True) Elevation Angle: -16.6° Horizon Angle: -01.0° Zoom: 1X</p>

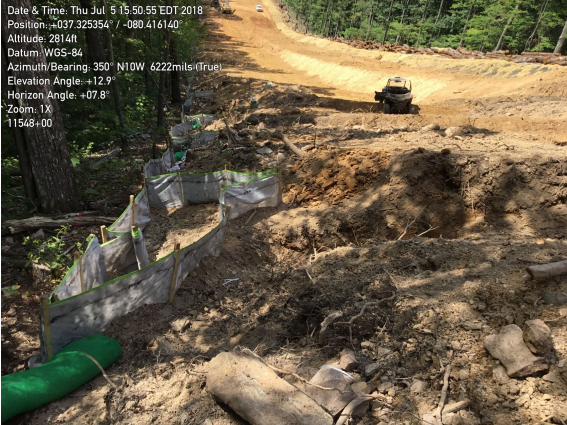
4. E&S BMPs (List BMPs and note if installed and maintained as per the plan. If corrective action is needed, a picture is required.)					
E&S BMPs		Compliance Level	Corrective Action	Corrective Time Frame	
Compost Filter Sock		Acceptable		Addressed	
Rock Construction Entrance		Acceptable		Addressed	
Silt Fence (Filter Fabric Fence)		Acceptable		Addressed	
Silt Fence (Reinforced Filter Fabric Fence)		Acceptable		Addressed	
Waterbar		Acceptable		Addressed	
Waterbar Outlet Protection		Problem Area		24 Hours

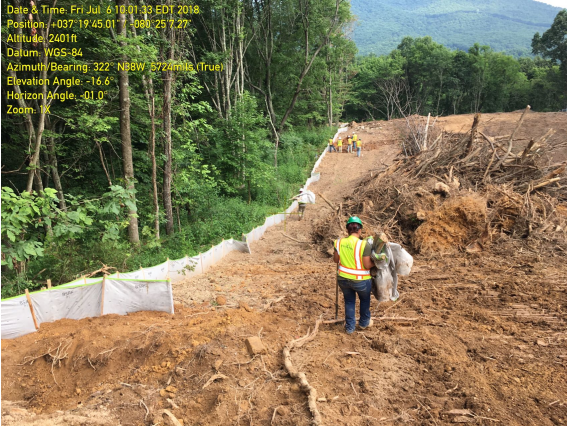
GPS Location	37.3193075275396, -80.6579052285111	GPS Location	37.3193075275396, -80.6579052285111		
Description	Crew re installing end treatments @ MP 218.5	Description	Water bar and end treatment acceptable @ MP 216		
<p>Date & Time: Fri Jul 6 12:00:32 EDT 2018 Position: +037°18'2.54" / -080°25'20.32" Altitude: 2164ft Datum: WGS-84 Azimuth/Bearing: 264° S64W 439mils (True) Elevation Angle: -04.1° Horizon Angle: +00.4° Zoom: 2X</p>

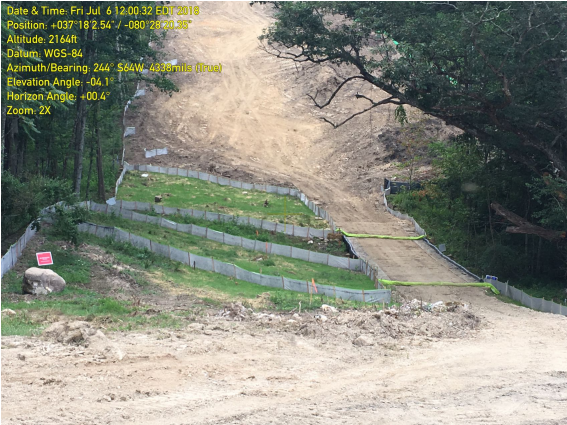
GPS Location	37.3193075275396, -80.6579052285111	GPS Location	37.3193075275396, -80.6579052285111		
Description	Aquatic Buffer, and ecds's for stream crossing S-NN12	Description	Aquatic Buffer and ECD's for stream crossing @ S-NN11
