# Visual Site Inspection Report

<b>Project Name</b>	H-600 Pipeline Spread G		<b>A/E</b>	124300137	<b>Spread</b>	H-600 Pipeline Spread G	
<b>Contractor</b>	Precision				<b>Report #</b>	5103	
<b>Inspector</b>	Garrett Barclay				<b>Date/Time</b>	7/24/2018 5:21 PM	
<b>Permit #</b>	TBD	<b>Inspection Type</b>	VA SWPP		<b>Station Begin</b>	11330+00	
<b>State</b>	VA	<b>Inspection Area</b>	Full		<b>Station End</b>	11550+00	
<b>County</b>	Giles	<b>Ground</b>	Muddy		<b>Temperature (°F)</b>	76.00	
<b>Municipality</b>	N/A	<b>Weather</b>	Cloudy		<b>Rain Gauge (in)</b>	0.30	
<b>GPS Location</b>	37.2427716572184, -80.4292315711085				<b>Rain Accumulation Time (days)</b>	1.00

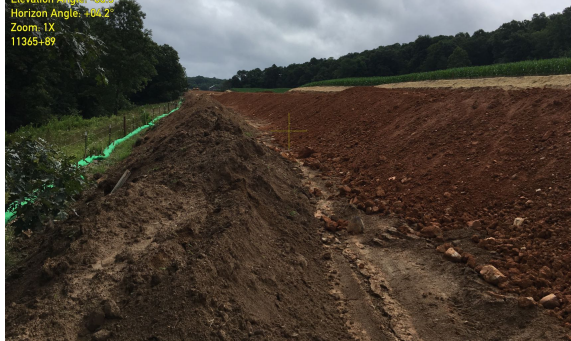
GPS Location	37.2428918118004, -80.4290457443152	GPS Location	37.2431792236562, -80.4290046120309		
Description	Soil segregation @ 11365+89	Description	Sediment off ROW @ 11485+00		
<p>Date &amp; Time: Tue Jul 24 12:11:14 EDT 2018 Position: +037°19'31.33" / -080°28'46.89" Altitude: 2226ft Datum: WGS-84 Azimuth/Bearing: 252° S77W-4569mils (True) Elevation Angle: -18.9° Horizon Angle: +01.4° Zoom: 1X 11500+00</p>

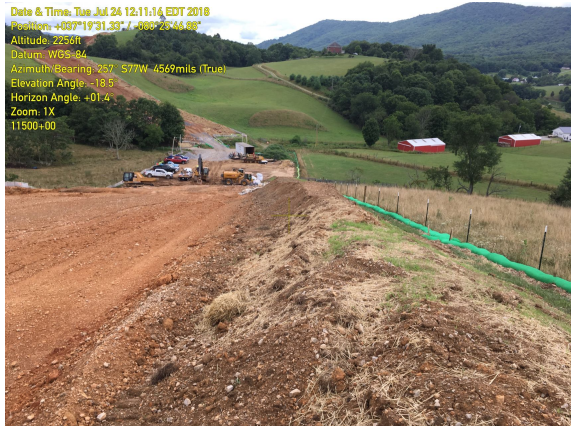
<b>A/E</b>	124300137	<b>Date/Time</b>	7/24/2018 5:21 PM	<b>Report #</b>	5103
<b>6. PCSM BMPs</b> (List BMPs and note if installed and maintained as per the plan. If corrective action is needed, a picture is required.)					
<b>PCSM BMPs</b>		<b>Compliance Level</b>	<b>Corrective Action</b>	<b>Corrective Time Frame</b>	
<b>7. Identify all remedial measures that have been taken since the previous inspection was conducted.</b>					
<b>Comments</b> (Reference above questions as appropriate.)					
Observed crews grading right of way from MP 213 - MP 218.5 Performed SWPP from MP 213 - MP 218.5 During SWPP observed sediment off ROW at 7 locations today. ECD's were overwhelmed from recent rain event. PAR were written for sediment off ROW. Lead EI and Land Agent were notified. Crews cleaned out sumps full from recent storm event. They also worked on end treatments and perimeter controls that were undermined or at capacity. Crew has improved there segregation of top soil and sub soil. See pictures below. Crew is working on stabilization of soil piles, still in progress

GPS Location	37.2427508700986, -80.4291688744728	GPS Location	37.2427508700986, -80.4291688744728		
Description	PAR for stabilization of soil pile @ 11500+00	Description	End treatment @ 11427+00		
<p>Date &amp; Time: Tue Jul 24 17:34:39 EDT 2018 Position: +037°18'54.30" / -080°27'30.22" Altitude: 2255ft Datum: WGS-84 Azimuth/Bearing: 039° N29E-5010mils (True) Elevation Angle: -23.7° Horizon Angle: +06.0° Zoom: 1X 11395+00</p>

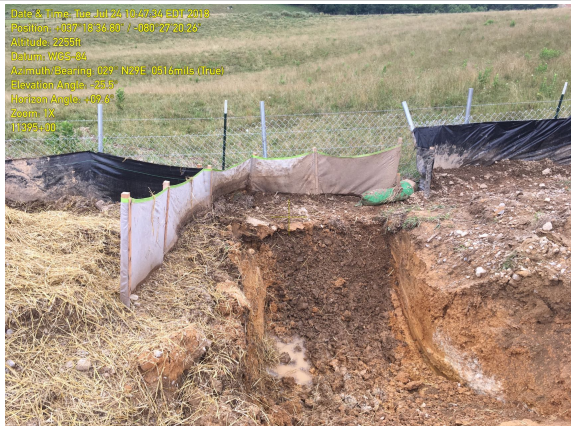
GPS Location	37.2427508700986, -80.4291688744728	GPS Location	37.2427508700986, -80.4291688744728		
Description	End treatment for water bar @ 11395+00	Description	Sediment off row @ 11395+00
