Visual Site Inspection Report

Project Name	H-600 Pipeline Spread G	A/E	124300137	Spread	H-600 Pipeline Spread G
Contractor	Precision			Report #	5458
Inspector	Garrett Barclay			Date/Time	7/30/2018 3:10 PM
Permit #	TBD	Inspection Type	VA SWPP	Station Begin	11330+00
State	VA	Inspection Area	Full	Station End	11550+00
County	Giles	Ground	Dusty	Temperature (°F)	84.00
Municipality	N/A	Weather	Cloudy	Rain Gauge (in)	0.00
GPS Location	37.309140069445, -80.4638267029826			Rain Accumulation Time (days)	1.00

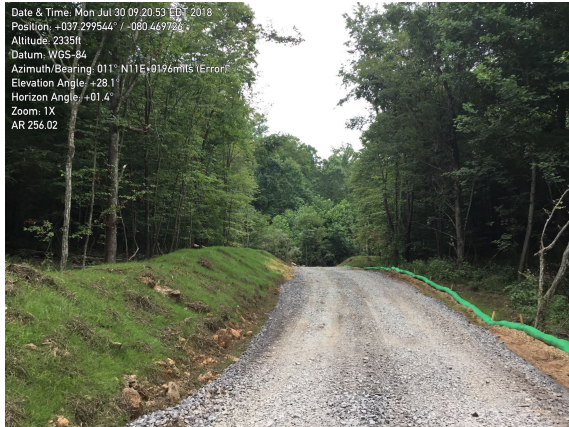
GPS Location	37.3091400694449, -80.4638267029826		GPS Location	37.3090470722293, -80.4639159702514	
Description	AR 256.02		Description	End treatment and water bar and stabilization @ 11339+00	
<p>Date & Time: Mon, Jul 30, 2018, 11:53:17 EDT Position: +037°17'20.89" / -080°28'20.07" Altitude: 2278ft Datum: WGS-84 Azimuth/Bearing: 245° S45W 4356mils (True) Elevation Angle: +05.5° Horizon Angle: -00.5° Zoom: 1X 11328+62</p>

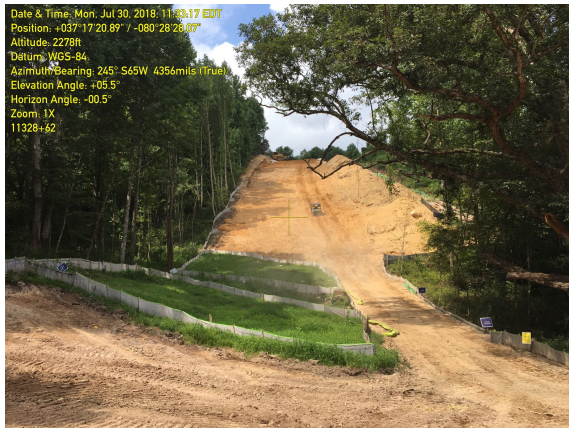
GPS Location	37.3090470722293, -80.4639159702514		GPS Location	37.3090470722293, -80.4639159702514	
Description	ECD's and mat bridge & aquatic Buffer @ 11328+62		Description	ECD's and mat bridge crossing @ 11353+61	
<p>Date & Time: Mon, Jul 30, 2018, 12:38:50 EDT Position: +037°18'14.17" / -080°28'7.31" Altitude: 2157ft Datum: WGS-84 Azimuth/Bearing: 004° N04E 0071mils (True) Elevation Angle: +15.7° Horizon Angle: -03.3° Zoom: 1X 11345+82</p>

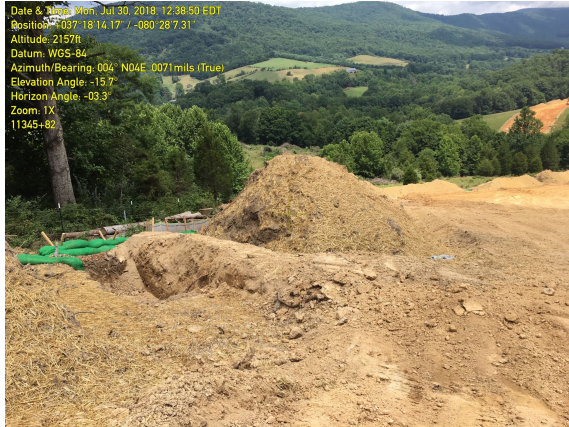
GPS Location	37.3090470722293, -80.4639159702514		GPS Location	37.3090470722293, -80.4639159702514	
Description	End treatment & water bar & stabilization @ 11345+82		Description	Mat bridge and ECD's @ 11353+61
