Visual Site Inspection Report

Project Name	H-600 Pipeline Spread G	AFE	124300137	Spread	H-600 Pipeline Spread G
Contractor	Precision			Report #	5749
Inspector	Garrett Barclay			Date/Time	8/3/2018 4:33 PM
Permit #	TBD	Inspection Type	VA SWPP	Station Begin	11330+00
State	VA	Inspection Area	Partial	Station End	11550+00
County	Giles	Ground	Wet	Temperature (°F)	73.00
Municipality	N/A	Weather	Light Rain	Rain Gauge (in)	2.00
GPS Location	37.2430376633739, -80.4290821713844			Rain Accumulation Time (days)	1.00

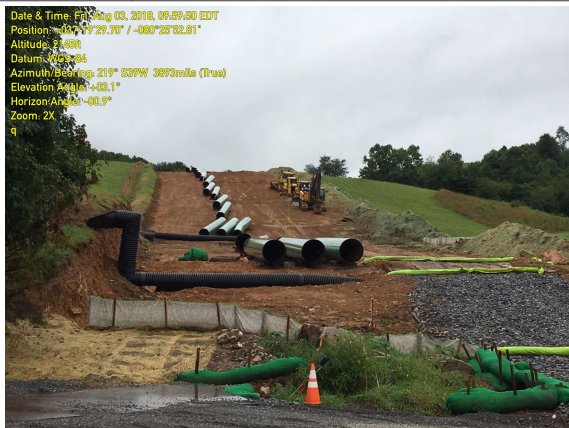
GPS Location	37.2426639497627, -80.4292558786277	GPS Location	37.2426639497627, -80.4292558786277		
Description	ROW conditions @ MP 217	Description	P1 overwhelmed @ MP 217		
<p>Date & Time: Fri, Aug 03, 2018, 10:06:19 EDT Position: +037°19'29.21" / -080°28'54.18" Altitude: 2161ft Datum: WGS-84 Azimuth/Bearing: 299° N61W 5316mils (True) Elevation Angle: -14.4° Horizon Angle: -01.2° Zoom: 1X 114891558</p>
