# Visual Site Inspection Report

<b>Project Name</b>	H-600 Pipeline Spread G	<b>AFE</b>	124300137	<b>Spread</b>	H-600 Pipeline Spread G
<b>Contractor</b>	Precision			<b>Report #</b>	6097
<b>Inspector</b>	Garrett Barclay			<b>Date/Time</b>	8/9/2018 6:24 PM
<b>Permit #</b>	TBD	<b>Inspection Type</b>	VA SWPP	<b>Station Begin</b>	11200+00
<b>State</b>	VA	<b>Inspection Area</b>	Partial	<b>Station End</b>	11550+00
<b>County</b>	Giles	<b>Ground</b>	Dusty	<b>Temperature (°F)</b>	80.00
<b>Municipality</b>	N/A	<b>Weather</b>	Sunny	<b>Rain Gauge (in)</b>	0.00
<b>GPS Location</b>	37.2426388878722, -80.4293877259646			<b>Rain Accumulation Time (days)</b>	1.00

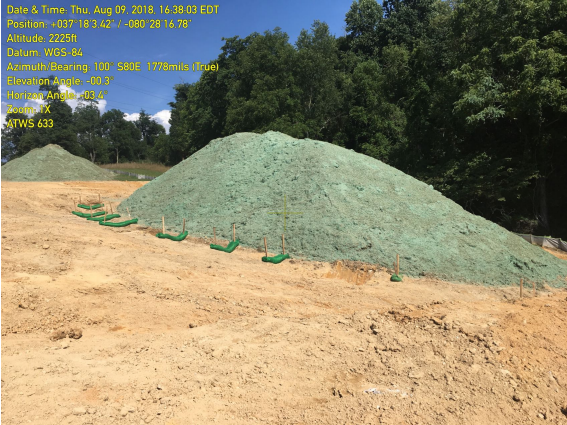
<b>GPS Location</b>	37.2427156661053, -80.4293111153696	<b>GPS Location</b>	37.2429537616355, -80.4291956842481		
<b>Description</b>	Stabilization and diversion channel @ ATWS 633	<b>Description</b>	Water bar and end treatments @ ATWS 633		
<p>Date &amp; Time: Thu, Aug 09, 2018, 15:54:00 EDT  Position: +037°18'1.29"/-080°28'24.17"  Altitude: 2190ft  Datum: WGS-84  Azimuth/Bearing: 142°53'38" (True)  Elevation Angle: -14.7°  Horizon Angle: +05.8°  Zoom: 1X  MP 215</p>

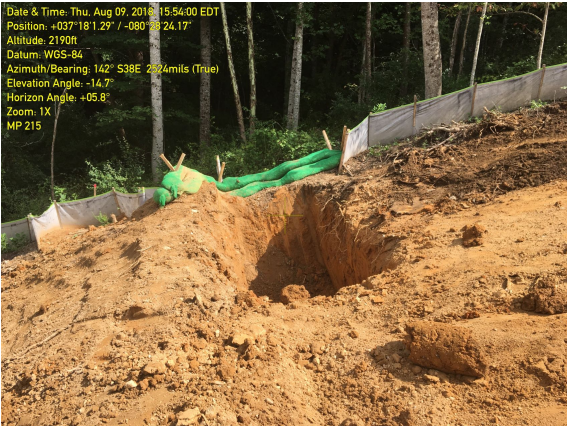
<b>GPS Location</b>	37.2427450446759, -80.4292358458791	<b>GPS Location</b>	37.2427450446759, -80.4292358458791		
<b>Description</b>	Water bars and end treatments @ MP 214.5	<b>Description</b>	Sump checks and end treatments @ ATWS 633		
<p>Date &amp; Time: Thu, Aug 09, 2018, 15:19:08 EDT  Position: +037°18'2.89"/-080°28'21.56"  Altitude: 2158ft  Datum: WGS-84  Azimuth/Bearing: 304°N54W-3440mils (True)  Elevation Angle: -10.1°  Horizon Angle: -02.9°  Zoom: 1X  ATWS633</p>

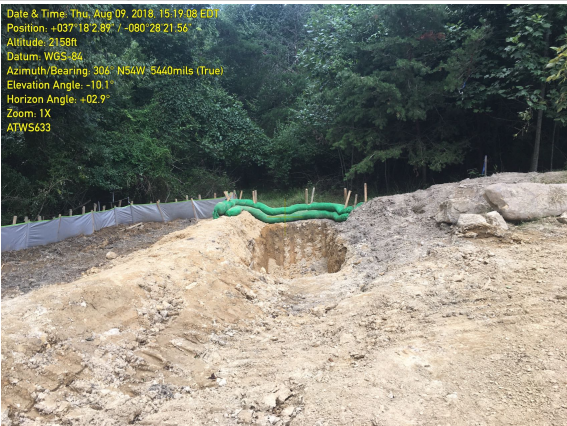
<b>GPS Location</b>	37.2427450446759, -80.4292358458791	<b>GPS Location</b>	37.2427450446759, -80.4292358458791		
<b>Description</b>	Water bars and end treatments @ ATWS 633	<b>Description</b>	Water bar and end treatment @ MP 214.5
