Visual Site Inspection Report

Project Name	H-600 Pipeline Spread G	AFE	124300137	Spread	H-600 Pipeline Spread G
Contractor	Precision			Report #	6383
Inspector	Garrett Barclay			Date/Time	8/15/2018 5:03 PM
Permit #	TBD	Inspection Type	VA SWPP	Station Begin	11330+00
State	VA	Inspection Area	Partial	Station End	11550+00
County	Giles	Ground	Damp	Temperature (°F)	75.00
Municipality	N/A	Weather	Sunny	Rain Gauge (in)	0.00
GPS Location	37.2427655803386, -80.4293250293289			Rain Accumulation Time (days)	1.00

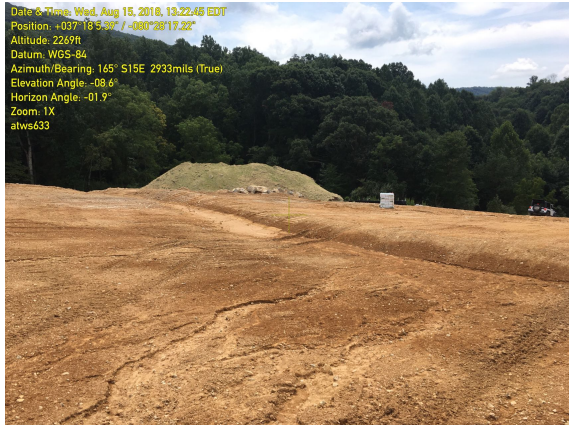
A/E	124300137	Date/Time	8/15/2018 5:03 PM	Report #	6383
Pictures					
<p>Date & Time: Wed, Aug 15, 2018, 13:22:45 EDT Position: +037°18'5.35" / -080°28'17.22" Altitude: 2269ft Datum: WGS-84 Azimuth/Bearing: 165° S15E 2933mils (True) Elevation Angle: -08.6° Horizon Angle: -01.9° Zoom: 1X atws633</p>

GPS Location	37.2426868742679, -80.4292876460407	GPS Location	37.2426868742679, -80.4292876460407		
Description	Water bar holding water @ ATWS 633	Description	Rill erosion @ 11422+48		
<p>Date & Time: Wed, Aug 15, 2018, 16:30:37 EDT Position: +037°30'31.79" / -080°55'14.68" Altitude: 2280ft Datum: WGS-84 Azimuth/Bearing: 345° N15W 6133mils (True) Elevation Angle: +20.7° Horizon Angle: +03.9° Zoom: 1X 11422+48</p>

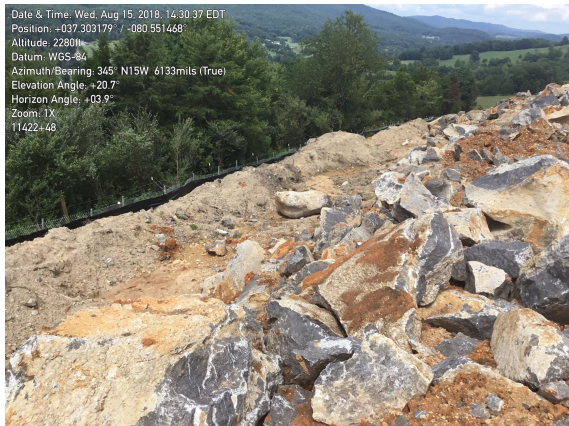
GPS Location	37.2426174721096, -80.4291811958704	GPS Location	37.2426174721096, -80.4291811958704		
Description	Stabilization recommended @ 11422+48	Description	End treatment undermined @ ATWS 633		
<p>Date & Time: Wed, Aug 15, 2018, 11:38:08 EDT Position: +037°29'43.85" / -080°48'35.0" Altitude: 2264ft Datum: WGS-84 Azimuth/Bearing: 257° S77W 4569mils (True) Elevation Angle: +26.4° Horizon Angle: +00.7° Zoom: 1X MP 213</p>

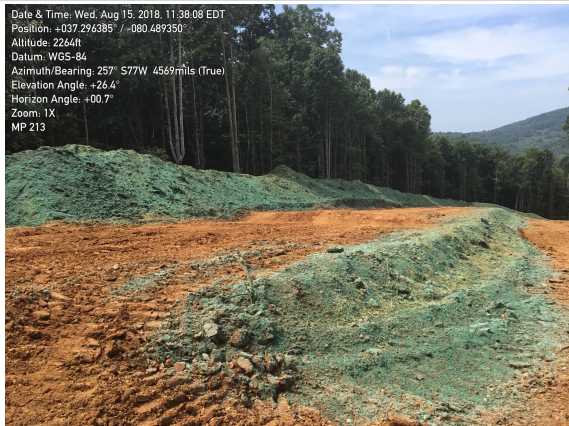
GPS Location	37.2426174721096, -80.4291811958704	GPS Location	37.2426174721096, -80.4291811958704		
Description	Stabilization with hydro seed @ MP 213	Description	ROW conditions @ 11291+00
