# Visual Site Inspection Report

<b>Project Name</b>	H-600 Pipeline Spread G	<b>AFE</b>	124300137	<b>Spread</b>	H-600 Pipeline Spread G
<b>Contractor</b>	Precision			<b>Report #</b>	6685
<b>Inspector</b>	Garrett Barclay			<b>Date/Time</b>	8/21/2018 12:02 PM
<b>Permit #</b>	TBD	<b>Inspection Type</b>	VA SWPP	<b>Station Begin</b>	11200+00
<b>State</b>	VA	<b>Inspection Area</b>	Partial	<b>Station End</b>	11400+00
<b>County</b>	Giles	<b>Ground</b>	Muddy	<b>Temperature (°F)</b>	75.00
<b>Municipality</b>	N/A	<b>Weather</b>	Cloudy	<b>Rain Gauge (in)</b>	0.20
<b>GPS Location</b>	37.2966046398853, -80.4794360698019			<b>Rain Accumulation Time (days)</b>	1.00

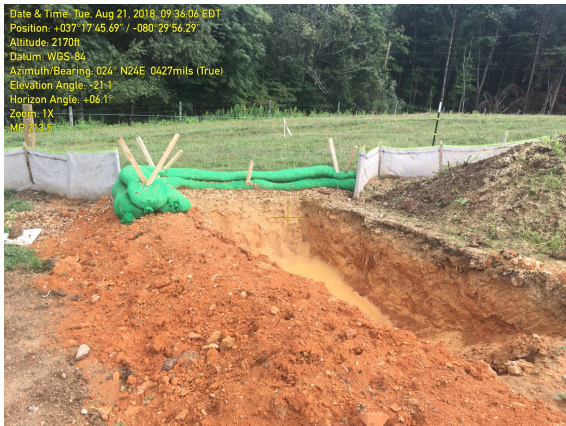
GPS Location	37.2966559371327, -80.479388879687	GPS Location	37.2964683082302, -80.4794883728777		
Description	Row conditions @ s-nn11	Description	End treatment @ mp 213.5		
<p>Date &amp; Time: Tue, Aug 21, 2018, 09:39:42 EDT Position: +037°17'47.47" / -080°28'49.06" Altitude: 2170ft Datum: WGS-84 Azimuth/Bearing: 308° N69W 5458mils (True) Elevation Angle: +18.2° Horizon Angle: +01.5° Zoom: 1X MP 213.5m</p>  		<p>Date &amp; Time: Tue, Aug 21, 2018, 09:40:42 EDT Position: +037°17'46.80" / -080°28'50.07" Altitude: 2139ft Datum: WGS-84 Azimuth/Bearing: 248° S88W 4888mils (True) Elevation Angle: -09.9° Horizon Angle: +00.9° Zoom: 1X MP 213.5m</p>  			
GPS Location	37.296720058692, -80.4794340581451	GPS Location	37.296720058692, -80.4794340581451		
Description	End treatment @ Mp 213.5	Description	Row conditions @ S-mm18
