Visual Site Inspection Report

Project Name	H-600 Pipeline Spread G	AFE	124300137	Spread	H-600 Pipeline Spread G
Contractor	Precision			Report #	7224
Inspector	Garrett Barclay			Date/Time	8/31/2018 4:23 PM
Permit #	TBD	Inspection Type	VA SWPP	Station Begin	11290+00
State	VA	Inspection Area	Full	Station End	11440+00
County	Giles	Ground	Damp	Temperature (°F)	78.00
Municipality	N/A	Weather	Cloudy	Rain Gauge (in)	0.75
GPS Location	37.2427789494742, -80.4291549605135			Rain Accumulation Time (days)	1.00

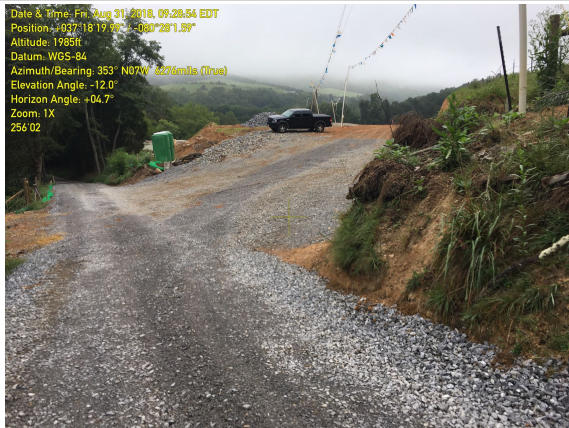
GPS Location	37.2426711581994, -80.4292413779352	GPS Location	37.2426711581994, -80.4292413779352		
Description	RCE for 256.02	Description	Sump, end treatment, and water bar @ 11290+00
