Visual Site Inspection Report

Project Name	H-600 Pipeline Spread G	AFE	124300137	Spread	H-600 Pipeline Spread G
Contractor	Precision			Report #	7442
Inspector	Garrett Barclay			Date/Time	9/6/2018 4:29 PM
Permit #	TBD	Inspection Type	VA SWPP	Station Begin	11290+00
State	VA	Inspection Area	Full	Station End	11440+00
County	Giles	Ground	Dry	Temperature (°F)	86.00
Municipality	N/A	Weather	Sunny	Rain Gauge (in)	0.00
GPS Location	37.2427855292682, -80.4292274639759			Rain Accumulation Time (days)	1.00

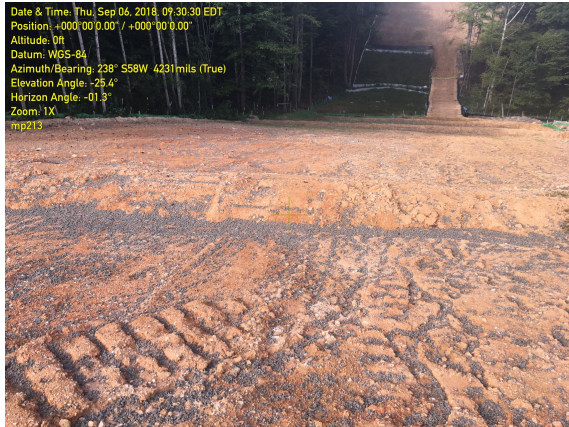
GPS Location	37.2426508739937, -80.4292521067713	GPS Location	37.2430301948381, -80.4292957828921		
Description	Stabilization 'growth' @ MP 213	Description	Stabilization growth @ S#MM18		
<p>Date & Time: Thu, Sep 06, 2018, 12:16:21 EDT Position: +037°12'40.37" / -080°28'36.67" Altitude: 2108ft Datum: WGS-84 Azimuth/Bearing: 350° N10W 6222mils (True) Elevation Angle: -20.8° Horizon Angle: +00.4° Zoom: 1X 11349+00</p>

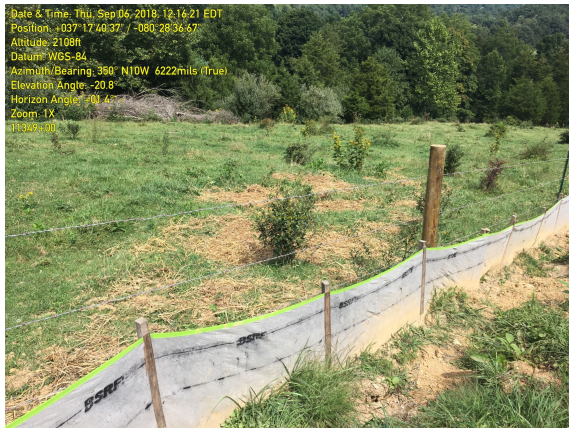
7. Identify all remedial measures that have been taken since the previous inspection was conducted.					
Comments (Reference above questions as appropriate.)					
Performed SWPP from MP 213 - MP 216 Crews have been working on installing access for LO per Land Agent and Environmental Coordinator request. In doing so some ECD's were removed to allow access for LO. Crews have also been installing controls and performing maintenance on existing controls. Crews have also retrieved sediment approved for retrieval in this area Observed crews installing flume pipe for a water bar @ ATWS 633, and also installed rock for LO access. Flume and rock were discussed being installed with Land Agent, Environmental Coordinator, and Foreman. Observed crew installing CFS, and perimeter fence @ 11350+00. Controls and new fence are being installed per LO. Land Agent, Environmental Coordinator, and Ast Superintendent approval. During SWPP did not observe any damaged ECD's or new sediment off ROW. Stabilization applied still has not shown much growth, only in a few small spots. Observed crews retrieving sediment @ 11349+00, crews seeded and stabilized after sediment was removed No environmental concerns at this time

GPS Location	37.2427232936371, -80.4291075189416	GPS Location	37.2427232936371, -80.4291075189416		
Description	Sediment retrieved from outside LOD @ 11349+00	Description	Water bar and end treatment @ Mp 213		
<p>Date & Time: Thu, Sep 06, 2018, 09:30:33 EDT Position: +000°00'0.00" / +000°00'0.00" Altitude: 0ft Datum: WGS-84 Azimuth/Bearing: 220° N20E 4444mils (True) Elevation Angle: -15.0° Horizon Angle: +12.2° Zoom: 1X smm18</p>

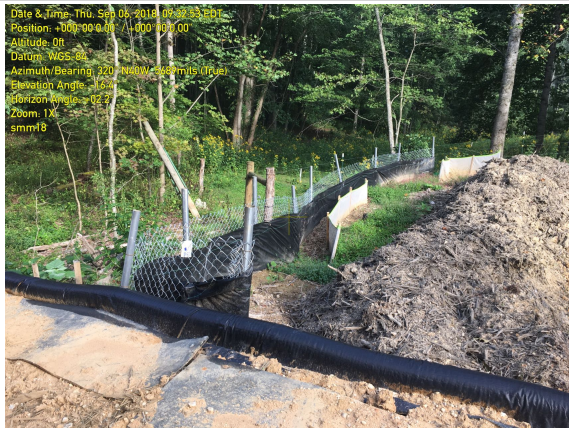
GPS Location	37.2427232936371, -80.4291075189416	GPS Location	37.2427740041513, -80.4291293118898		
Description	ECD's installed @ S-MM18	Description	ROW conditions @ MP 213.5
