Visual Site Inspection Report

Project Name	H-600 Pipeline Spread G	AFE	124300137	Spread	H-600 Pipeline Spread G
Contractor	Precision			Report #	7759
Inspector	Garrett Barclay			Date/Time	9/12/2018 1:15 PM
Permit #	TBD	Inspection Type	VA SWPP	Station Begin	11290+00
State	VA	Inspection Area	Full	Station End	11440+00
County	Giles	Ground	Muddy	Temperature (°F)	72.00
Municipality	N/A	Weather	Cloudy	Rain Gauge (in)	0.60
GPS Location	37.2426591301684, -80.4293622449789			Rain Accumulation Time (days)	1.00

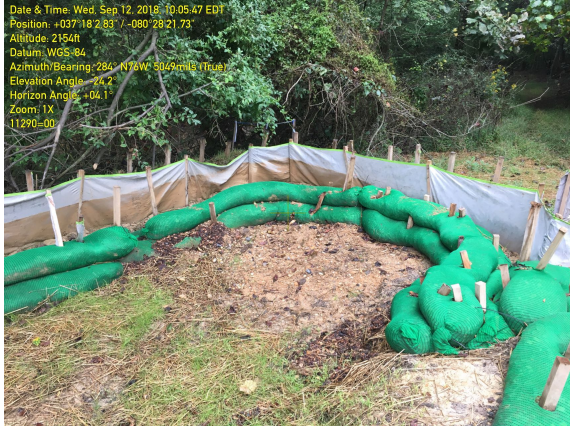
GPS Location 37.242701835965, -80.4293448944394	
Description ECD's @ 11290+00		Description CFS and P1 @ SnN12		GPS Location 37.2429788146396, -80.4292755162028	
<p>Date & Time: Wed, Sep 12, 2018, 10:07:03 EDT Position: +037°18'1.66" / -080°28'23.07" Altitude: 2158ft Datum: WGS-84 Azimuth/Bearing: 230° S50W 4089mils (True) Elevation Angle: -11.3° Horizon Angle: -02.4° Zoom: 1X 11327+34</p>

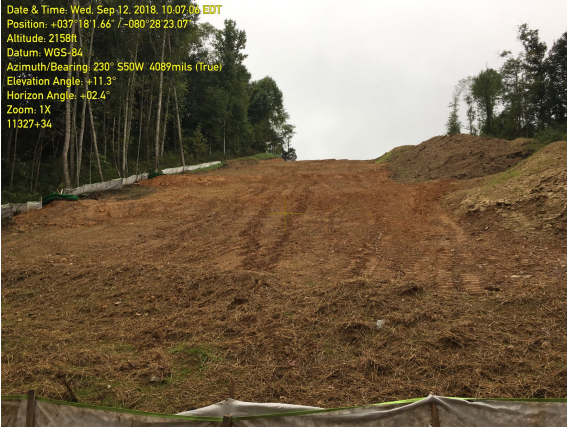
Description ROW conditions @ 11327+34		Description Flumed water bar installed @ 11330+00		GPS Location 37.2426622314725, -80.4293291364614	
<p>Date & Time: Wed, Sep 12, 2018, 10:11:25 EDT Position: +037°18'1.64" / -080°28'19.56" Altitude: 2183ft Datum: WGS-84 Azimuth/Bearing: 050° N50E 6889mils (True) Elevation Angle: -10.3° Horizon Angle: -03.4° Zoom: 1X 11327+34</p>  		<p>Date & Time: Wed, Sep 12, 2018, 10:28:11 EDT Position: +037°18'24.94" / -080°28'11.05" Altitude: 1984ft Datum: WGS-84 Azimuth/Bearing: 329° N31W 5849mils (True) Elevation Angle: -23.4° Horizon Angle: -01.2° Zoom: 1X 11300+00</p>  		GPS Location 37.2427048953597, -80.4293479957436	
Description Stabilization growth @ ATWS 633		Description Water bar end treatment @ MP 215		GPS Location 37.2427048953597, -80.4293479957436
