Visual Site Inspection Report

Project Name	H-600 Pipeline Spread G	AFE	124300137	Spread	H-600 Pipeline Spread G
Contractor	Precision			Report #	8058
Inspector	Garrett Barclay			Date/Time	9/18/2018 4:45 PM
Permit #	TBD	Inspection Type	VA SWPP	Station Begin	11258+00
State	VA	Inspection Area	Full	Station End	11426+00
County	Giles	Ground	Muddy	Temperature (°F)	76.00
Municipality	N/A	Weather	Cloudy	Rain Gauge (in)	0.90
GPS Location	37.2429565395277, -80.4292294091193			Rain Accumulation Time (days)	1.00

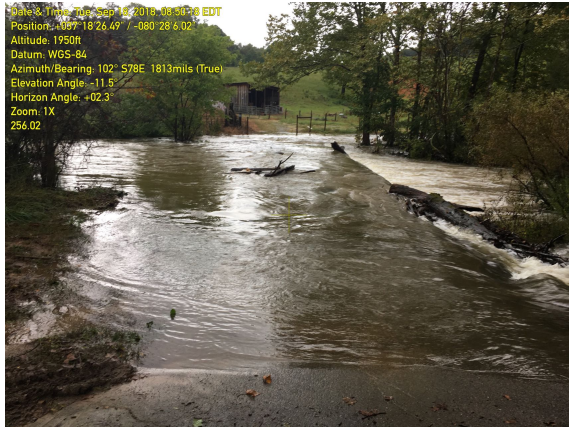
GPS Location	37.2426662128766, -80.4291291442517	GPS Location	37.242687209544, -80.4292908311639		
Description	Road to AR 256.02 flooded	Description	Deep rill erosion @ 11285+00		
<p>Date & Time: Tue, Sep 18, 2018, 11:05:30 EDT Position: +037° 17' 50.00" / -080° 28' 37.35" Altitude: 1720ft Datum: WGS-84 Azimuth/Bearing: 087° N07E 1547mils (True) Elevation Angle: -02.6° Horizon Angle: -00.2° Zoom: 1X 11290+00</p>

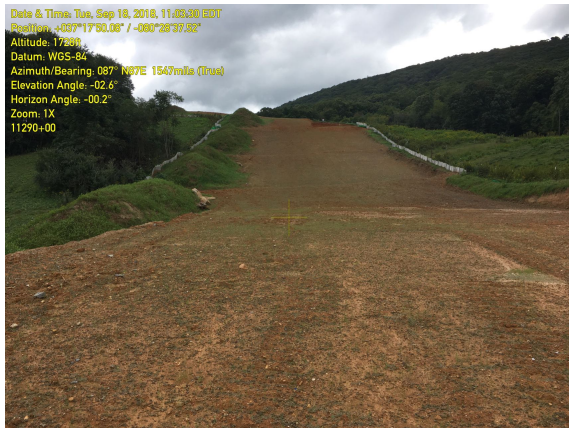
GPS Location	37.242687209544, -80.4292908311639	GPS Location	37.242687209544, -80.4292908311639		
Description	ROW conditions @ 11290+00	Description	ECD,S @ S-mm18		
<p>Date & Time: Tue, Sep 18, 2018, 12:26:00 EDT Position: +037° 18' 42.50" / -080° 27' 7.96" Altitude: 2220ft Datum: WGS-84 Azimuth/Bearing: 033° N03E 3387mils (True) Elevation Angle: -28.9° Horizon Angle: -12.8° Zoom: 1X 11407+00</p>

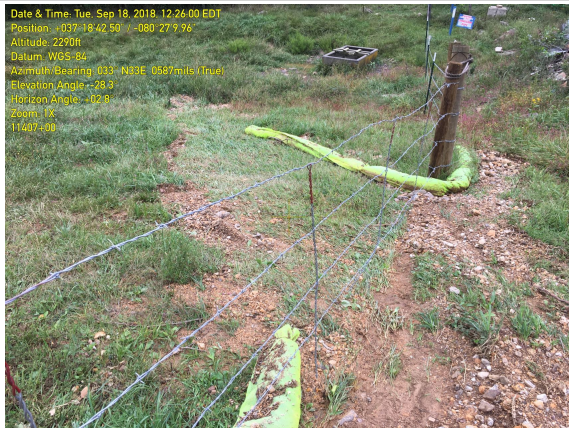
GPS Location	37.242687209544, -80.4292908311639	GPS Location	37.242687209544, -80.4292908311639		
Description	Sediment off ROW @ 11407+00	Description	Sediment off ROW @ 11418+00
