Visual Site Inspection Report

Project Name	H-600 Pipeline Spread G	AFE	124300137	Spread	H-600 Pipeline Spread G
Contractor	Precision			Report #	8845
Inspector	Garrett Barclay			Date/Time	10/4/2018 12:18 PM
Permit #	TBD	Inspection Type	VA SWPP	Station Begin	11226+98
State	VA	Inspection Area	Partial	Station End	11432+00
County	Giles	Ground	Dry	Temperature (°F)	75.00
Municipality	N/A	Weather	Sunny	Rain Gauge (in)	0.00
GPS Location	37.3133561667402, -80.4505291488771			Rain Accumulation Time (days)	1.00

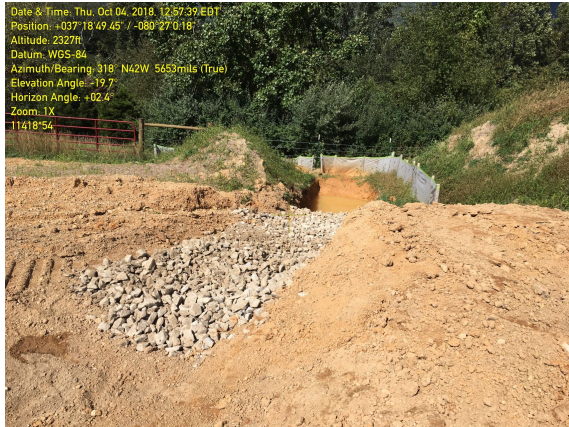
GPS Location	37.3133561667402, -80.4505291488771	GPS Location	37.3133561667402, -80.4505291488771		
Description	Rock lined channel for water bar @ 11418+00	Description	ECD's for KaRst feature @ 11388+00		
<p>Date & Time: Thu, Oct 04, 2018, 13:05:32 EDT Position: +037°18'48.89" / -080°27'1.70" Altitude: 2226ft Datum: WGS-84 Azimuth/Bearing: 233° S53W 4142mils (True) Elevation Angle: -10.9° Horizon Angle: +00.3° Zoom: 1X 11399+00</p>

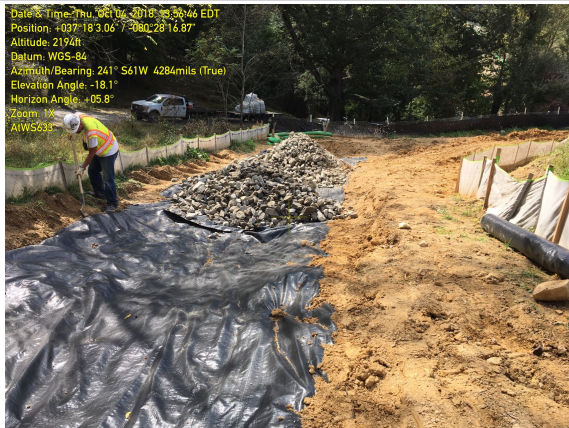
GPS Location	37.3133171070715, -80.4505755008016	GPS Location	37.3133171070715, -80.4505755008016		
Description	Crews installing rock lined channel @ ATWS 633	Description	Crews repairing water bars @ 11322+00
