# Visual Site Inspection Report

<b>Project Name</b>	H-600 Pipeline Spread G		<b>AFE</b>	124300137	<b>Spread</b>	H-600 Pipeline Spread G	
<b>Contractor</b>	Precision				<b>Report #</b>	2050	
<b>Inspector</b>	Jared Saunders				<b>Date/Time</b>	5/22/2018 5:54 AM	
<b>Permit #</b>	TBD	<b>Inspection Type</b>	VA SWPP		<b>Station Begin</b>	11788+00	
<b>State</b>	VA	<b>Inspection Area</b>	Partial		<b>Station End</b>	11900+00	
<b>County</b>	Montgomery	<b>Ground</b>	Dry		<b>Temperature (°F)</b>	80.00	
<b>Municipality</b>	N/A	<b>Weather</b>	Sunny		<b>Rain Gauge (in)</b>	0.00	
<b>GPS Location</b>	37.3506902304549, -80.7657250547364				<b>Rain Accumulation Time (days)</b>	0.00

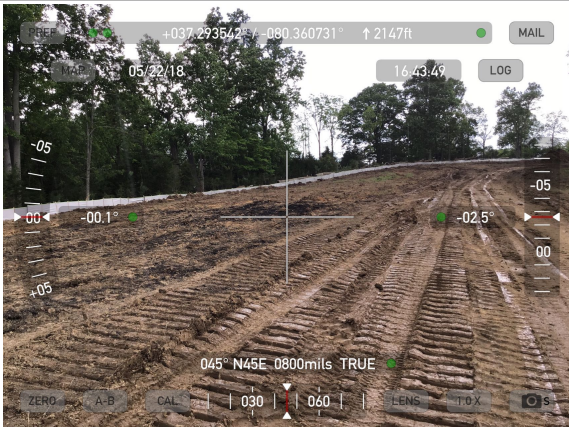
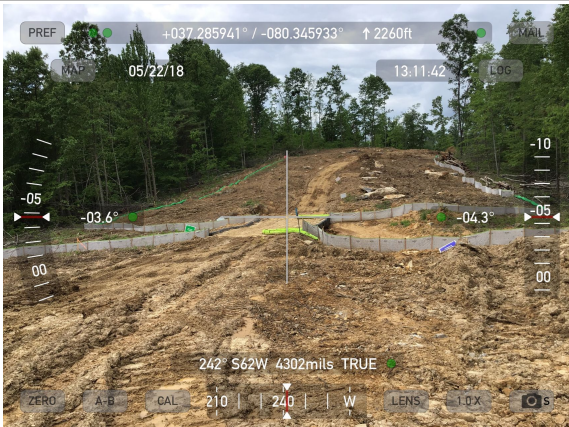
<b>GPS Location</b>	37.2958248295237, -80.361214103252	<b>GPS Location</b>	37.2958248295237, -80.361214103252		
<b>Description</b>	See photo for GPS location. P-1 silt fence installed at MP 223.65.	<b>Description</b>	See photo for GPS location. ECDs in place at wetland P-KL2 crossing located at MP 224.7

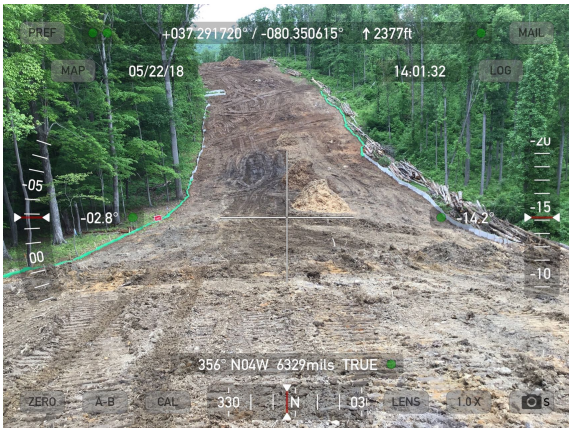
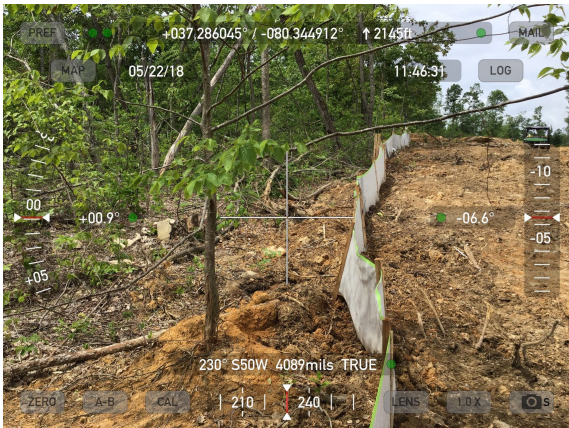
<b>GPS Location</b>	37.2961164778446, -80.3608965967599	<b>GPS Location</b>	37.2961164778446, -80.3608965967599		
<b>Description</b>	See photo for GPS location. ECDs in place at MP 224.22.	<b>Description</b>	See photo for GPS location. P-1 silt fence in place at MP 224.72

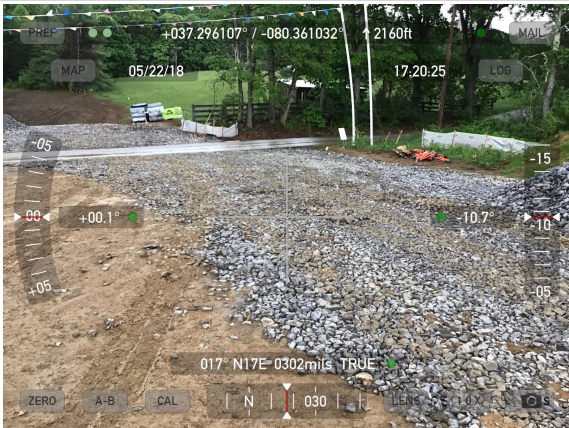
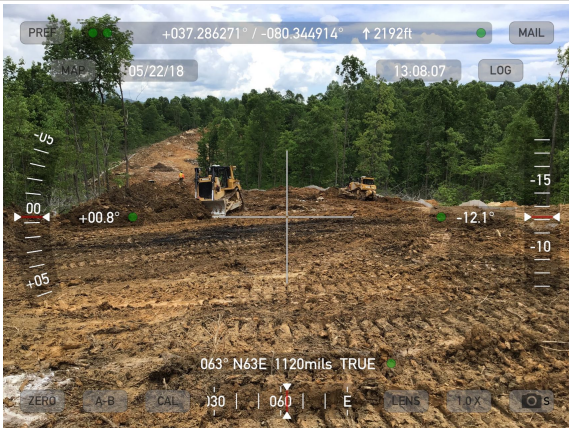
<b>GPS Location</b>	37.2967716694643, -80.3602556575819	<b>GPS Location</b>	37.2967716694643, -80.3602556575819		
<b>Description</b>	See photo for GPS location. RCE in place at MP 223.27	<b>Description</b>	See photo for GPS location. Top soil being stripped at MP 224.77
