Visual Site Inspection Report

Project Name	H-600 Pipeline Spread G		A/E	124300137	Spread	H-600 Pipeline Spread G	
Contractor	Precision				Report #	3333	
Inspector	Jared Saunders				Date/Time	6/20/2018 4:26 PM	
Permit #	TBD	Inspection Type	VA SWPP		Station Begin	11290+00	
State	VA	Inspection Area	Partial		Station End	11470+00	
County	Montgomery	Ground	Dry		Temperature (°F)	85.00	
Municipality	N/A	Weather	Sunny		Rain Gauge (in)	0.01	
GPS Location	37.296574, -80.500535				Rain Accumulation Time (days)	0.01

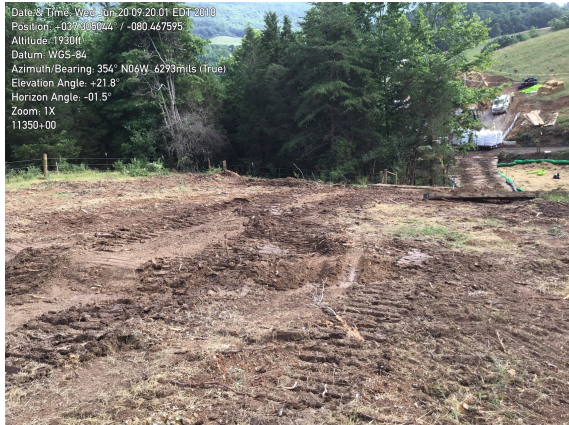
</div></div>			
GPS Location	37.3000643961479, -80.4822336976235	GPS Location	37.3000643961479, -80.4822336976235		
Description	See photo for GPS location and station number. Top soil needs stripped to prevent soil mixing.	Description	See photo for GPS location and station number. Side rail being installed on air bridge.		
<div><div><div>Date & Time: Wed Jun 20 13:05:10 EDT 2018 Position: +037.299700 / -080.481953 Altitude: 2032ft Datum: WGS-84 Azimuth/Bearing: 330° N06W 6636mils (True) Elevation Angle: +33.1° Horizon Angle: +01.5° Zoom: 1X 11361+00</div>

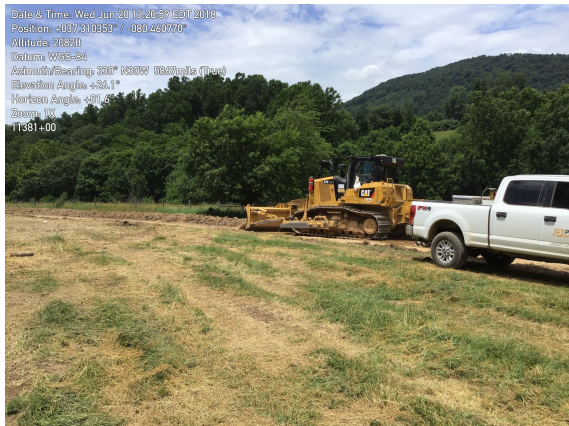
GPS Location	37.2997004539122, -80.4819530715053	GPS Location	37.2999988077556, -80.4820122477417		
Description	See photo for GPS location and station number. Stripping top soil.	Description	See photo for GPS location and station number. Buffer zones ECDs installed at stream.		
Insert image here		Insert image here			
GPS Location		GPS Location			
Description		Description
